Manhole Inspection Report

Date:	04/13/2018	Weather:		Coding:	RZMACP
MH#:	M-910-029	Owner:	NA	Len. Surveyed:	4.7
P.O.#:		Surveyor:	John Kuglmaier	Rim to Invert:	5.2
Customer:		Cert. #:	U-1215-07002349	Wall Material:	Concrete (reinforced)

Street:	434' Southeast of Norris Dr.	Project:	Hobart, IN
City:	Hobart, IN	GPS Northing:	2911941.081
Location:		GPS Easting:	2911941.081
Drain Area:	Southeast	GPS Accuracy:	Sub-Meter
Cover Shape:	Circular	Evidence of Surcharge:	Yes
Cover Size:	29.0	Potential for Runoff:	None
Comments:	29 inch lid too large for 22.5 hole

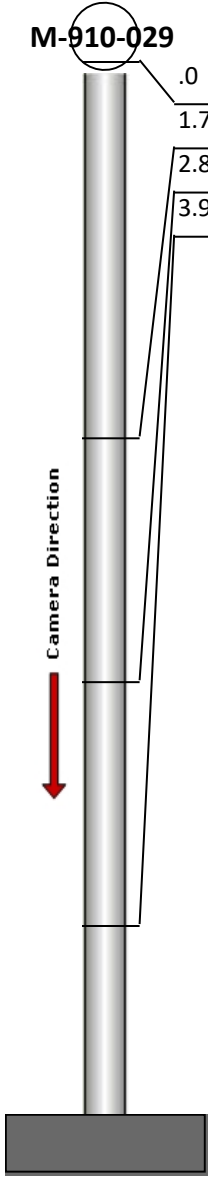
Position	Code	Observation	Video (sec)	Grade

.0	MGP	General Photo	10	NA
	1.7	MGP	General Photo	27	NA
	2.8	DAZ	Deposits Attached Other	43	M 2
	3.9	MGO	General Observation	57	NA
