## Profile/Photo Observation Report

| Street: | <b>3770 34th Ave</b> | Flow Control: | <b>Not Controlled</b> |
| US MH: | <b>M-902-032A</b> | DS MH: | <b>M-902-027</b> |

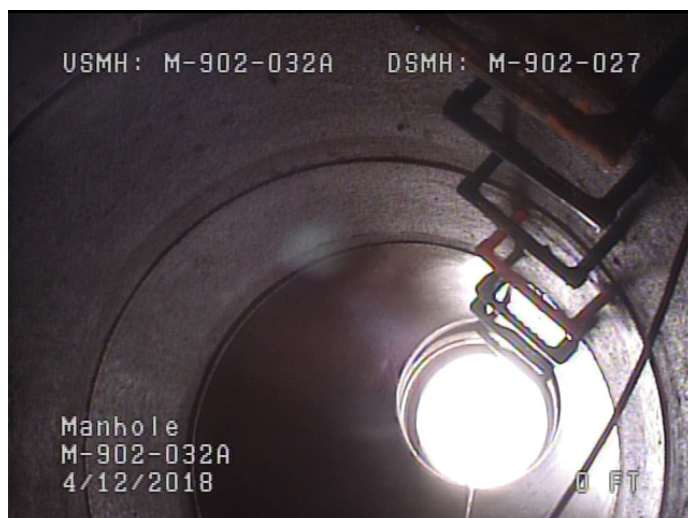
| Code: | <b>AMH</b> |
| Description: | <b>Manhole</b> |
| Distance (ft): | <b>.0</b> |
| Remarks: | <b>M-902-032A</b> |

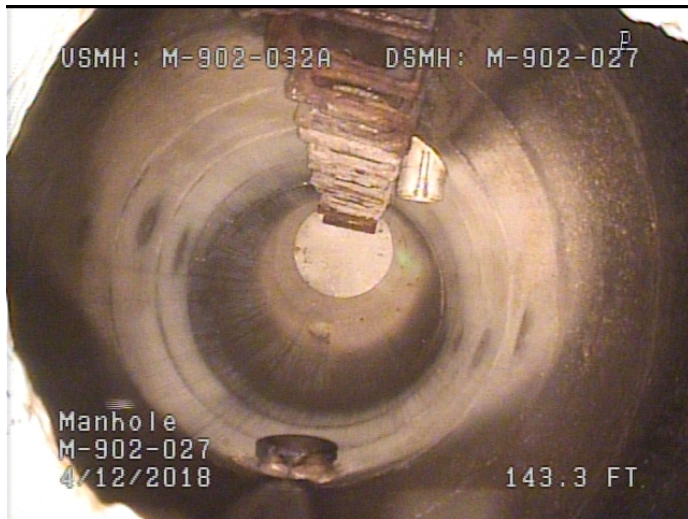
| Code: | AMH |
| Description: | Manhole |
