Profile/Photo Observation Report

Date:	11/10/2021	Weather:		Coding:	PACP 7.0
Pipe Length (ft):	219.1	Owner:	City of Hobart	Pre Clean:	No Pre-Cleaning
P.O.#:	YES502259	Surveyor:	Steven Bucklin	PSR:	M-604-057.1-M-604-057
Customer:	City of Hobart, IN (Red	Clean Date:		Shape:	C

Street:	North Connection Street	Flow Control:	Not Controlled
City:	City of Hobart	Year Renewed:	
Location:	Alley	Tape/Media #:	
Purpose:	Routine Assessment	Dia/Height:	8"
Use:	Sanitary Sewage Pipe	Material:	CP
Drain Area:		Lining:	None
Category:	NA		
Comment:			
Location Details:		Direction of Survey:	Upstream
US MH:	M-604-057.1	DS MH:	M-604-057
		Total Length Surveyed (ft):	219.1

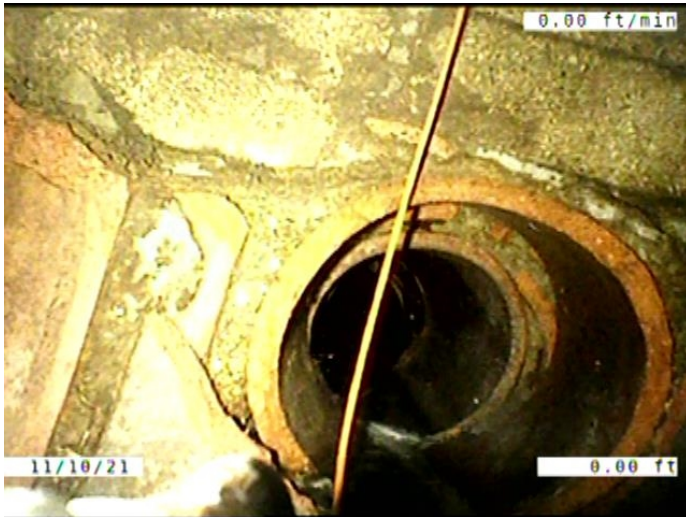
Code: **AMH**
Description: **Manhole**

Distance (ft): **.0**
Structural Grade: **0**
O&M Grade: **0**
Clock Start/From:
Clock To:
1st Value:
2nd Value:
Value Percent:
Continuous Index:
Within 8" of Joint: **NO**
Remarks: **M-604-057**

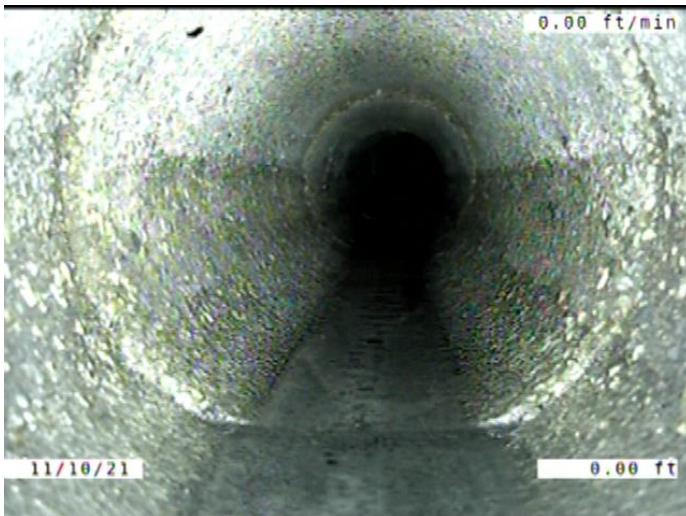
Code: **MWL**
Description: **Miscellaneous Water Level**

Distance (ft): **.0**
Structural Grade: **0**
O&M Grade: **0**
Clock Start/From:
Clock To:
1st Value:
2nd Value:
Value Percent: **5.000**
Continuous Index:
Within 8" of Joint: **NO**
Remarks:
