Profile/Photo Observation Report

Date:	01/31/2023	Weather:		Coding:	PACP 7.0
Pipe Length (ft):	115.0	Owner:	City of Hobart	Pre Clean:	Heavy Cleaning
P.O.#:	YES502259	Surveyor:	S. Bucklin	PSR:	M-805-037.2-M-805-037.
Customer:	City of Hobart	Clean Date:	11/12/2022	Shape:	C

Street:	South Liberty Place	Flow Control:	Not Controlled
City:	Hobart, IN	Year Renewed:	
Location:	Local rural streets with light traffic, t	Tape/Media #:	
Purpose:	Routine Assessment	Dia/Height:	8"
Use:	Sanitary Sewage Pipe	Material:	PVC
Drain Area:		Lining:	None
Category:	NA

Location Details:		Direction of Survey:	Upstream
US MH:	M-805-037.2	DS MH:	M-805-037.1
		Total Length Surveyed (ft):	115.8

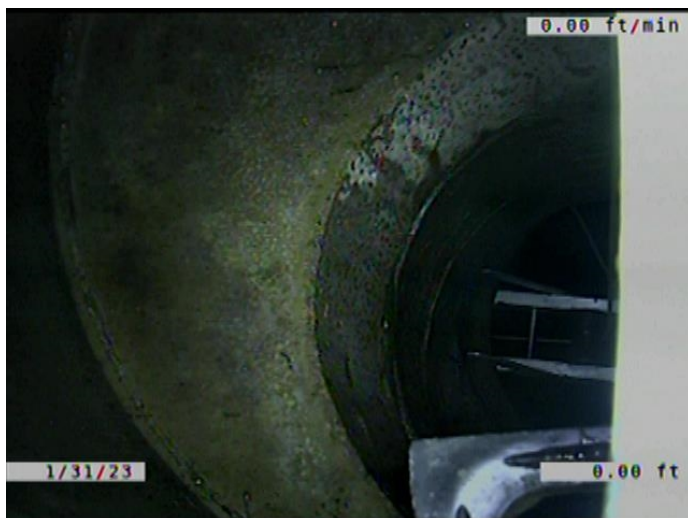
Code: **AMH**
Description: **Manhole**

Distance (ft): **.0**
Structural Grade: **0**
O&M Grade: **0**
Clock Start/From:
Clock To:
1st Value:
2nd Value:
Value Percent:
Continuous Index:
Within 8" of Joint: **NO**
Remarks: **M-805-037.1**

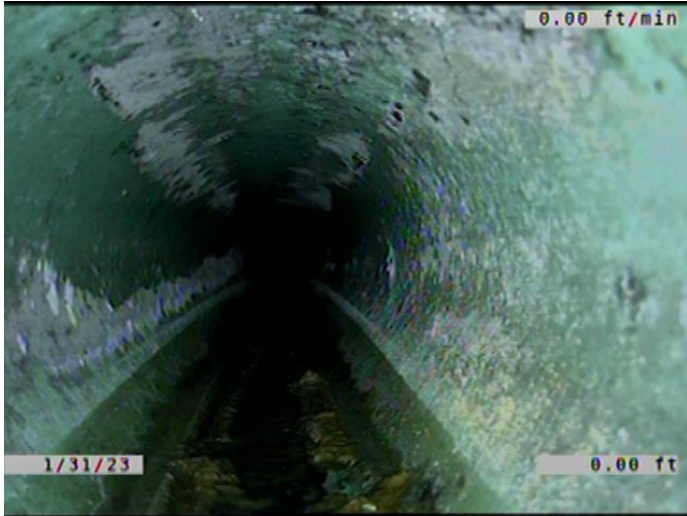
Code: **MWL**
Description: **Miscellaneous Water Level**

Distance (ft): **.0**
Structural Grade: **0**
O&M Grade: **0**
Clock Start/From:
Clock To:
1st Value:
2nd Value:
Value Percent: **5.000**
Continuous Index:
Within 8" of Joint: **NO**
Remarks:

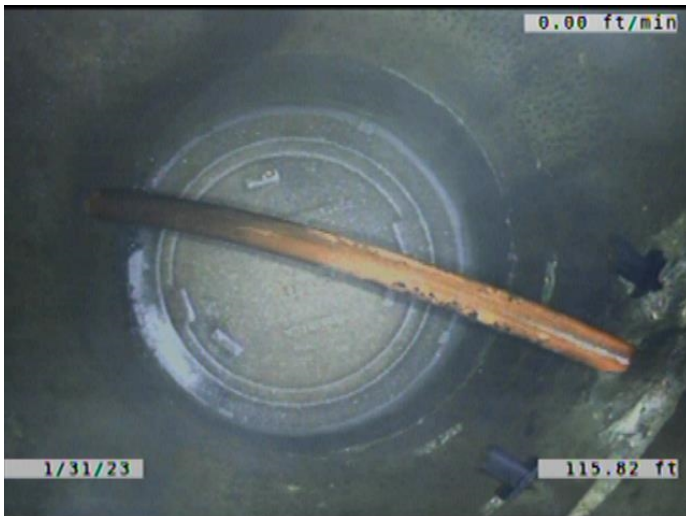
Code:	AMH
Description:	Manhole
Distance (ft):	115.8
Structural Grade:	0
O&M Grade:	0
Clock Start/From:	
Clock To:	
1st Value:	
2nd Value:	
Value Percent:	
Continuous Index:	
Within 8" of Joint:	NO
Remarks:	M-805-037.2
