Profile/Photo Observation Report

Date: 09/07/2021 Weather: **PACP 7.0** Coding: Pipe Length (ft): 160.2 Owner: **City of Hobart** Pre Clean: **Light Cleaning** P.O.#: YES502259 S. Bucklin PSR: P-504-113-112 Surveyor:

Street: 41st Avenue Flow Control: Not Controlled

US MH: M-503-032 DS MH: M-504-112 Total Length Surveyed (ft): 160.2

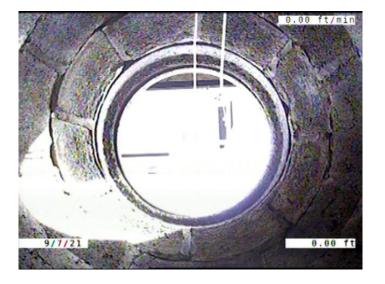
Code: AMH Description: Manhole Distance (ft): .0 Structural Grade: 0 O&M Grade: 0 Clock Start/From: Clock To: 1st Value: 2nd Value: Value Percent: Continuous Index: Within 8" of Joint: NO

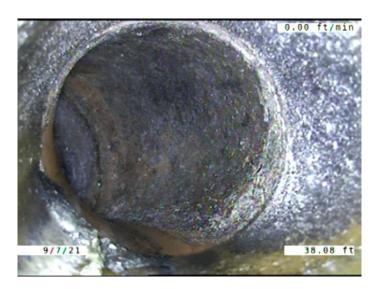
Code: **TF**

Description: Tap Factory

Distance (ft): 38.1
Structural Grade: 0

Clock Start/From: 11

1st Value: **4.000**

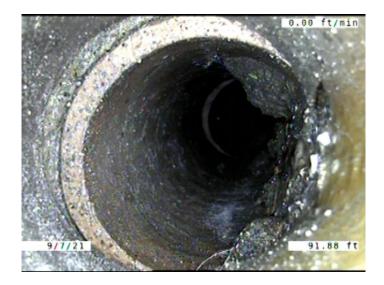
Code: **TF**

Description: **Tap Factory**

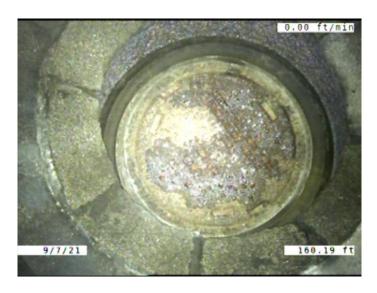
Code: AMH
Description: Manhole

Distance (ft): 160.2
Structural Grade: 0
