Profile/Photo Observation Report

Date:	11/10/2021	Weather:		Coding:	PACP 7.0
Pipe Length (ft):	163.5	Owner:	City of Hobart	Pre Clean:	Heavy Cleaning
P.O.#:	YES502259	Surveyor:	Steven Bucklin	PSR:	
Customer:	City of Hobart, IN (Red	Clean Date:	11/10/2021	Shape:	C

Street:	West Home Avenue	Flow Control:	Not Controlled
City:	City of Hobart	Year Renewed:	
Location:	Local rural streets with light traffic, t	Tape/Media #:	
Purpose:	Routine Assessment	Dia/Height:	10"
Use:	Sanitary Sewage Pipe	Material:	VCP
Drain Area:		Lining:	None
Category:	NA		
Comment:			
Location Details:		Direction of Survey:	Downstream
US MH:	UNK W HOME AVE	DS MH:	M-604-058
		Total Length Surveyed (ft):	163.5

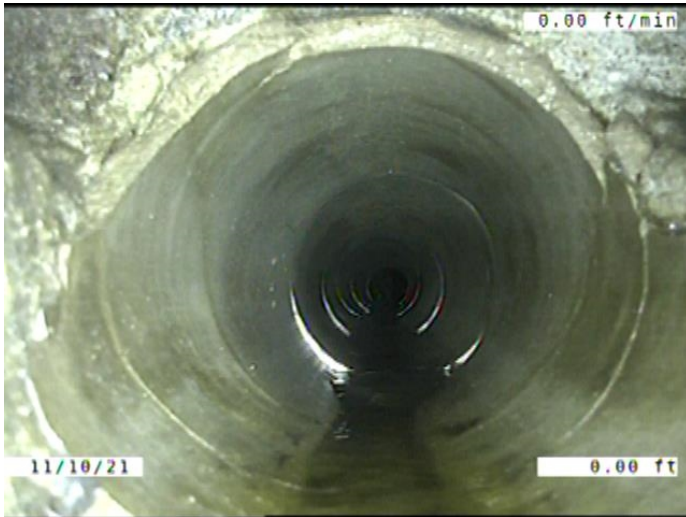
Code: **AMH**
Description: **Manhole**

Distance (ft): **.0**
Structural Grade: **0**
O&M Grade: **0**
Clock Start/From:
Clock To:
1st Value:
2nd Value:
Value Percent:
Continuous Index:
Within 8" of Joint: **NO**
Remarks: **UNK W HOME AVE**

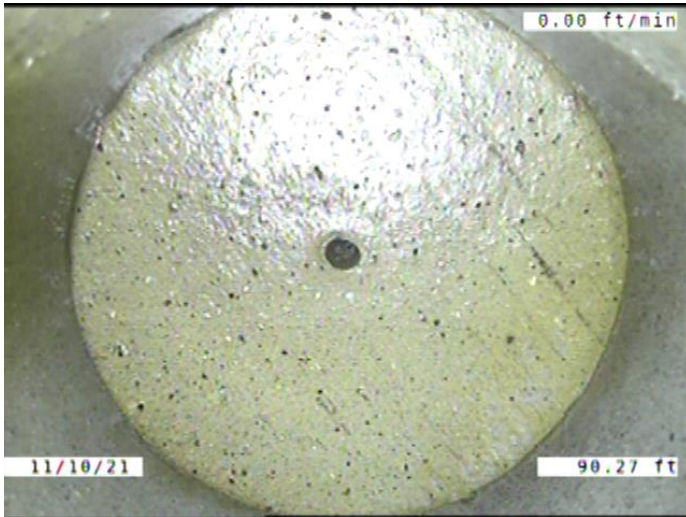
Code: **FS**
 Description: **Fracture Spiral**

Distance (ft): **89.5**
 Structural Grade: **3**
 O&M Grade: **0**
 Clock Start/From: **11**
 Clock To: **12**
 1st Value:
 2nd Value:
 Value Percent:
 Continuous Index:
 Within 8" of Joint: **YES**
 Remarks:
