Profile/Photo Observation Report

Street:	FOXCROFT STREET	Flow Control:	Not Controlled
City:	Hobart, IN	Year Renewed:	
Location:	Light Highway	Tape/Media #:	
Purpose:	Routine Assessment	Dia/Height:	8"
Use:	Sanitary	Material:	PVC
Drain Area:	NA	Lining:	
Category:	NA		
Comment:	Flow direction Wrong

Location Details:		Direction of Survey:	Upstream
US MH:	M-108-002	DS MH:	M-108-048
		Total Length Surveyed (ft):	187.2

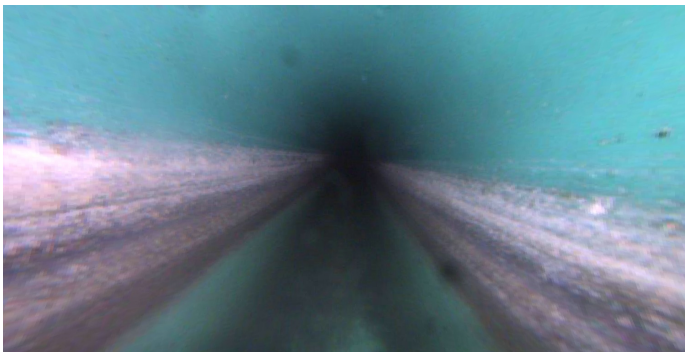
Code: **AMH**
Description: **Manhole**

Distance (ft): **.0**
Structural Grade: **0**
O&M Grade: **0**
Clock Start/From:
Clock To:
1st Value:
2nd Value:
Value Percent:
Continuous Index:
Within 8" of Joint: **NO**
Remarks: **M-108-048**

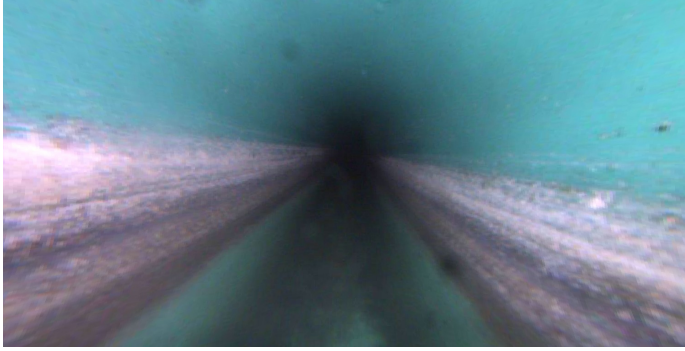
Code: **MWL**
Description: **Water Level**

Distance (ft): **.0**
Structural Grade: **0**
O&M Grade: **0**
Clock Start/From:
Clock To:
1st Value:
2nd Value:
Value Percent: **5.000**
Continuous Index:
Within 8" of Joint: **NO**
Remarks:

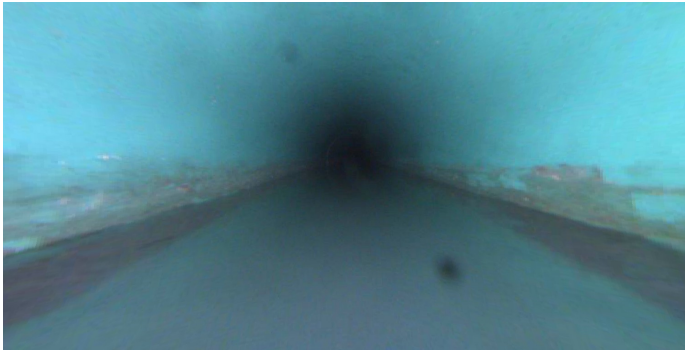
Code: **MWL**
Description: **Water Level**

Distance (ft): **20.8**
Structural Grade: **0**
O&M Grade: **0**
Clock Start/From:
Clock To:
1st Value:
2nd Value:
Value Percent: **20.000**
Continuous Index:
Within 8" of Joint: **NO**
Remarks:

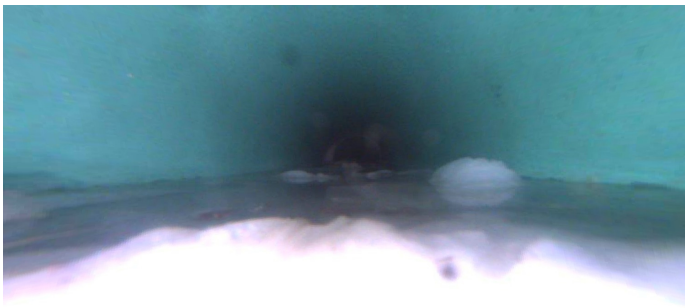
Code: **MWL**
Description: **Water Level**

Distance (ft): **33.0**
Structural Grade: **0**
O&M Grade: **0**
Clock Start/From:
Clock To:
1st Value:
2nd Value:
Value Percent: **40.000**
Continuous Index:
Within 8" of Joint: **NO**
Remarks:

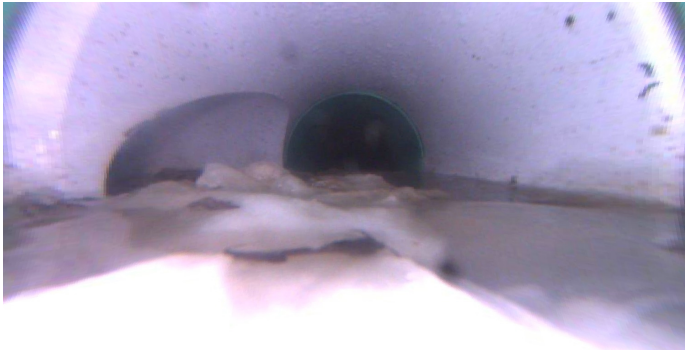
Code: **TF**
Description: **Tap Factory**

Distance (ft): **34.9**
Structural Grade: **0**
O&M Grade: **0**
Clock Start/From: **9**
Clock To:
1st Value: **6.000**
2nd Value:
Value Percent:
Continuous Index:
Within 8" of Joint:
Remarks:

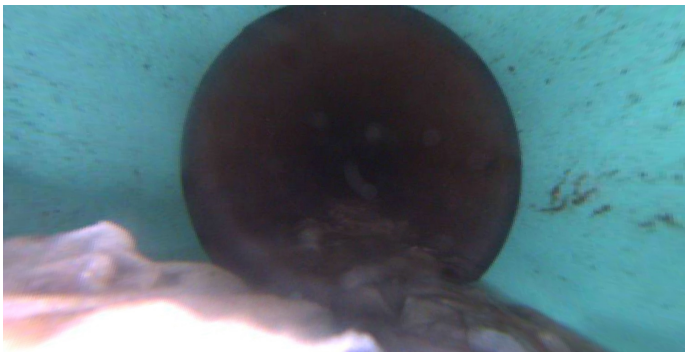
Code: **MMC**
Description: **Material Change**

Distance (ft): **37.5**
Structural Grade: **0**
O&M Grade: **0**
Clock Start/From:
Clock To:
1st Value:
2nd Value:
Value Percent:
Continuous Index:
Within 8" of Joint: **NO**
Remarks: **pvc to vcp**

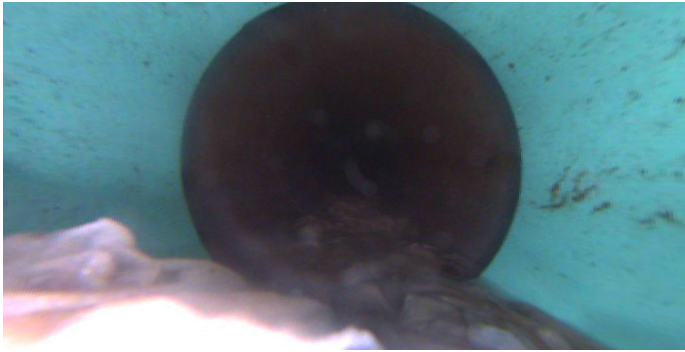
Code: **MWL**
Description: **Water Level**

Distance (ft): **37.5**
Structural Grade: **0**
O&M Grade: **0**
Clock Start/From:
Clock To:
1st Value:
2nd Value:
Value Percent: **10.000**
Continuous Index:
Within 8" of Joint: **NO**
Remarks:

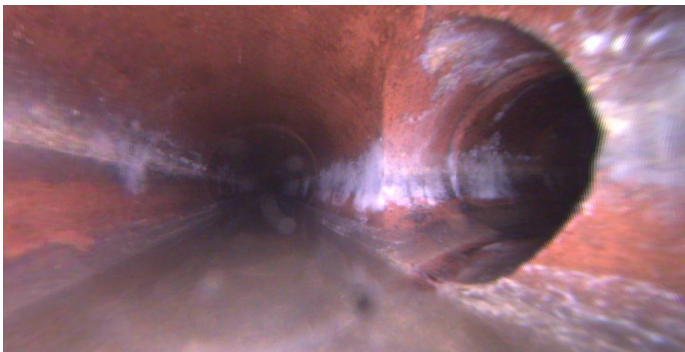
Code: **TF**
Description: **Tap Factory**

Distance (ft): **52.0**
Structural Grade: **0**
O&M Grade: **0**
Clock Start/From: **3**
Clock To:
1st Value: **6.000**
2nd Value:
Value Percent:
Continuous Index:
Within 8" of Joint:
Remarks:

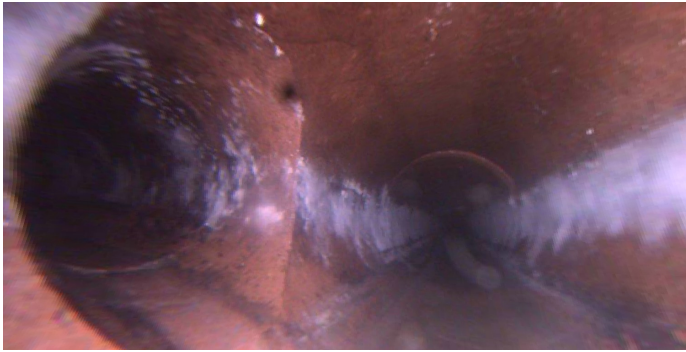
Code: **TF**
Description: **Tap Factory**

Distance (ft): **69.2**
Structural Grade: **0**
O&M Grade: **0**
Clock Start/From: **9**
Clock To:
1st Value: **6.000**
2nd Value:
Value Percent:
Continuous Index:
Within 8" of Joint:
Remarks:

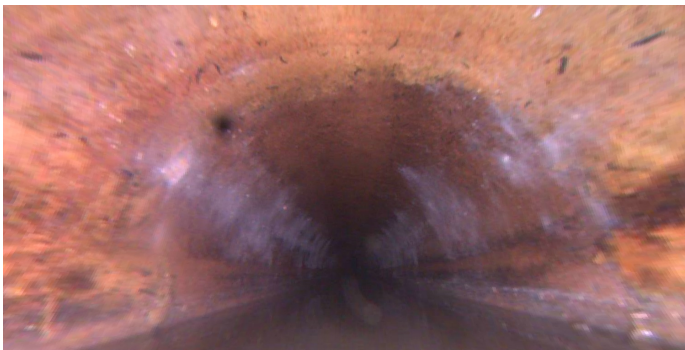
Code: **MGO**
Description: **General Observation**

Distance (ft): **118.2**
Structural Grade: **0**
O&M Grade: **0**
Clock Start/From:
Clock To:
1st Value:
2nd Value:
Value Percent:
Continuous Index:
Within 8" of Joint: **NO**
Remarks: **end of spot liner**

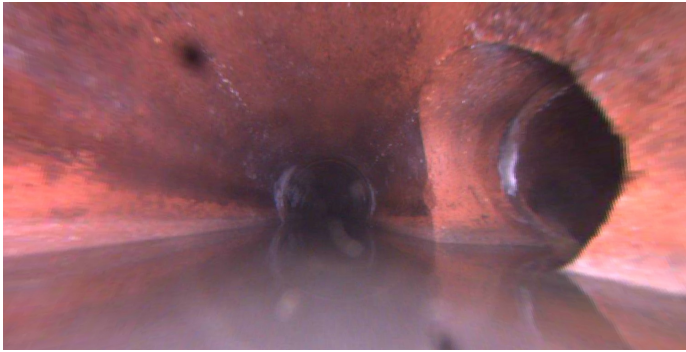
Code: **TF**
Description: **Tap Factory**

Distance (ft): **126.6**
Structural Grade: **0**
O&M Grade: **0**
Clock Start/From: **3**
Clock To:
1st Value: **6.000**
2nd Value:
Value Percent:
Continuous Index:
Within 8" of Joint:
Remarks:

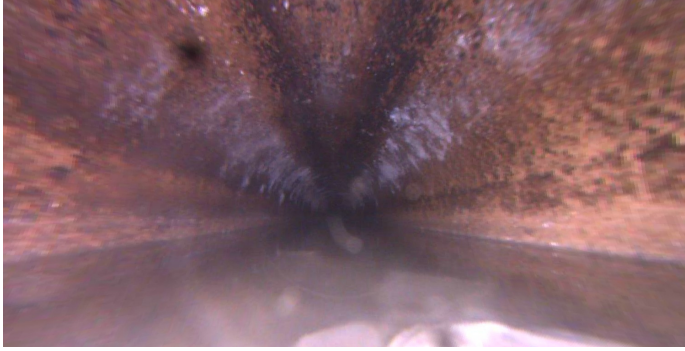
Code: **MWL**
Description: **Water Level**

Distance (ft): **134.1**
Structural Grade: **0**
O&M Grade: **0**
Clock Start/From:
Clock To:
1st Value:
2nd Value:
Value Percent: **25.000**
Continuous Index:
Within 8" of Joint: **NO**
Remarks:

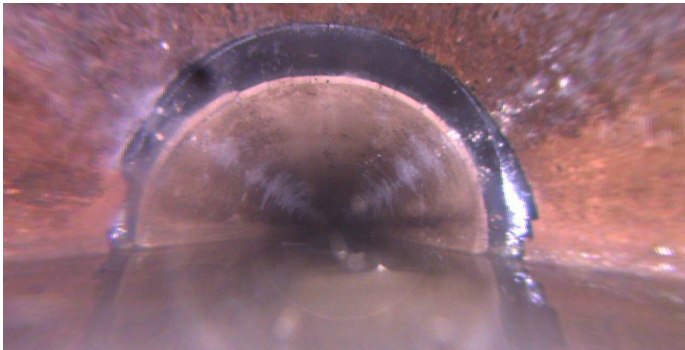
Code: **MMC**
Description: **Material Change**

Distance (ft): **156.0**
Structural Grade: **0**
O&M Grade: **0**
Clock Start/From:
Clock To:
1st Value:
2nd Value:
Value Percent:
Continuous Index:
Within 8" of Joint: **NO**
Remarks: **vcp to pvc**

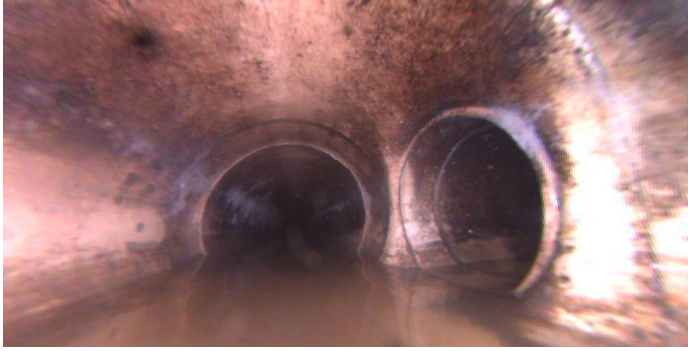
Code: **TF**
Description: **Tap Factory**

Distance (ft): **164.1**
Structural Grade: **0**
O&M Grade: **0**
Clock Start/From: **3**
Clock To:
1st Value: **6.000**
2nd Value:
Value Percent:
Continuous Index:
Within 8" of Joint:
Remarks:

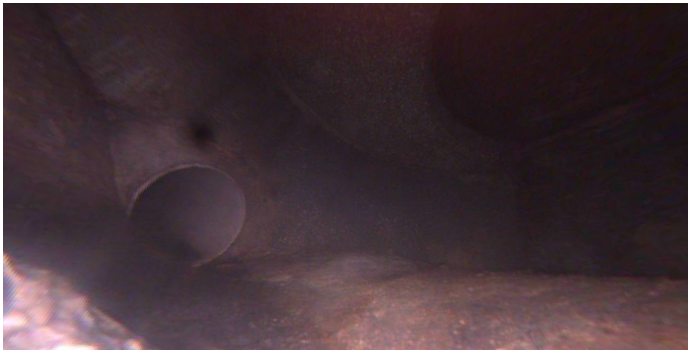
Code: **AMH**
Description: **Manhole**

Distance (ft): **187.2**
Structural Grade: **0**
O&M Grade: **0**
Clock Start/From:
Clock To:
1st Value:
2nd Value:
Value Percent:
Continuous Index:
Within 8" of Joint: **NO**
Remarks: **M-108-002**
