Profile/Photo Observation Report

Street:	FOXCROFT STREET	Flow Control:	Not Controlled
City:	Hobart, IN	Year Renewed:	
Location:	Light Highway	Tape/Media #:	
Purpose:	Routine Assessment	Dia/Height:	12"
Use:	Sanitary	Material:	VCP
Drain Area:	NA	Lining:	Cured in Place
Category:	NA		
Comment:	Flow direction Wrong		
Location Details:		Direction of Survey:	Upstream
US MH:	M-108-007	DS MH:	M-108-006
		Total Length Surveyed (ft):	273.1

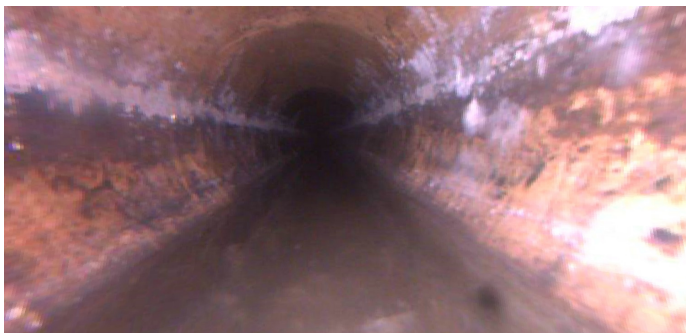
Code: **AMH**
Description: **Manhole**

Distance (ft): **.0**
Structural Grade: **0**
O&M Grade: **0**
Clock Start/From:
Clock To:
1st Value:
2nd Value:
Value Percent:
Continuous Index:
Within 8" of Joint: **NO**
Remarks: **M-108-006**

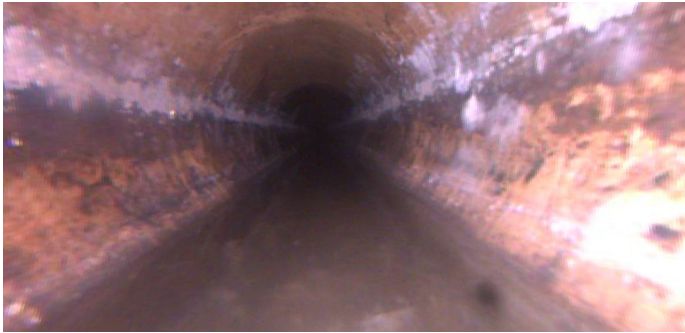
Code:	MWL
Description:	Water Level

Distance (ft):	.0
Structural Grade:	0
O&M Grade:	0
Clock Start/From:	
Clock To:	
1st Value:	
2nd Value:	
Value Percent:	5.000
Continuous Index:	
Within 8" of Joint:	NO
Remarks:

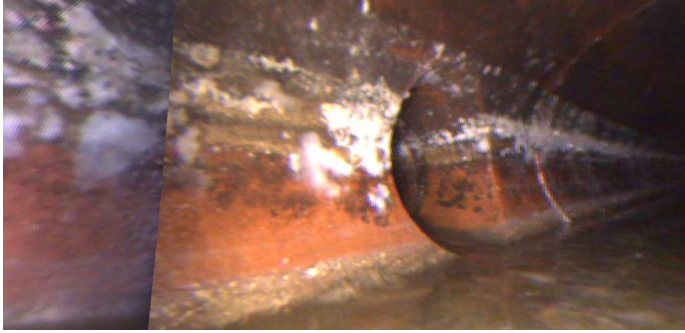
Code: **TF**
Description: **Tap Factory**

Distance (ft): **13.3**
Structural Grade: **0**
O&M Grade: **0**
Clock Start/From: **3**
Clock To:
1st Value: **4.000**
2nd Value:
Value Percent:
Continuous Index:
Within 8" of Joint: **YES**
Remarks:

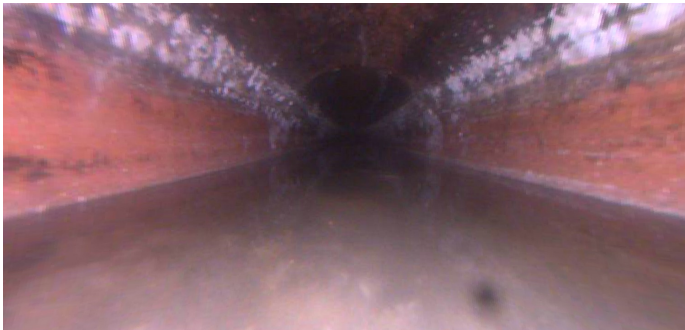
Code: **MWL**
Description: **Water Level**

Distance (ft): **18.0**
Structural Grade: **0**
O&M Grade: **0**
Clock Start/From:
Clock To:
1st Value:
2nd Value:
Value Percent: **25.000**
Continuous Index:
Within 8" of Joint: **NO**
Remarks:

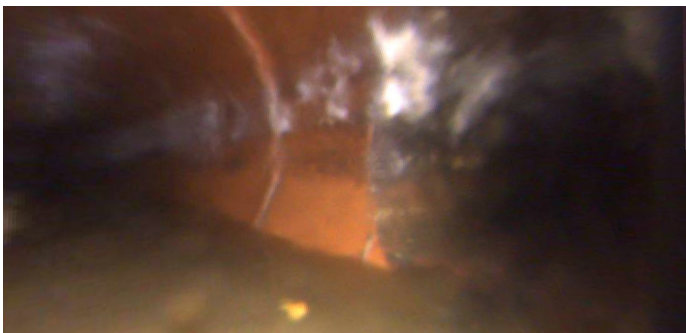
Code: **TF**
Description: **Tap Factory**

Distance (ft): **171.3**
Structural Grade: **0**
O&M Grade: **0**
Clock Start/From: **9**
Clock To:
1st Value: **4.000**
2nd Value:
Value Percent:
Continuous Index:
Within 8" of Joint: **YES**
Remarks:

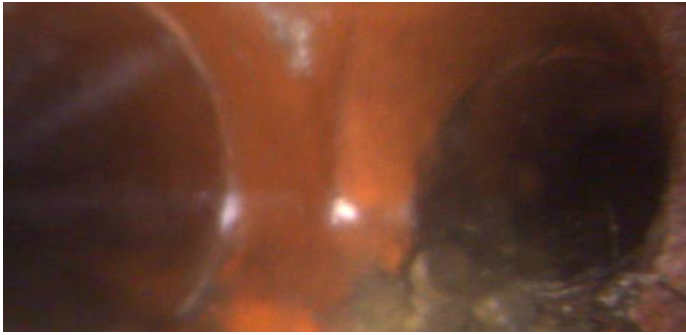
Code: **TF**
Description: **Tap Factory**

Distance (ft): **247.6**
Structural Grade: **0**
O&M Grade: **0**
Clock Start/From: **9**
Clock To:
1st Value: **4.000**
2nd Value:
Value Percent:
Continuous Index:
Within 8" of Joint:
Remarks:

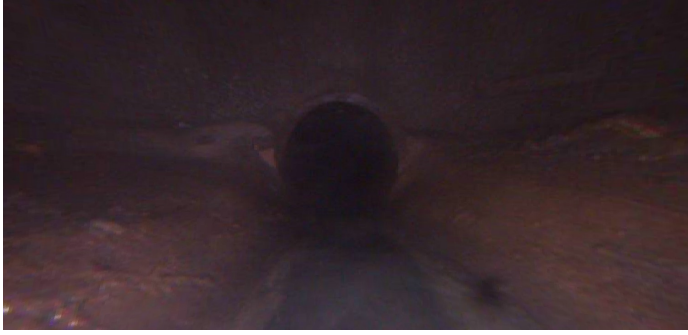
Code:	AMH
Description:	Manhole
Distance (ft):	273.1
Structural Grade:	0
O&M Grade:	0
Clock Start/From:	
Clock To:	
1st Value:	
2nd Value:	
Value Percent:	
Continuous Index:	
Within 8" of Joint:	NO
Remarks:	M-108-007
