Profile/Photo Observation Report

Date:	03/24/2018	Weather:		Coding:	PACP 6.0
Pipe Length (ft):	243.7	Owner:	NA	Pre Clean:	No Pre-Cleaning
P.O.#:		Surveyor:	Byrd Fitzgerald	PSR:	P-108-007-008
Customer:		Clean Date:	01/01/1900	Shape:	C

Street:	FOXCROFT STREET	Flow Control:	Not Controlled
City:	Hobart, IN	Year Renewed:	
Location:	Light Highway	Tape/Media #:	
Purpose:	Routine Assessment	Dia/Height:	12"
Use:	Sanitary	Material:	VCP
Drain Area:	NA	Lining:	
Category:	NA		
Comment:	Flow direction wrong		
Location Details:		Direction of Survey:	Downstream
US MH:	M-108-008	DS MH:	M-108-007
		Total Length Surveyed (ft):	245.7

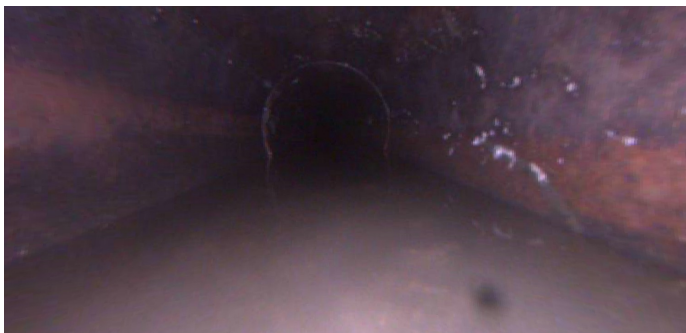
Code: **AMH**
Description: **Manhole**

Distance (ft): **.0**
Structural Grade: **0**
O&M Grade: **0**
Clock Start/From:
Clock To:
1st Value:
2nd Value:
Value Percent:
Continuous Index:
Within 8" of Joint: **NO**
Remarks: **M-108-008**

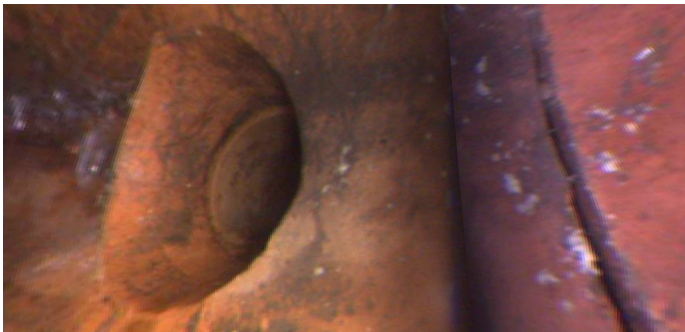
Code:	TF
Description:	Tap Factory

Distance (ft):	11.1
Structural Grade:	0
O&M Grade:	0
Clock Start/From:	9
Clock To:	
1st Value:	4.000
2nd Value:	
Value Percent:	
Continuous Index:	
Within 8" of Joint:	YES
Remarks:

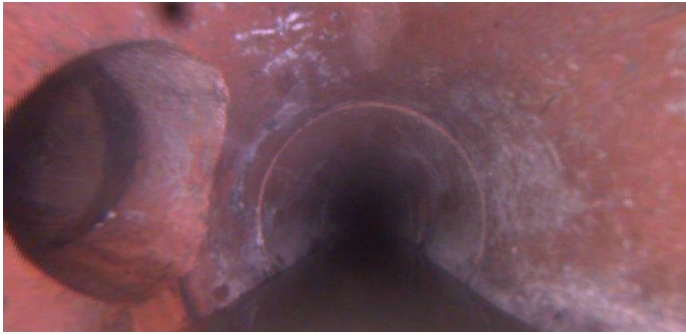
Code: **TF**
Description: **Tap Factory**

Distance (ft): **48.1**
Structural Grade: **0**
O&M Grade: **0**
Clock Start/From: **9**
Clock To:
1st Value: **4.000**
2nd Value:
Value Percent:
Continuous Index:
Within 8" of Joint: **YES**
Remarks:

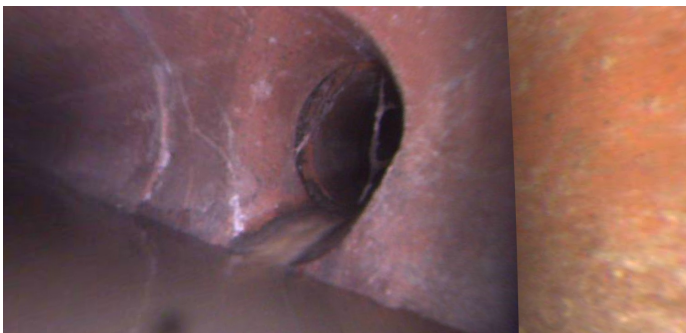
Code: **TF**
Description: **Tap Factory**

Distance (ft): **50.2**
Structural Grade: **0**
O&M Grade: **0**
Clock Start/From: **3**
Clock To:
1st Value: **4.000**
2nd Value:
Value Percent:
Continuous Index:
Within 8" of Joint:
Remarks:

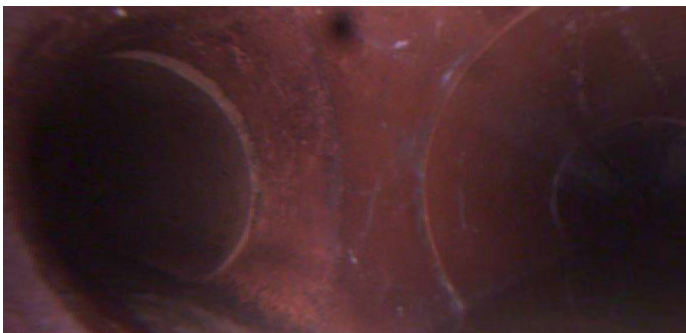
Code: **TF**
Description: **Tap Factory**

Distance (ft): **136.3**
Structural Grade: **0**
O&M Grade: **0**
Clock Start/From: **9**
Clock To:
1st Value: **4.000**
2nd Value:
Value Percent:
Continuous Index:
Within 8" of Joint: **YES**
Remarks:

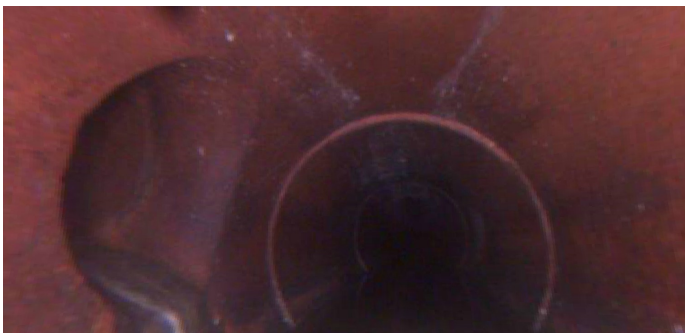
Code: **TF**
Description: **Tap Factory**

Distance (ft): **193.9**
Structural Grade: **0**
O&M Grade: **0**
Clock Start/From: **9**
Clock To:
1st Value: **4.000**
2nd Value:
Value Percent:
Continuous Index:
Within 8" of Joint: **YES**
Remarks:

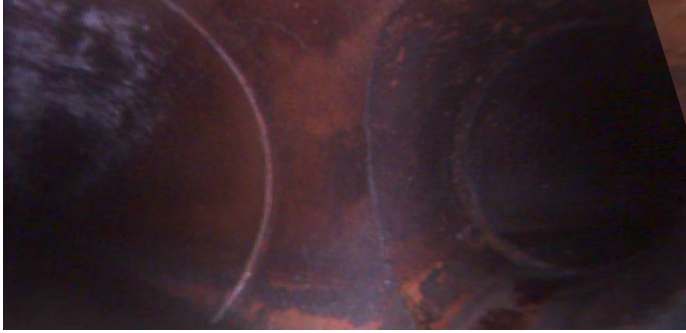
Code: **TF**
Description: **Tap Factory**

Distance (ft): **196.4**
Structural Grade: **0**
O&M Grade: **0**
Clock Start/From: **3**
Clock To:
1st Value: **4.000**
2nd Value:
Value Percent:
Continuous Index:
Within 8" of Joint: **YES**
Remarks:

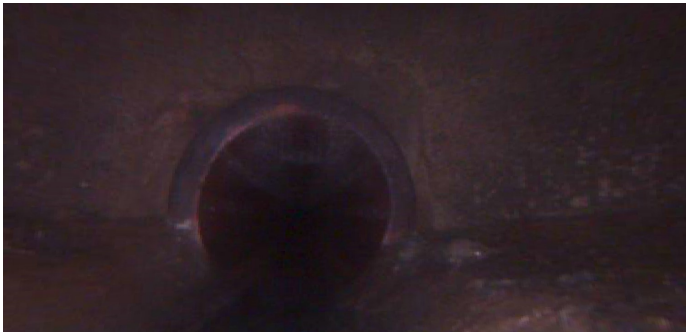
Code: **AMH**
Description: **Manhole**

Distance (ft): **245.7**
Structural Grade: **0**
O&M Grade: **0**
Clock Start/From:
Clock To:
1st Value:
2nd Value:
Value Percent:
Continuous Index:
Within 8" of Joint: **NO**
Remarks: **M-108-007**
