Profile/Photo Observation Report

Date:	03/25/2018	Weather:		Coding:	PACP 6.0
Pipe Length (ft):	166.8	Owner:	NA	Pre Clean:	No Pre-Cleaning
P.O.#:		Surveyor:	Byrd Fitzgerald	PSR:	P-108-011-010
Customer:		Clean Date:	01/01/1900	Shape:	C

Street:	15TH ST	Flow Control:	Not Controlled
City:	Hobart, IN	Year Renewed:	
Location:	Light Highway	Tape/Media #:	
Purpose:	Routine Assessment	Dia/Height:	8"
Use:	Sanitary	Material:	VCP
Drain Area:	NA	Lining:	
Category:	NA		
Comment:	P_C at 158 ft roots/ debris . Flow direction wrong		
Location Details:		Direction of Survey:	Downstream
US MH:	M-108-010	DS MH:	M-108-011
		Total Length Surveyed (ft):	160.0

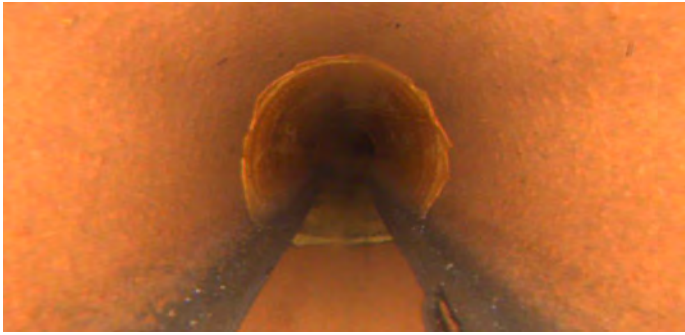
Code: **AMH**
Description: **Manhole**

Distance (ft): **.0**
Structural Grade: **0**
O&M Grade: **0**
Clock Start/From:
Clock To:
1st Value:
2nd Value:
Value Percent:
Continuous Index:
Within 8" of Joint: **NO**
Remarks: **M-108-010**

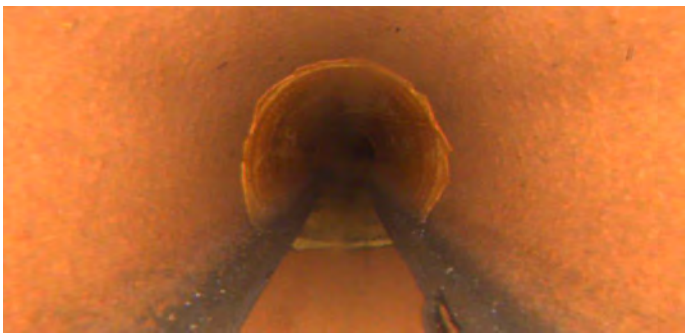
Code: **MWL**
Description: **Water Level**

Distance (ft): **.0**
Structural Grade: **0**
O&M Grade: **0**
Clock Start/From:
Clock To:
1st Value:
2nd Value:
Value Percent: **5.000**
Continuous Index:
Within 8" of Joint: **NO**
Remarks:

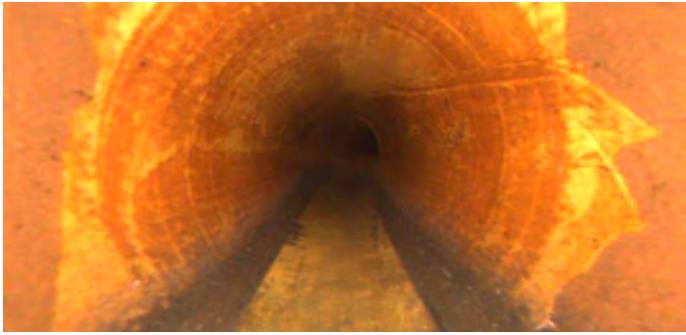
Code: **MLC**
Description: **Lining Change**

Distance (ft): **.8**
Structural Grade: **0**
O&M Grade: **0**
Clock Start/From:
Clock To:
1st Value:
2nd Value:
Value Percent:
Continuous Index:
Within 8" of Joint: **NO**
Remarks: **cip**

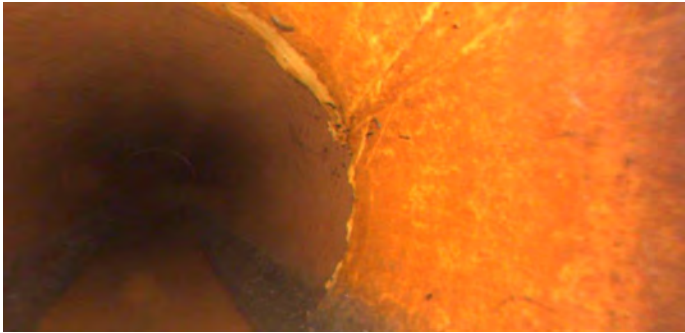
Code: **MLC**
Description: **Lining Change**

Distance (ft): **5.3**
Structural Grade: **0**
O&M Grade: **0**
Clock Start/From:
Clock To:
1st Value:
2nd Value:
Value Percent:
Continuous Index:
Within 8" of Joint: **NO**
Remarks: **vcp**

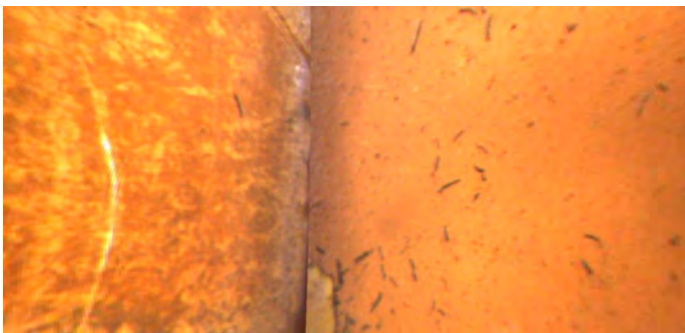
Code: **MLC**
Description: **Lining Change**

Distance (ft): **57.3**
Structural Grade: **0**
O&M Grade: **0**
Clock Start/From:
Clock To:
1st Value:
2nd Value:
Value Percent:
Continuous Index:
Within 8" of Joint: **NO**
Remarks: **CIP**

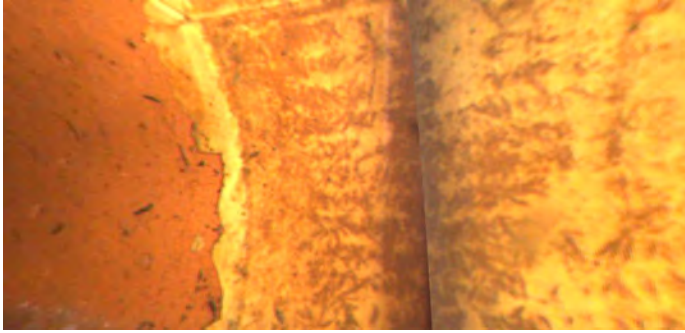
Code: **MLC**
Description: **Lining Change**

Distance (ft): **61.2**
Structural Grade: **0**
O&M Grade: **0**
Clock Start/From:
Clock To:
1st Value:
2nd Value:
Value Percent:
Continuous Index:
Within 8" of Joint: **NO**
Remarks: **END CIP**

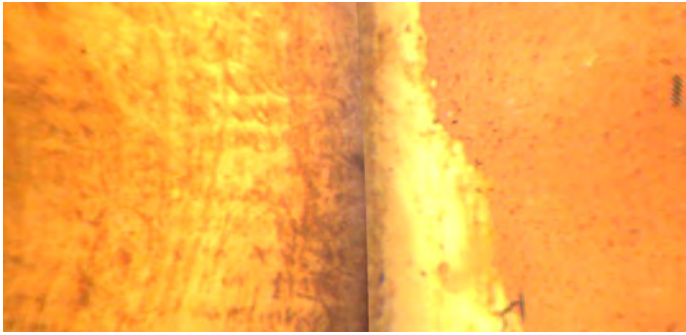
Code: **MLC**
Description: **Lining Change**

Distance (ft): **67.8**
Structural Grade: **0**
O&M Grade: **0**
Clock Start/From:
Clock To:
1st Value:
2nd Value:
Value Percent:
Continuous Index:
Within 8" of Joint: **NO**
Remarks: **cip**

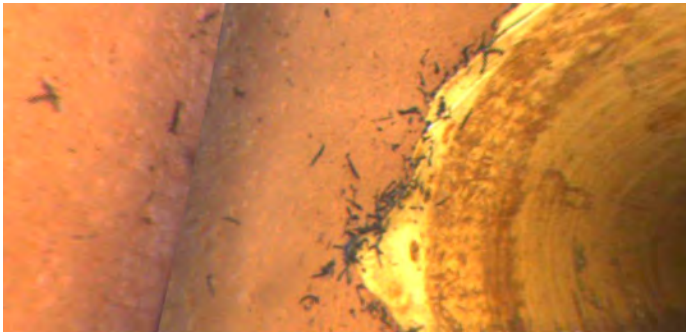
Code: **MLC**
Description: **Lining Change**

Distance (ft): **71.9**
Structural Grade: **0**
O&M Grade: **0**
Clock Start/From:
Clock To:
1st Value:
2nd Value:
Value Percent:
Continuous Index:
Within 8" of Joint: **NO**
Remarks: **end cip**

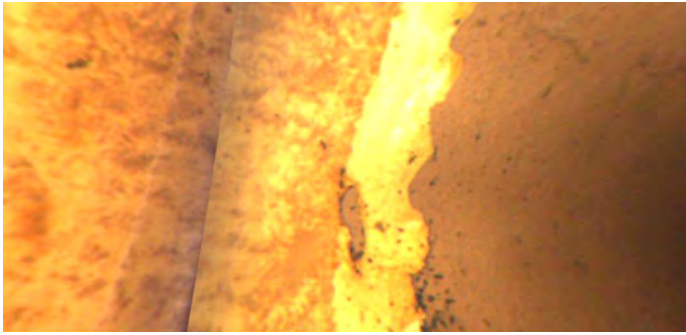
Code: **MLC**
Description: **Lining Change**

Distance (ft): **78.8**
Structural Grade: **0**
O&M Grade: **0**
Clock Start/From:
Clock To:
1st Value:
2nd Value:
Value Percent:
Continuous Index:
Within 8" of Joint: **NO**
Remarks: **CIP**

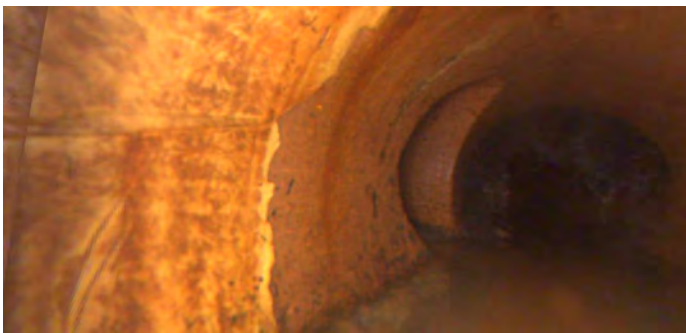
Code: **MLC**
Description: **Lining Change**

Distance (ft): **82.4**
Structural Grade: **0**
O&M Grade: **0**
Clock Start/From:
Clock To:
1st Value:
2nd Value:
Value Percent:
Continuous Index:
Within 8" of Joint: **NO**
Remarks: **CIP END**

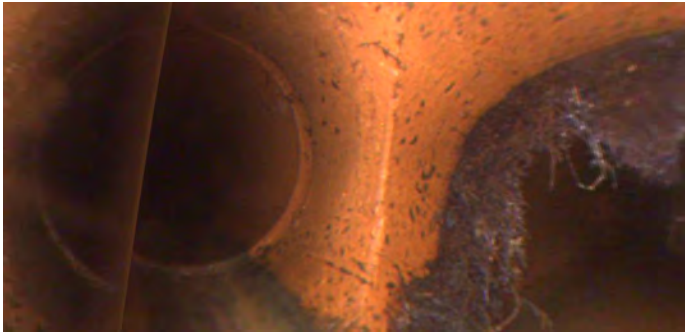
Code: **TF**
Description: **Tap Factory**

Distance (ft): **83.2**
Structural Grade: **0**
O&M Grade: **0**
Clock Start/From: **9**
Clock To:
1st Value: **4.000**
2nd Value:
Value Percent:
Continuous Index:
Within 8" of Joint: **YES**
Remarks:

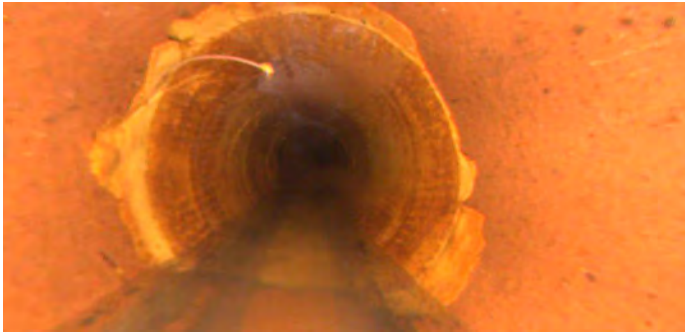
Code: **MMC**
Description: **Material Change**

Distance (ft): **86.5**
Structural Grade: **0**
O&M Grade: **0**
Clock Start/From:
Clock To:
1st Value:
2nd Value:
Value Percent:
Continuous Index:
Within 8" of Joint: **NO**
Remarks: **lining**

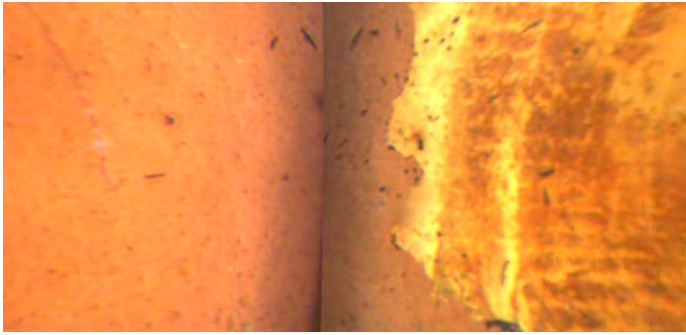
Code: **MLC**
Description: **Lining Change**

Distance (ft): **106.6**
Structural Grade: **0**
O&M Grade: **0**
Clock Start/From:
Clock To:
1st Value:
2nd Value:
Value Percent:
Continuous Index:
Within 8" of Joint: **NO**
Remarks: **CIP**

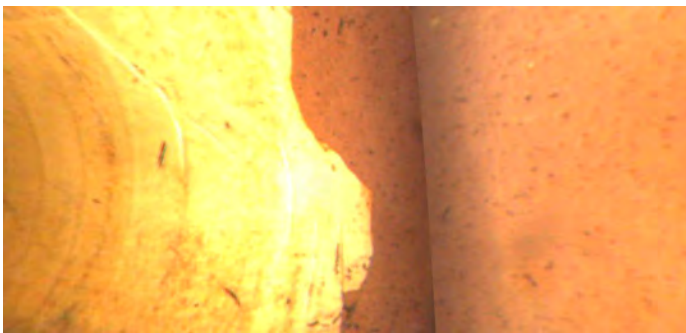
Code: **MLC**
Description: **Lining Change**

Distance (ft): **112.3**
Structural Grade: **0**
O&M Grade: **0**
Clock Start/From:
Clock To:
1st Value:
2nd Value:
Value Percent:
Continuous Index:
Within 8" of Joint: **NO**
Remarks: **cip**

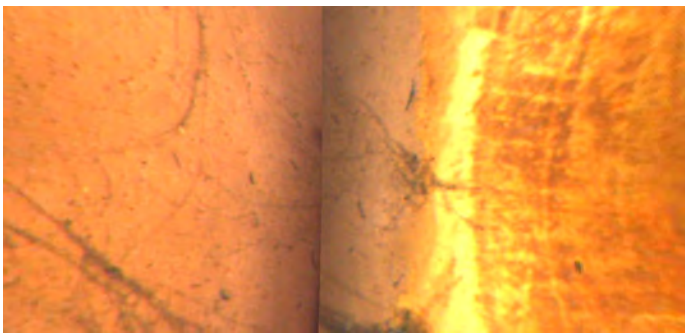
Code: **MLC**
Description: **Lining Change**

Distance (ft): **121.7**
Structural Grade: **0**
O&M Grade: **0**
Clock Start/From:
Clock To:
1st Value:
2nd Value:
Value Percent:
Continuous Index:
Within 8" of Joint: **NO**
Remarks: **CIP**

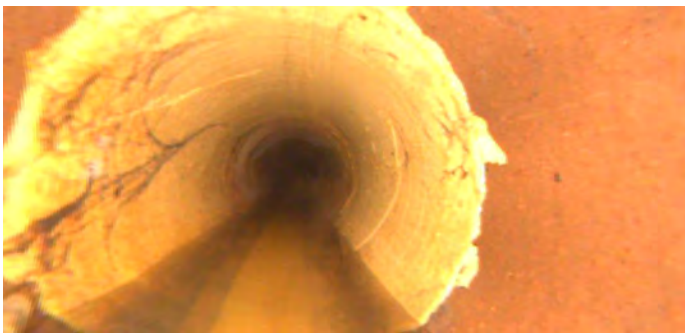
Code: **MLC**
Description: **Lining Change**

Distance (ft): **130.0**
Structural Grade: **0**
O&M Grade: **0**
Clock Start/From:
Clock To:
1st Value:
2nd Value:
Value Percent:
Continuous Index:
Within 8" of Joint: **NO**
Remarks: **END CIP**

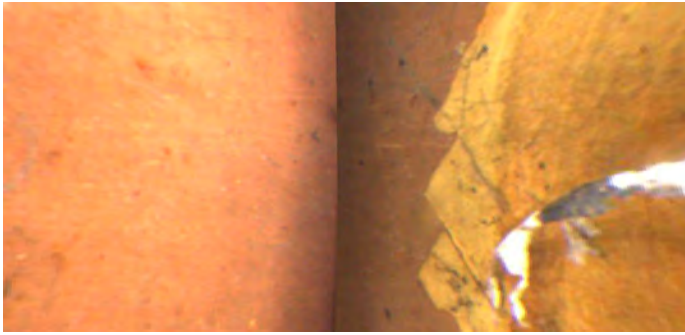
Code: **MMC**
Description: **Material Change**

Distance (ft): **135.7**
Structural Grade: **0**
O&M Grade: **0**
Clock Start/From:
Clock To:
1st Value:
2nd Value:
Value Percent:
Continuous Index:
Within 8" of Joint: **NO**
Remarks: **vcp**

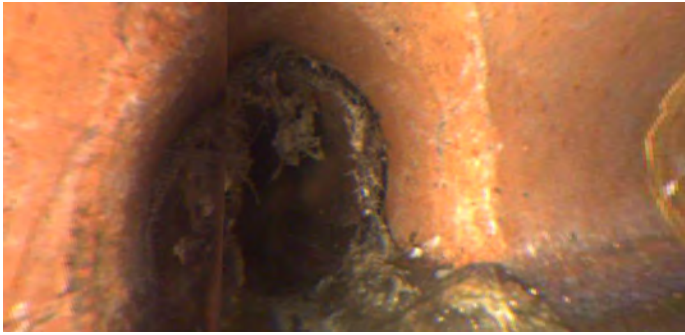
Code: **TF**
Description: **Tap Factory**

Distance (ft): **136.6**
Structural Grade: **0**
O&M Grade: **0**
Clock Start/From: **3**
Clock To:
1st Value: **4.000**
2nd Value:
Value Percent:
Continuous Index:
Within 8" of Joint: **YES**
Remarks:

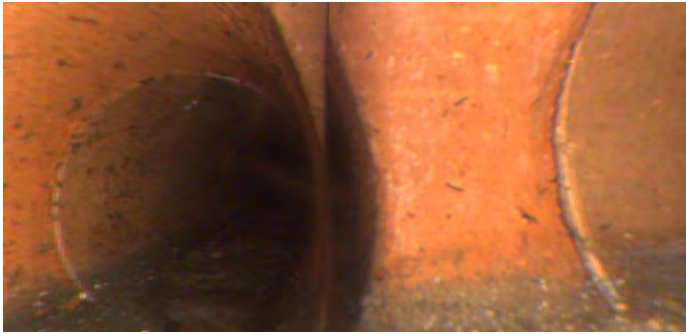
Code: **TF**
Description: **Tap Factory**

Distance (ft): **138.8**
Structural Grade: **0**
O&M Grade: **0**
Clock Start/From: **9**
Clock To:
1st Value: **4.000**
2nd Value:
Value Percent:
Continuous Index:
Within 8" of Joint: **YES**
Remarks:

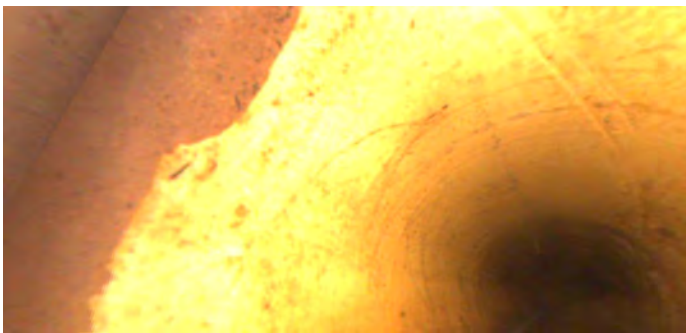
Code: **MMC**
Description: **Material Change**

Distance (ft): **141.5**
Structural Grade: **0**
O&M Grade: **0**
Clock Start/From:
Clock To:
1st Value:
2nd Value:
Value Percent:
Continuous Index:
Within 8" of Joint: **NO**
Remarks: **lining**

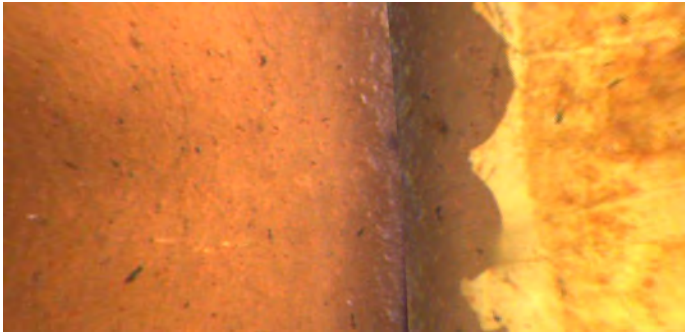
Code: **MMC**
Description: **Material Change**

Distance (ft): **145.8**
Structural Grade: **0**
O&M Grade: **0**
Clock Start/From:
Clock To:
1st Value:
2nd Value:
Value Percent:
Continuous Index:
Within 8" of Joint: **NO**
Remarks: **vcp**
