Profile/Photo Observation Report

Date:	03/25/2018	Weather:		Coding:	PACP 6.0
Pipe Length (ft):	166.8	Owner:	NA	Pre Clean:	No Pre-Cleaning
P.O.#:		Surveyor:	Byrd Fitzgerald	PSR:	P-108-011-010
Customer:		Clean Date:	01/01/1900	Shape:	C

Street:	FOXCROFT STREET	Flow Control:	Not Controlled
City:	Hobart, IN	Year Renewed:	
Location:	Light Highway	Tape/Media #:	
Purpose:	Routine Assessment	Dia/Height:	8"
Use:	Sanitary	Material:	VCP
Drain Area:	NA	Lining:	
Category:	NA		
Comment:	P_C at 158 ft roots/ debris . Flow direction wrong		
Location Details:		Direction of Survey:	Downstream
US MH:	M-108-010	DS MH:	M-108-011
		Total Length Surveyed (ft):	160.0

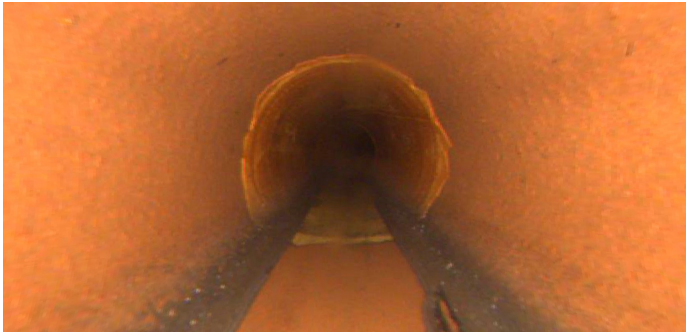
Code: **AMH**
Description: **Manhole**

Distance (ft): **.0**
Structural Grade: **0**
O&M Grade: **0**
Clock Start/From:
Clock To:
1st Value:
2nd Value:
Value Percent:
Continuous Index:
Within 8" of Joint: **NO**
Remarks: **M-108-010**

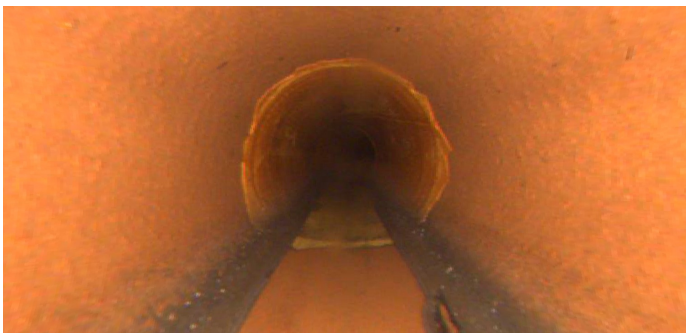
Code: **MWL**
Description: **Water Level**

Distance (ft): **.0**
Structural Grade: **0**
O&M Grade: **0**
Clock Start/From:
Clock To:
1st Value:
2nd Value:
Value Percent: **5.000**
Continuous Index:
Within 8" of Joint: **NO**
Remarks:

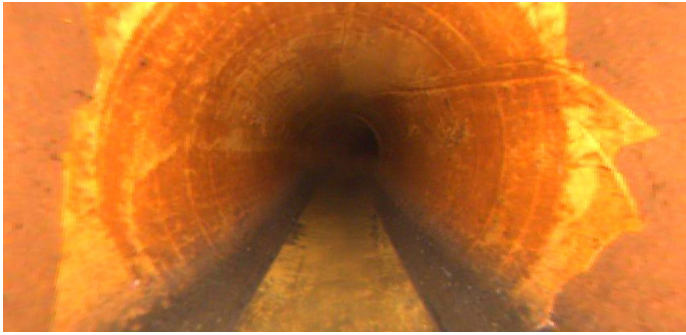
Code: **MLC**
Description: **Lining Change**

Distance (ft): **.8**
Structural Grade: **0**
O&M Grade: **0**
Clock Start/From:
Clock To:
1st Value:
2nd Value:
Value Percent:
Continuous Index:
Within 8" of Joint: **NO**
Remarks: **cip**

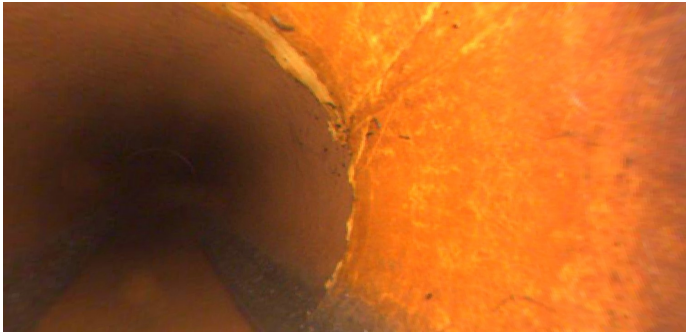
Code: **MLC**
Description: **Lining Change**

Distance (ft): **5.3**
Structural Grade: **0**
O&M Grade: **0**
Clock Start/From:
Clock To:
1st Value:
2nd Value:
Value Percent:
Continuous Index:
Within 8" of Joint: **NO**
Remarks: **vcp**

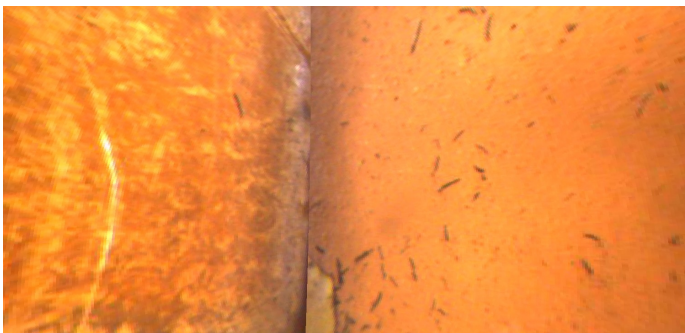
Code: **MLC**
Description: **Lining Change**

Distance (ft): **57.3**
Structural Grade: **0**
O&M Grade: **0**
Clock Start/From:
Clock To:
1st Value:
2nd Value:
Value Percent:
Continuous Index:
Within 8" of Joint: **NO**
Remarks: **CIP**

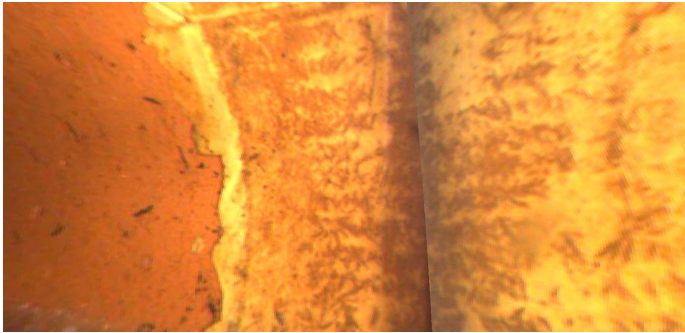
Code: **MLC**
Description: **Lining Change**

Distance (ft): **61.2**
Structural Grade: **0**
O&M Grade: **0**
Clock Start/From:
Clock To:
1st Value:
2nd Value:
Value Percent:
Continuous Index:
Within 8" of Joint: **NO**
Remarks: **END CIP**

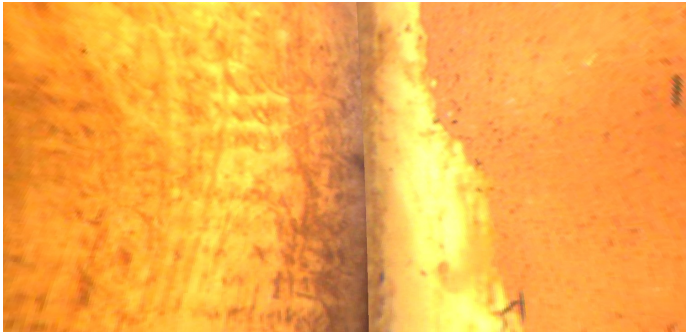
Code: **MLC**
Description: **Lining Change**

Distance (ft): **67.8**
Structural Grade: **0**
O&M Grade: **0**
Clock Start/From:
Clock To:
1st Value:
2nd Value:
Value Percent:
Continuous Index:
Within 8" of Joint: **NO**
Remarks: **cip**

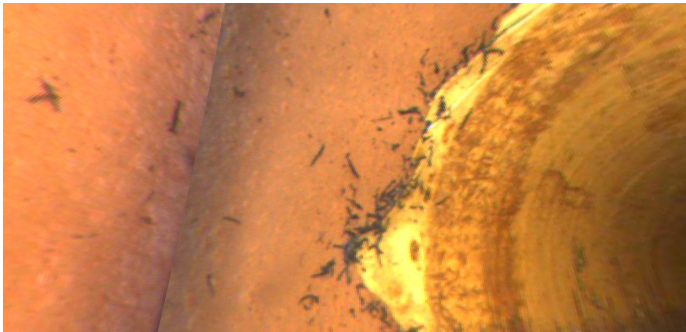
Code: **MLC**
Description: **Lining Change**

Distance (ft): **71.9**
Structural Grade: **0**
O&M Grade: **0**
Clock Start/From:
Clock To:
1st Value:
2nd Value:
Value Percent:
Continuous Index:
Within 8" of Joint: **NO**
Remarks: **end cip**

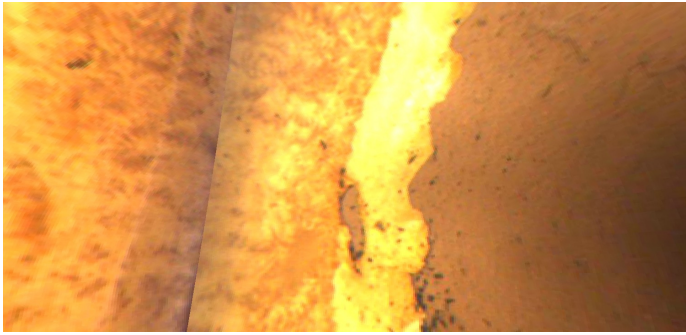
Code: **MLC**
Description: **Lining Change**

Distance (ft): **78.8**
Structural Grade: **0**
O&M Grade: **0**
Clock Start/From:
Clock To:
1st Value:
2nd Value:
Value Percent:
Continuous Index:
Within 8" of Joint: **NO**
Remarks: **CIP**

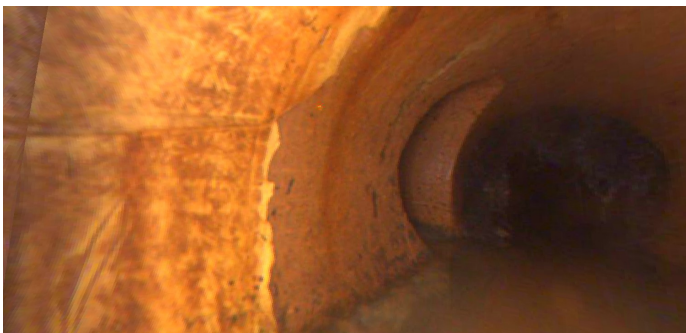
Code: **MLC**
Description: **Lining Change**

Distance (ft): **82.4**
Structural Grade: **0**
O&M Grade: **0**
Clock Start/From:
Clock To:
1st Value:
2nd Value:
Value Percent:
Continuous Index:
Within 8" of Joint: **NO**
Remarks: **CIP END**

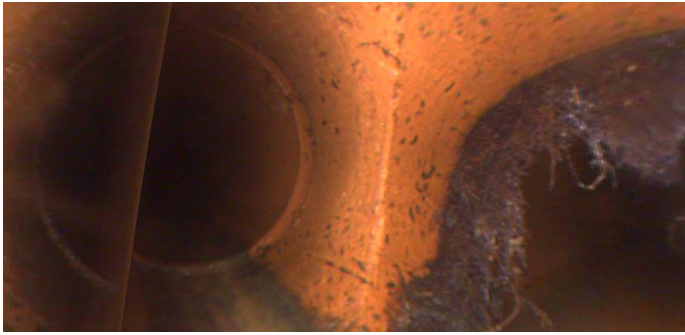
Code: **TF**
Description: **Tap Factory**

Distance (ft): **83.2**
Structural Grade: **0**
O&M Grade: **0**
Clock Start/From: **9**
Clock To:
1st Value: **4.000**
2nd Value:
Value Percent:
Continuous Index:
Within 8" of Joint: **YES**
Remarks:

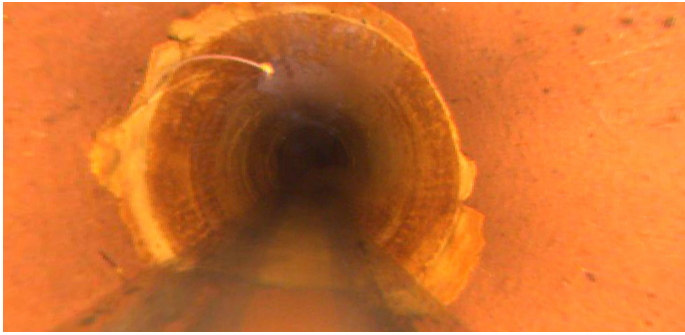
Code: **MMC**
Description: **Material Change**

Distance (ft): **86.5**
Structural Grade: **0**
O&M Grade: **0**
Clock Start/From:
Clock To:
1st Value:
2nd Value:
Value Percent:
Continuous Index:
Within 8" of Joint: **NO**
Remarks: **lining**

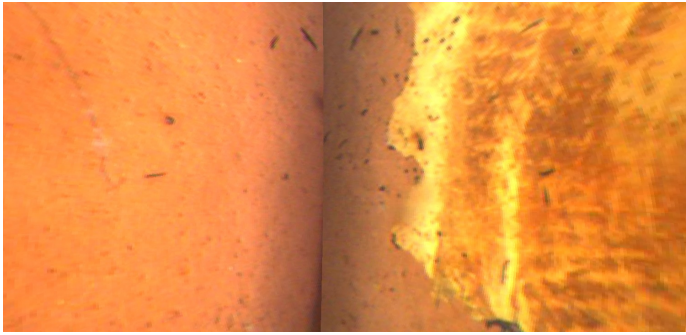
Code: **MLC**
Description: **Lining Change**

Distance (ft): **106.6**
Structural Grade: **0**
O&M Grade: **0**
Clock Start/From:
Clock To:
1st Value:
2nd Value:
Value Percent:
Continuous Index:
Within 8" of Joint: **NO**
Remarks: **CIP**

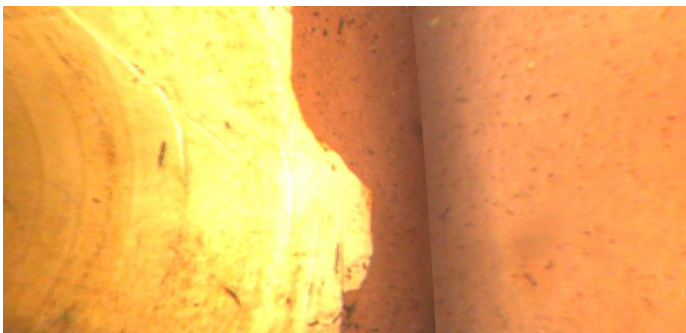
Code: **MLC**
Description: **Lining Change**

Distance (ft): **112.3**
Structural Grade: **0**
O&M Grade: **0**
Clock Start/From:
Clock To:
1st Value:
2nd Value:
Value Percent:
Continuous Index:
Within 8" of Joint: **NO**
Remarks: **cip**

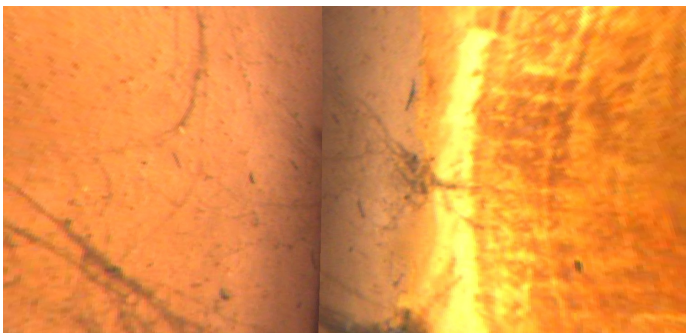
Code: **MLC**
Description: **Lining Change**

Distance (ft): **121.7**
Structural Grade: **0**
O&M Grade: **0**
Clock Start/From:
Clock To:
1st Value:
2nd Value:
Value Percent:
Continuous Index:
Within 8" of Joint: **NO**
Remarks: **CIP**

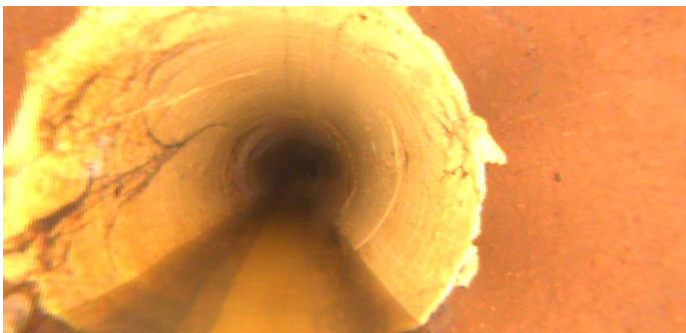
Code: **MLC**
Description: **Lining Change**

Distance (ft): **130.0**
Structural Grade: **0**
O&M Grade: **0**
Clock Start/From:
Clock To:
1st Value:
2nd Value:
Value Percent:
Continuous Index:
Within 8" of Joint: **NO**
Remarks: **END CIP**

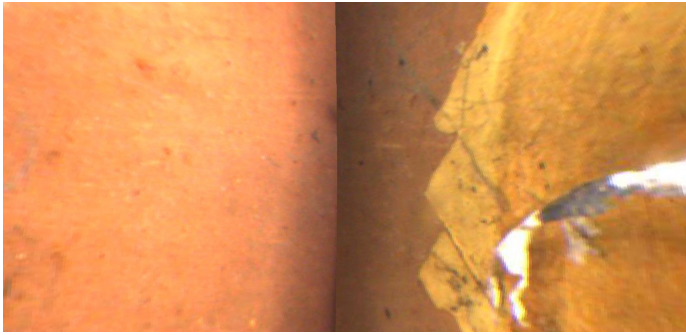
Code: **MMC**
Description: **Material Change**

Distance (ft): **135.7**
Structural Grade: **0**
O&M Grade: **0**
Clock Start/From:
Clock To:
1st Value:
2nd Value:
Value Percent:
Continuous Index:
Within 8" of Joint: **NO**
Remarks: **vcp**

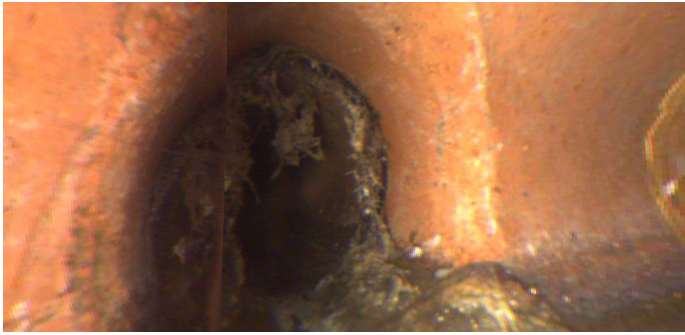
Code: **TF**
Description: **Tap Factory**

Distance (ft): **136.6**
Structural Grade: **0**
O&M Grade: **0**
Clock Start/From: **3**
Clock To:
1st Value: **4.000**
2nd Value:
Value Percent:
Continuous Index:
Within 8" of Joint: **YES**
Remarks:

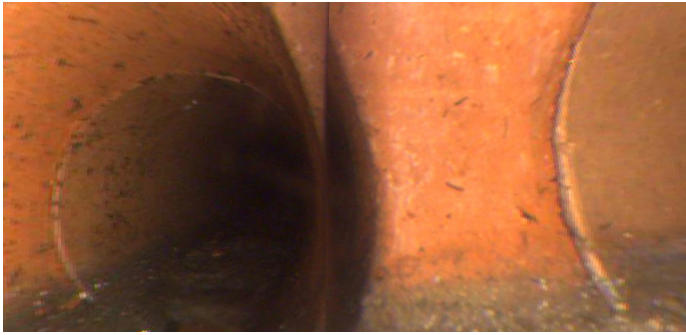
Code: **TF**
Description: **Tap Factory**

Distance (ft): **138.8**
Structural Grade: **0**
O&M Grade: **0**
Clock Start/From: **9**
Clock To:
1st Value: **4.000**
2nd Value:
Value Percent:
Continuous Index:
Within 8" of Joint: **YES**
Remarks:

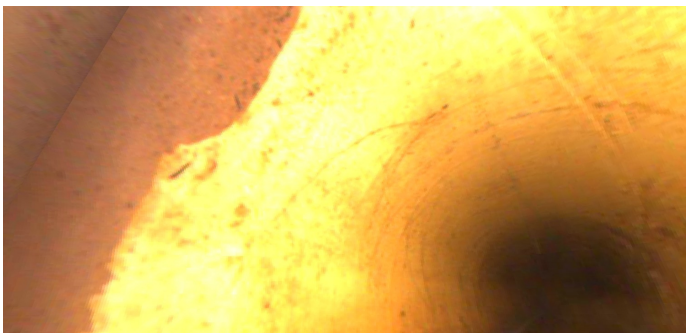
Code: **MMC**
Description: **Material Change**

Distance (ft): **141.5**
Structural Grade: **0**
O&M Grade: **0**
Clock Start/From:
Clock To:
1st Value:
2nd Value:
Value Percent:
Continuous Index:
Within 8" of Joint: **NO**
Remarks: **lining**

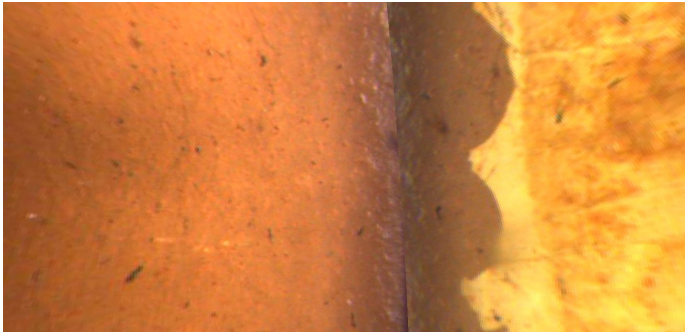
Code: **MMC**
Description: **Material Change**

Distance (ft): **145.8**
Structural Grade: **0**
O&M Grade: **0**
Clock Start/From:
Clock To:
1st Value:
2nd Value:
Value Percent:
Continuous Index:
Within 8" of Joint: **NO**
Remarks: **vcp**
