## Profile/Photo Observation Report

Date:	<b>03/25/2018</b>	Weather:		Coding:	<b>PACP 6.0</b>
Pipe Length (ft):	<b>186.5</b>	Owner:	<b>NA</b>	Pre Clean:	<b>No Pre-Cleaning</b>
P.O.#:		Surveyor:	<b>Byrd Fitzgerald</b>	PSR:	<b>P-108-013-010</b>
Customer:		Clean Date:	<b>01/01/1900</b>	Shape:	<b>C</b>

Street:	<b>15TH ST</b>	Flow Control:	<b>Not Controlled</b>
City:	<b>Hobart, IN</b>	Year Renewed:	
Location:	<b>Light Highway</b>	Tape/Media #:	
Purpose:	<b>Routine Assessment</b>	Dia/Height:	<b>8"</b>
Use:	<b>Sanitary</b>	Material:	<b>VCP</b>
Drain Area:	<b>NA</b>	Lining:	
Category:	<b>NA</b>		
Comment:	<b>Flow direction wrong</b>

Location Details:		Direction of Survey:	<b>Downstream</b>
US MH:	<b>M-108-010</b>	DS MH:	<b>M-108-013</b>
		Total Length Surveyed (ft):	<b>184.1</b>

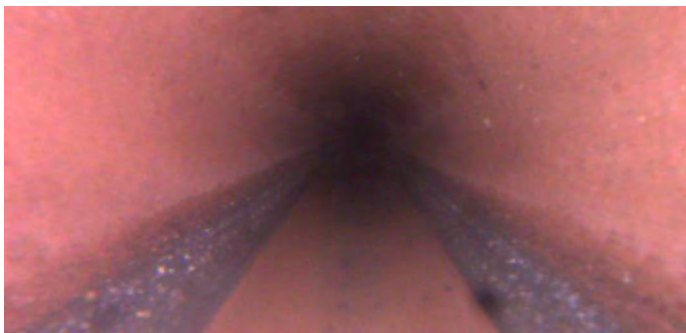
Code: **AMH**  
Description: **Manhole**

Distance (ft): **.0**  
Structural Grade: **0**  
O&M Grade: **0**  
Clock Start/From:  
Clock To:  
1st Value:  
2nd Value:  
Value Percent:  
Continuous Index:  
Within 8" of Joint: **NO**  
Remarks: **M-108-010**

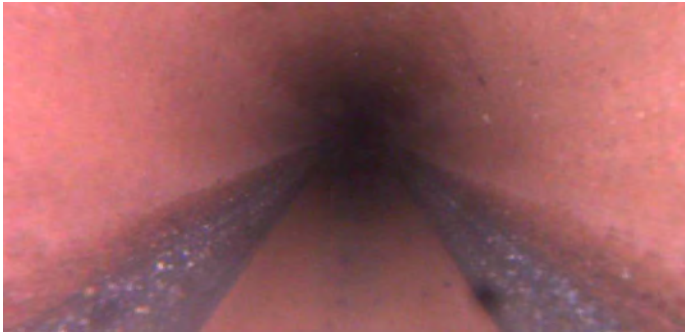
Code:	<b>MWL</b>
Description:	<b>Water Level</b>

Distance (ft):	<b>.0</b>
Structural Grade:	<b>0</b>
O&M Grade:	<b>0</b>
Clock Start/From:	
Clock To:	
1st Value:	
2nd Value:	
Value Percent:	<b>5.000</b>
Continuous Index:	
Within 8" of Joint:	<b>NO</b>
Remarks:

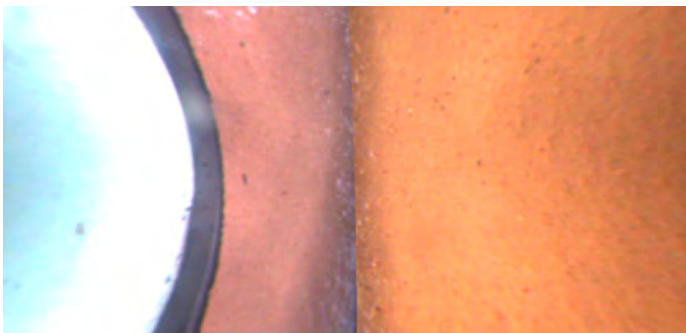
Code: **MMC**  
Description: **Material Change**

Distance (ft): **45.3**  
Structural Grade: **0**  
O&M Grade: **0**  
Clock Start/From:  
Clock To:  
1st Value:  
2nd Value:  
Value Percent:  
Continuous Index:  
Within 8" of Joint: **NO**  
Remarks: **pvc**

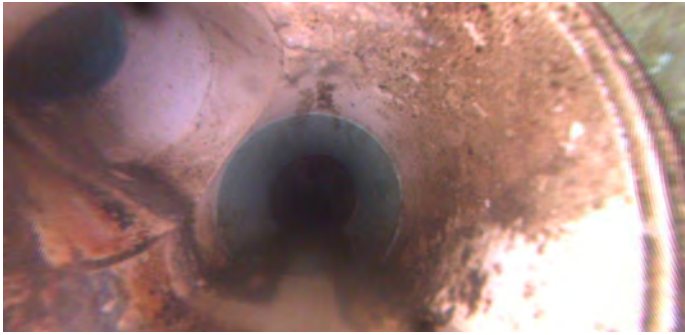
Code: **TF**  
Description: **Tap Factory**

Distance (ft): **48.5**  
Structural Grade: **0**  
O&M Grade: **0**  
Clock Start/From: **11**  
Clock To:  
1st Value: **4.000**  
2nd Value:  
Value Percent:  
Continuous Index:  
Within 8" of Joint: **YES**  
Remarks:

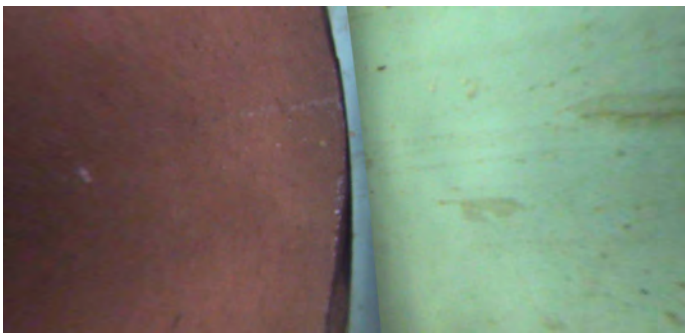
Code: **MMC**  
Description: **Material Change**

Distance (ft): **50.1**  
Structural Grade: **0**  
O&M Grade: **0**  
Clock Start/From:  
Clock To:  
1st Value:  
2nd Value:  
Value Percent:  
Continuous Index:  
Within 8" of Joint: **NO**  
Remarks: **vcp**

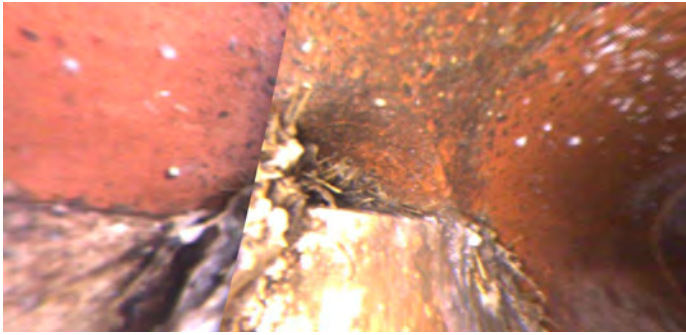
Code: **MGP**  
Description: **General Photo**

Distance (ft): **101.0**  
Structural Grade: **0**  
O&M Grade: **0**  
Clock Start/From:  
Clock To:  
1st Value:  
2nd Value:  
Value Percent:  
Continuous Index:  
Within 8" of Joint: **NO**  
Remarks:

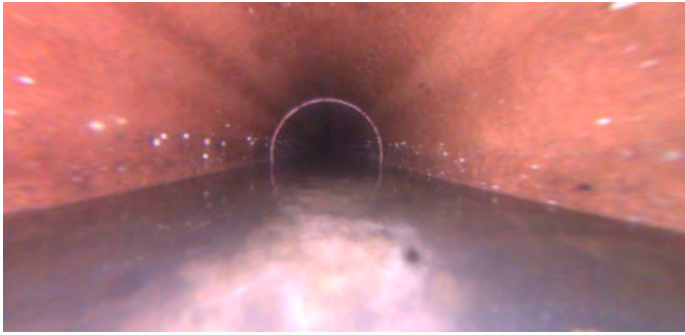
Code: **MWL**  
Description: **Water Level**

Distance (ft): **115.3**  
Structural Grade: **0**  
O&M Grade: **0**  
Clock Start/From:  
Clock To:  
1st Value:  
2nd Value:  
Value Percent: **25.000**  
Continuous Index:  
Within 8" of Joint: **NO**  
Remarks:

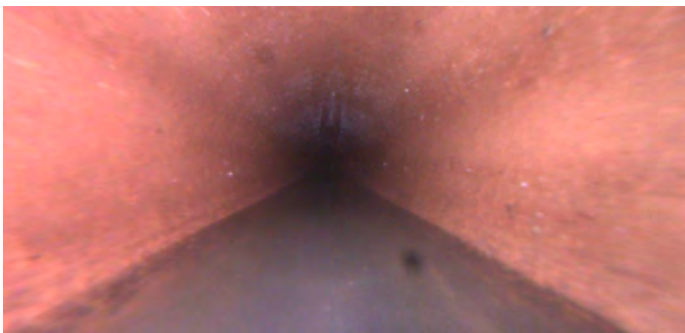
Code: **MWL**  
Description: **Water Level**

Distance (ft): **122.5**  
Structural Grade: **0**  
O&M Grade: **0**  
Clock Start/From:  
Clock To:  
1st Value:  
2nd Value:  
Value Percent: **5.000**  
Continuous Index:  
Within 8" of Joint: **NO**  
Remarks:

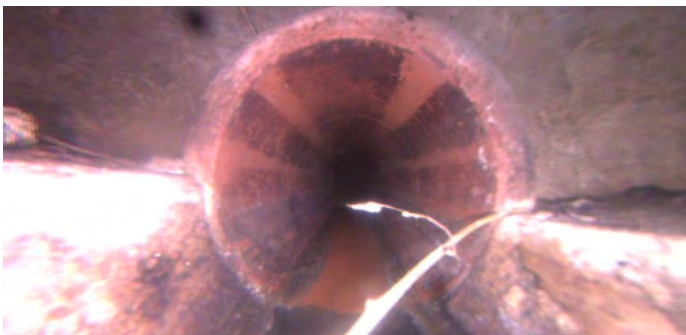
Code: **AMH**  
Description: **Manhole**

Distance (ft): **184.1**  
Structural Grade: **0**  
O&M Grade: **0**  
Clock Start/From:  
Clock To:  
1st Value:  
2nd Value:  
Value Percent:  
Continuous Index:  
Within 8" of Joint: **NO**  
Remarks: **M-108-013**
