Profile/Photo Observation Report

Date:	03/25/2018	Weather:		Coding:	PACP 6.0
Pipe Length (ft):	186.5	Owner:	NA	Pre Clean:	No Pre-Cleaning
P.O.#:		Surveyor:	Byrd Fitzgerald	PSR:	P-108-013-010
Customer:		Clean Date:	01/01/1900	Shape:	C

Street:	FOXCROFT STREET	Flow Control:	Not Controlled
City:	Hobart, IN	Year Renewed:	
Location:	Light Highway	Tape/Media #:	
Purpose:	Routine Assessment	Dia/Height:	8"
Use:	Sanitary	Material:	VCP
Drain Area:	NA	Lining:	
Category:	NA		
Comment:	Flow direction wrong

Location Details:		Direction of Survey:	Downstream
US MH:	M-108-010	DS MH:	M-108-013
		Total Length Surveyed (ft):	184.1

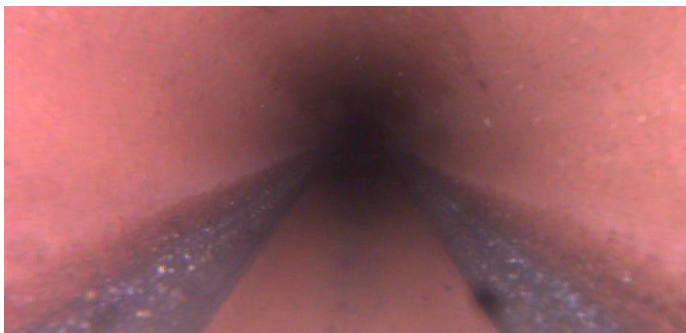
Code: **AMH**
Description: **Manhole**

Distance (ft): **.0**
Structural Grade: **0**
O&M Grade: **0**
Clock Start/From:
Clock To:
1st Value:
2nd Value:
Value Percent:
Continuous Index:
Within 8" of Joint: **NO**
Remarks: **M-108-010**

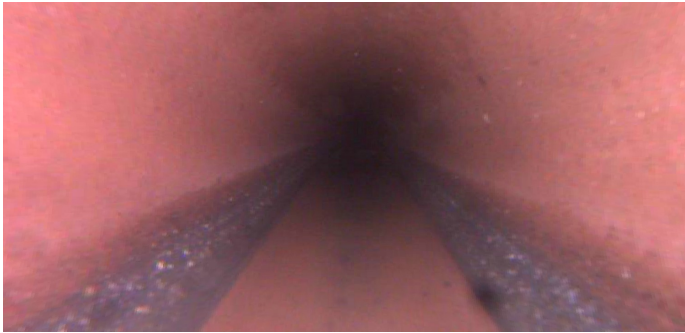
Code:	MWL
Description:	Water Level

Distance (ft):	.0
Structural Grade:	0
O&M Grade:	0
Clock Start/From:	
Clock To:	
1st Value:	
2nd Value:	
Value Percent:	5.000
Continuous Index:	
Within 8" of Joint:	NO
Remarks:

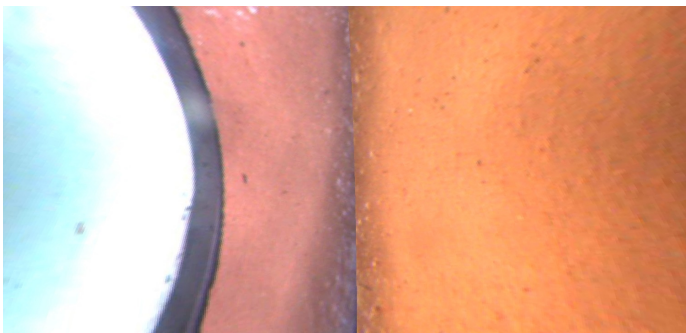
Code: **MMC**
Description: **Material Change**

Distance (ft): **45.3**
Structural Grade: **0**
O&M Grade: **0**
Clock Start/From:
Clock To:
1st Value:
2nd Value:
Value Percent:
Continuous Index:
Within 8" of Joint: **NO**
Remarks: **pvc**

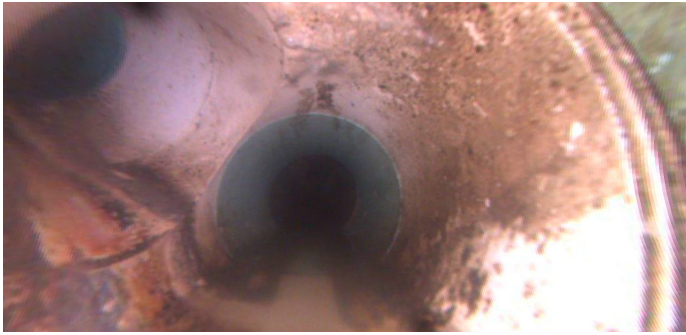
Code: **TF**
Description: **Tap Factory**

Distance (ft): **48.5**
Structural Grade: **0**
O&M Grade: **0**
Clock Start/From: **11**
Clock To:
1st Value: **4.000**
2nd Value:
Value Percent:
Continuous Index:
Within 8" of Joint: **YES**
Remarks:

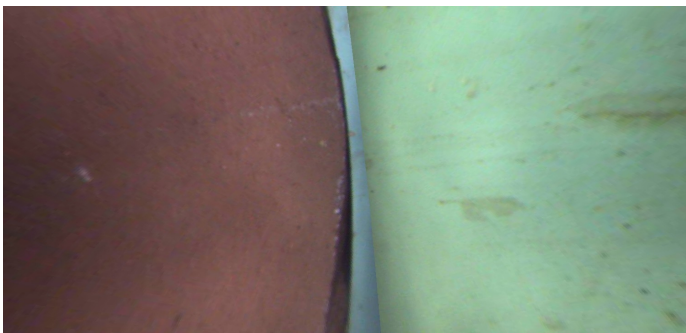
Code: **MMC**
Description: **Material Change**

Distance (ft): **50.1**
Structural Grade: **0**
O&M Grade: **0**
Clock Start/From:
Clock To:
1st Value:
2nd Value:
Value Percent:
Continuous Index:
Within 8" of Joint: **NO**
Remarks: **vcp**

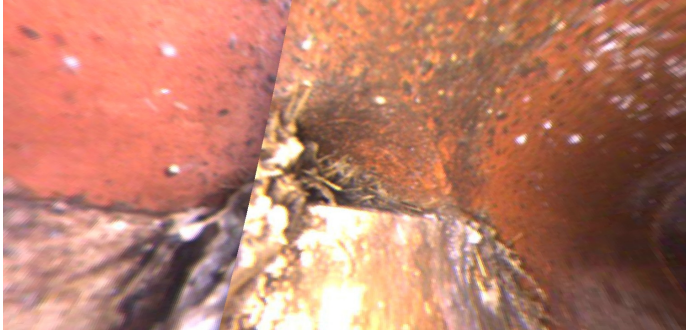
Code: **MGP**
Description: **General Photo**

Distance (ft): **101.0**
Structural Grade: **0**
O&M Grade: **0**
Clock Start/From:
Clock To:
1st Value:
2nd Value:
Value Percent:
Continuous Index:
Within 8" of Joint: **NO**
Remarks:

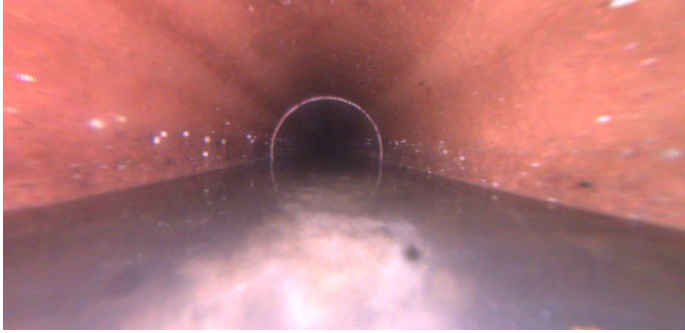
Code: **MWL**
Description: **Water Level**

Distance (ft): **115.3**
Structural Grade: **0**
O&M Grade: **0**
Clock Start/From:
Clock To:
1st Value:
2nd Value:
Value Percent: **25.000**
Continuous Index:
Within 8" of Joint: **NO**
Remarks:

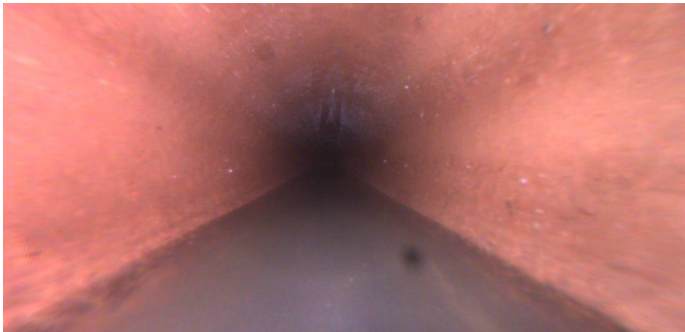
Code: **MWL**
Description: **Water Level**

Distance (ft): **122.5**
Structural Grade: **0**
O&M Grade: **0**
Clock Start/From:
Clock To:
1st Value:
2nd Value:
Value Percent: **5.000**
Continuous Index:
Within 8" of Joint: **NO**
Remarks:

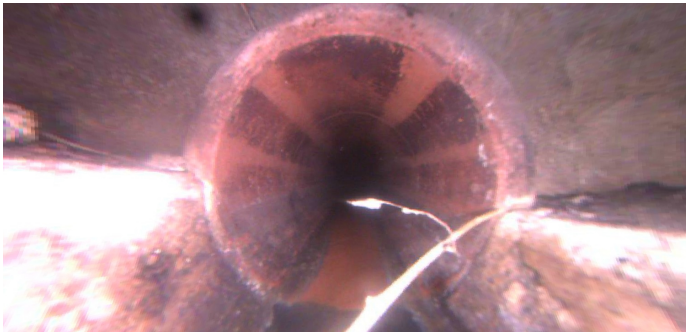
Code: **AMH**
Description: **Manhole**

Distance (ft): **184.1**
Structural Grade: **0**
O&M Grade: **0**
Clock Start/From:
Clock To:
1st Value:
2nd Value:
Value Percent:
Continuous Index:
Within 8" of Joint: **NO**
Remarks: **M-108-013**
