Profile/Photo Observation Report

Date:	03/24/2018	Weather:		Coding:	PACP 6.0
Pipe Length (ft):	280.6	Owner:	NA	Pre Clean:	No Pre-Cleaning
P.O.#:		Surveyor:	Byrd Fitzgerald	PSR:	P-108-028-027
Customer:		Clean Date:	01/01/1900	Shape:	C

Street:	ALLEY BETWEEN SWIFT ST & ALABA	Flow Control:	Not Controlled
City:	Hobart, IN	Year Renewed:	
Location:	Light Highway	Tape/Media #:	
Purpose:	Routine Assessment	Dia/Height:	10"
Use:	Sanitary	Material:	VCP
Drain Area:	NA	Lining:	
Category:	NA		
Comment:	Flow direction wrong

Location Details:		Direction of Survey:	Downstream
US MH:	M-108-027	DS MH:	M-108-028
		Total Length Surveyed (ft):	288.8

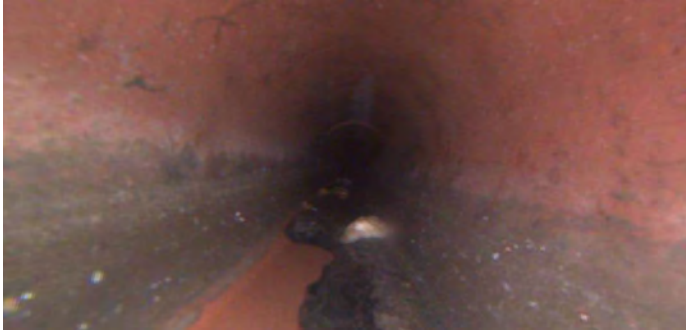
Code: **AMH**
Description: **Manhole**

Distance (ft): **.0**
Structural Grade: **0**
O&M Grade: **0**
Clock Start/From:
Clock To:
1st Value:
2nd Value:
Value Percent:
Continuous Index:
Within 8" of Joint: **NO**
Remarks: **M-108-027**

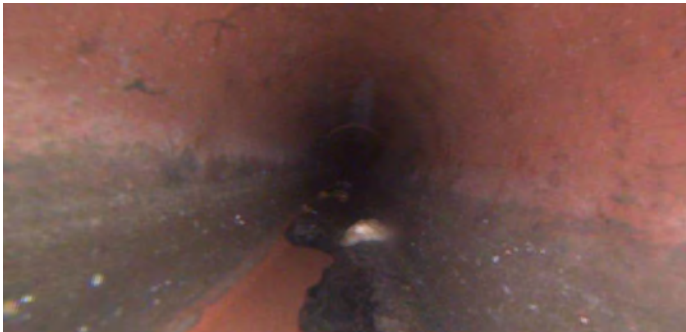
Code: **MWL**
Description: **Water Level**

Distance (ft): **.0**
Structural Grade: **0**
O&M Grade: **0**
Clock Start/From:
Clock To:
1st Value:
2nd Value:
Value Percent: **5.000**
Continuous Index:
Within 8" of Joint: **NO**
Remarks:

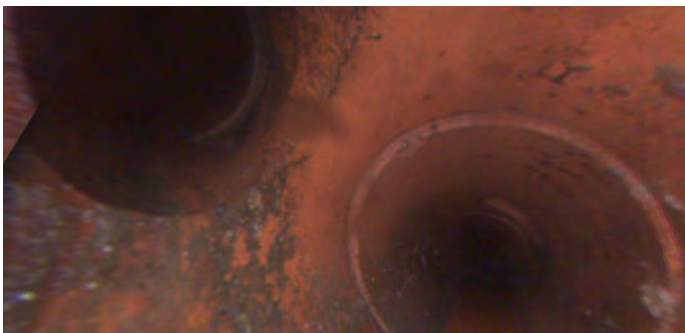
Code: **TF**
Description: **Tap Factory**

Distance (ft): **78.9**
Structural Grade: **0**
O&M Grade: **0**
Clock Start/From: **11**
Clock To:
1st Value: **4.000**
2nd Value:
Value Percent:
Continuous Index:
Within 8" of Joint: **YES**
Remarks:

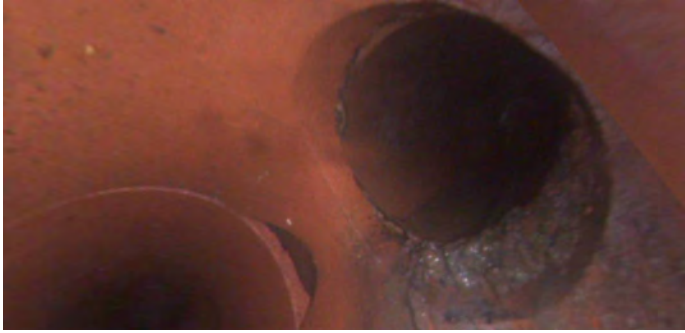
Code: **TF**
Description: **Tap Factory**

Distance (ft): **80.9**
Structural Grade: **0**
O&M Grade: **0**
Clock Start/From: **2**
Clock To:
1st Value: **4.000**
2nd Value:
Value Percent:
Continuous Index:
Within 8" of Joint:
Remarks:

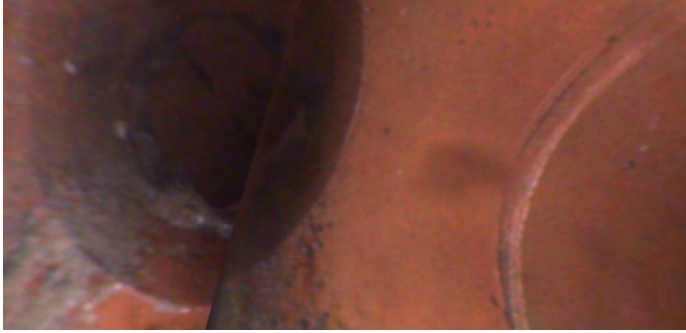
Code: **TF**
Description: **Tap Factory**

Distance (ft): **141.9**
Structural Grade: **0**
O&M Grade: **0**
Clock Start/From: **10**
Clock To:
1st Value: **4.000**
2nd Value:
Value Percent:
Continuous Index:
Within 8" of Joint: **YES**
Remarks:

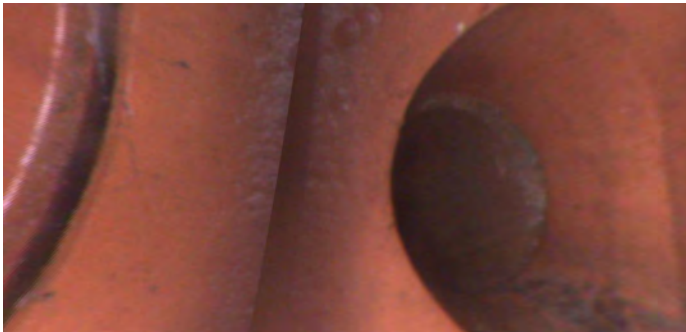
Code: **TF**
Description: **Tap Factory**

Distance (ft): **144.4**
Structural Grade: **0**
O&M Grade: **0**
Clock Start/From: **2**
Clock To:
1st Value: **4.000**
2nd Value:
Value Percent:
Continuous Index:
Within 8" of Joint: **YES**
Remarks:

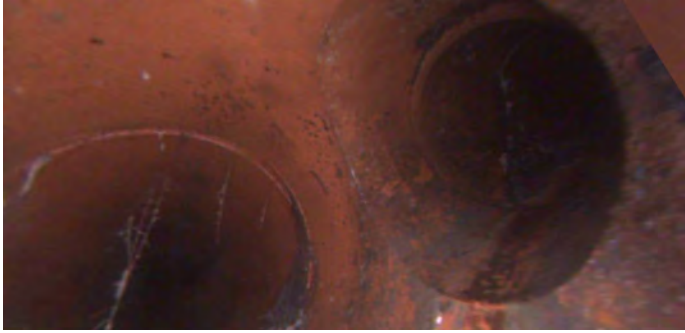
Code: **TF**
Description: **Tap Factory**

Distance (ft): **217.1**
Structural Grade: **0**
O&M Grade: **0**
Clock Start/From: **2**
Clock To:
1st Value: **4.000**
2nd Value:
Value Percent:
Continuous Index:
Within 8" of Joint:
Remarks:

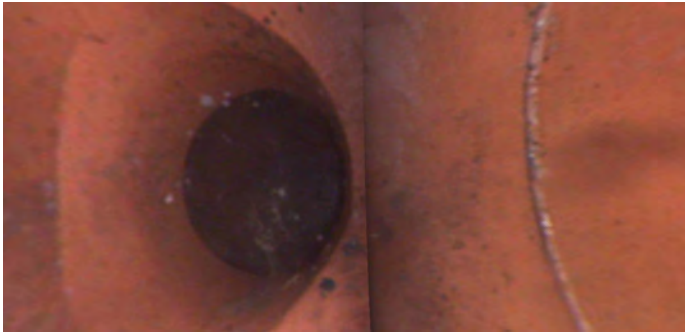
Code: **TFC**
Description: **Tap Factory Capped**

Distance (ft): **278.7**
Structural Grade: **0**
O&M Grade: **0**
Clock Start/From: **10**
Clock To:
1st Value: **4.000**
2nd Value:
Value Percent:
Continuous Index:
Within 8" of Joint: **YES**
Remarks:

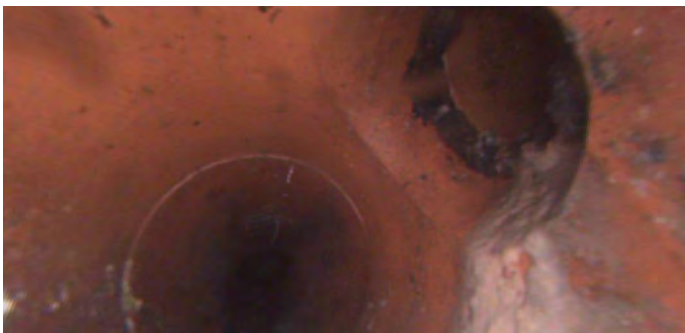
Code: **TF**
Description: **Tap Factory**

Distance (ft): **280.0**
Structural Grade: **0**
O&M Grade: **0**
Clock Start/From: **2**
Clock To:
1st Value: **4.000**
2nd Value:
Value Percent:
Continuous Index:
Within 8" of Joint: **YES**
Remarks:

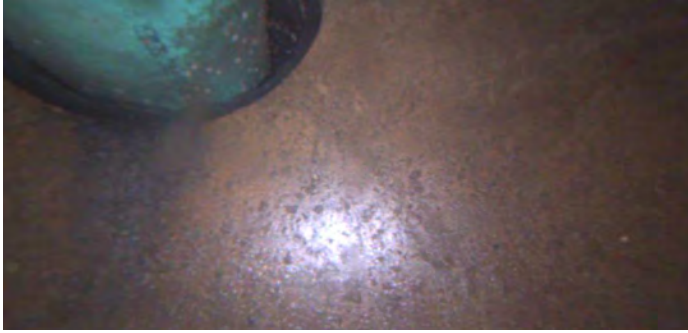
Code:	AMH
Description:	Manhole
Distance (ft):	288.8
Structural Grade:	0
O&M Grade:	0
Clock Start/From:	
Clock To:	
1st Value:	
2nd Value:	
Value Percent:	
Continuous Index:	
Within 8" of Joint:	NO
Remarks:	M-108-028
