Profile/Photo Observation Report

Street:	FOXCROFT STREET	Flow Control:	Not Controlled
City:	Hobart, IN	Year Renewed:	
Location:	Light Highway	Tape/Media #:	
Purpose:	Routine Assessment	Dia/Height:	10"
Use:	Sanitary	Material:	VCP
Drain Area:	NA	Lining:	
Category:	NA		
Comment:	Flow direction wrong

Location Details:		Direction of Survey:	Upstream
US MH:	M-108-038	DS MH:	M-108-037
		Total Length Surveyed (ft):	272.1

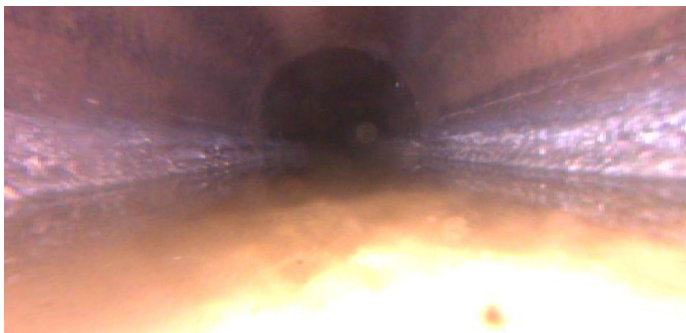
Code: **AMH**
Description: **Manhole**

Distance (ft): **.0**
Structural Grade: **0**
O&M Grade: **0**
Clock Start/From:
Clock To:
1st Value:
2nd Value:
Value Percent:
Continuous Index:
Within 8" of Joint: **NO**
Remarks: **M-108-037**

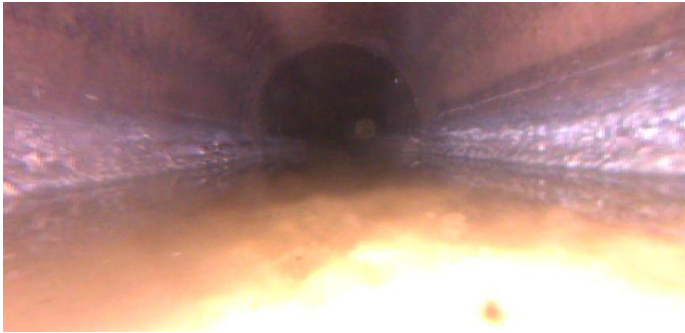
Code:	MWL
Description:	Water Level

Distance (ft):	.0
Structural Grade:	0
O&M Grade:	0
Clock Start/From:	
Clock To:	
1st Value:	
2nd Value:	
Value Percent:	20.000
Continuous Index:	
Within 8" of Joint:	NO
Remarks:

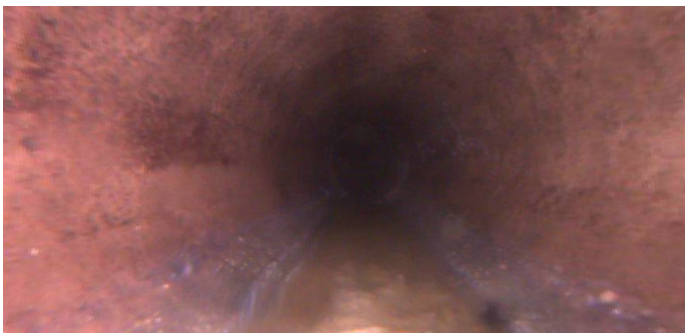
Code: **MWL**
Description: **Water Level**

Distance (ft): **9.2**
Structural Grade: **0**
O&M Grade: **0**
Clock Start/From:
Clock To:
1st Value:
2nd Value:
Value Percent: **5.000**
Continuous Index:
Within 8" of Joint: **NO**
Remarks:

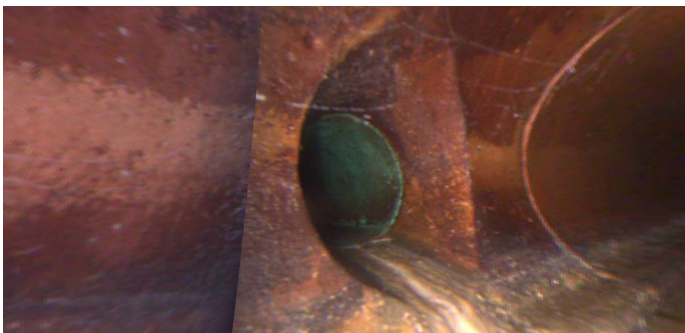
Code: **TF**
Description: **Tap Factory**

Distance (ft): **48.2**
Structural Grade: **0**
O&M Grade: **0**
Clock Start/From: **3**
Clock To:
1st Value: **4.000**
2nd Value:
Value Percent:
Continuous Index:
Within 8" of Joint: **YES**
Remarks:

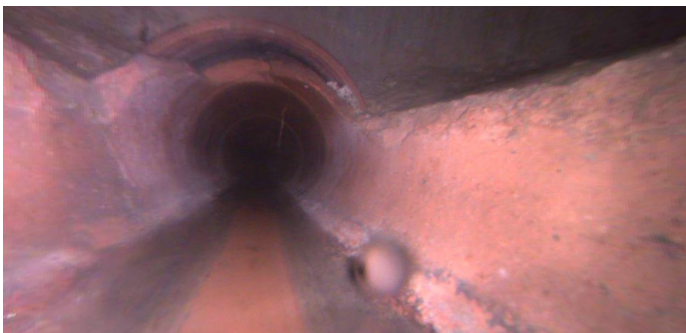
Code: **AMH**
Description: **Manhole**

Distance (ft): **272.1**
Structural Grade: **0**
O&M Grade: **0**
Clock Start/From:
Clock To:
1st Value:
2nd Value:
Value Percent:
Continuous Index:
Within 8" of Joint: **NO**
Remarks: **M-108-038**
