Profile/Photo Observation Report

Street:	OFF 15TH PL	Flow Control:	Not Controlled
City:	Hobart, IN	Year Renewed:	
Location:	Light Highway	Tape/Media #:	
Purpose:	Routine Assessment	Dia/Height:	10"
Use:	Sanitary	Material:	VCP
Drain Area:	NA	Lining:	
Category:	NA		
Comment:	Flow direction wrong

Location Details:		Direction of Survey:	Downstream
US MH:	M-108-039	DS MH:	M-108-038
		Total Length Surveyed (ft):	203.6

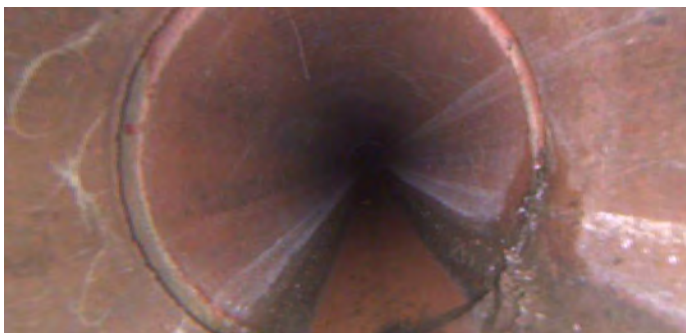
Code: **AMH**
Description: **Manhole**

Distance (ft): **.0**
Structural Grade: **0**
O&M Grade: **0**
Clock Start/From:
Clock To:
1st Value:
2nd Value:
Value Percent:
Continuous Index:
Within 8" of Joint: **NO**
Remarks: **M-108-039**

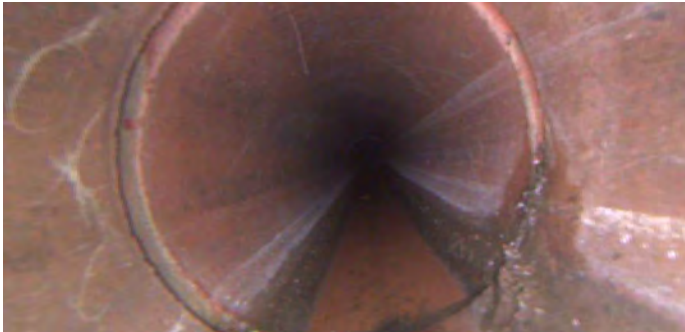
Code:	MWL
Description:	Water Level

Distance (ft):	.0
Structural Grade:	0
O&M Grade:	0
Clock Start/From:	
Clock To:	
1st Value:	
2nd Value:	
Value Percent:	5.000
Continuous Index:	
Within 8" of Joint:	NO
Remarks:

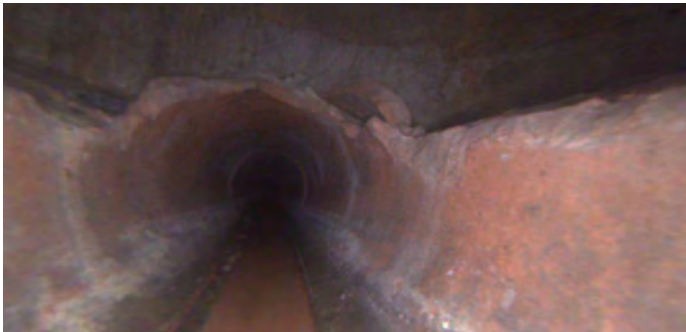
Code: **AMH**
Description: **Manhole**

Distance (ft): **203.6**
Structural Grade: **0**
O&M Grade: **0**
Clock Start/From:
Clock To:
1st Value:
2nd Value:
Value Percent:
Continuous Index:
Within 8" of Joint: **NO**
Remarks: **M-108-038**
