Profile/Photo Observation Report

Street:	FOXCROFT STREET	Flow Control:	Not Controlled
City:	Hobart, IN	Year Renewed:	
Location:	Light Highway	Tape/Media #:	
Purpose:	Routine Assessment	Dia/Height:	10"
Use:	Sanitary	Material:	VCP
Drain Area:	NA	Lining:	
Category:	NA		
Comment:	Flow direction wrong

Location Details:		Direction of Survey:	Downstream
US MH:	M-108-039	DS MH:	M-108-038
		Total Length Surveyed (ft):	203.6

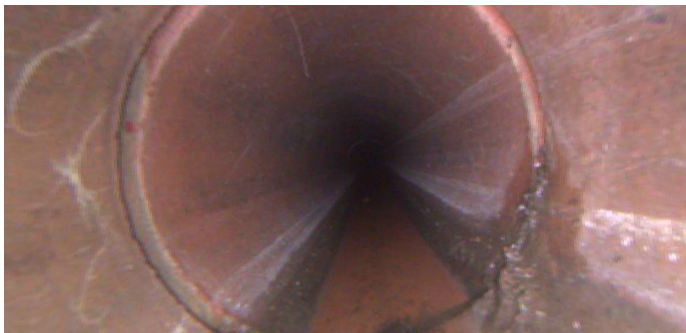
Code: **AMH**
Description: **Manhole**

Distance (ft): **.0**
Structural Grade: **0**
O&M Grade: **0**
Clock Start/From:
Clock To:
1st Value:
2nd Value:
Value Percent:
Continuous Index:
Within 8" of Joint: **NO**
Remarks: **M-108-039**

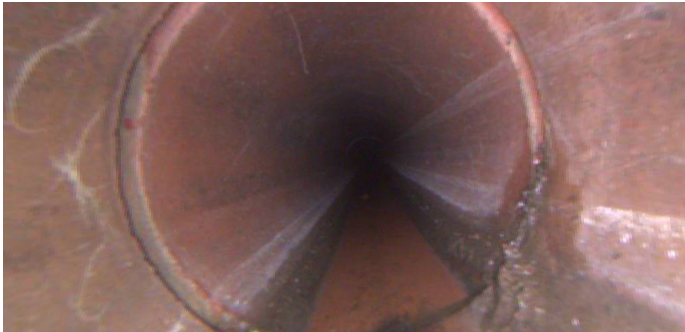
Code:	MWL
Description:	Water Level

Distance (ft):	.0
Structural Grade:	0
O&M Grade:	0
Clock Start/From:	
Clock To:	
1st Value:	
2nd Value:	
Value Percent:	5.000
Continuous Index:	
Within 8" of Joint:	NO
Remarks:

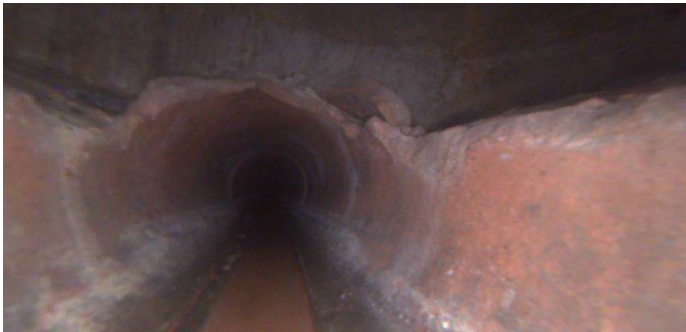
Code: **AMH**
Description: **Manhole**

Distance (ft): **203.6**
Structural Grade: **0**
O&M Grade: **0**
Clock Start/From:
Clock To:
1st Value:
2nd Value:
Value Percent:
Continuous Index:
Within 8" of Joint: **NO**
Remarks: **M-108-038**
