Profile/Photo Observation Report

Street:	OFF 15TH PL	Flow Control:	Not Controlled
City:	Hobart, IN	Year Renewed:	
Location:	Light Highway	Tape/Media #:	
Purpose:	Routine Assessment	Dia/Height:	10"
Use:	Sanitary	Material:	VCP
Drain Area:	NA	Lining:	
Category:	NA		
Comment:	Flow direction wrong

Location Details:		Direction of Survey:	Upstream
US MH:	M-108-040	DS MH:	M-108-039
		Total Length Surveyed (ft):	174.0

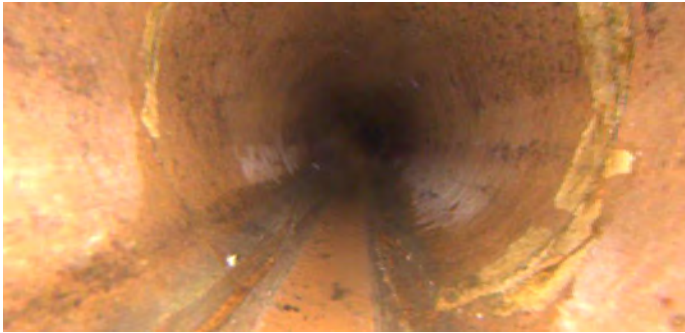
Code:	AMH
Description:	Manhole

Distance (ft):	.0
Structural Grade:	0
O&M Grade:	0
Clock Start/From:	
Clock To:	
1st Value:	
2nd Value:	
Value Percent:	
Continuous Index:	
Within 8" of Joint:	NO
Remarks:	M-108-039

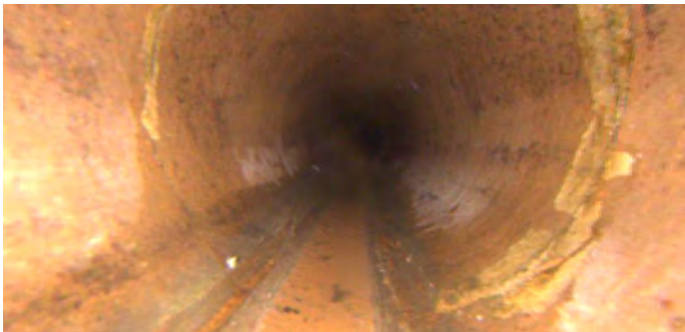
Code:	MWL
Description:	Water Level

Distance (ft):	.0
Structural Grade:	0
O&M Grade:	0
Clock Start/From:	
Clock To:	
1st Value:	
2nd Value:	
Value Percent:	5.000
Continuous Index:	
Within 8" of Joint:	NO
Remarks:

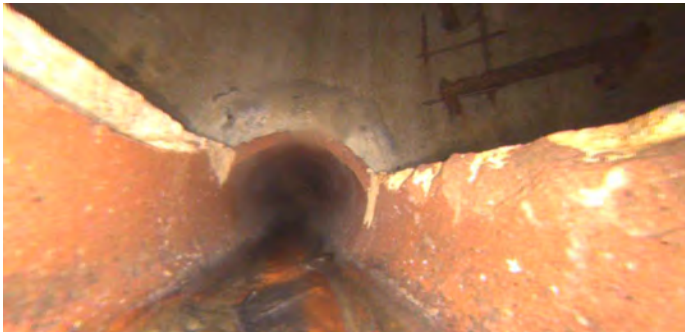
Code: **AMH**
Description: **Manhole**

Distance (ft): **174.0**
Structural Grade: **0**
O&M Grade: **0**
Clock Start/From:
Clock To:
1st Value:
2nd Value:
Value Percent:
Continuous Index:
Within 8" of Joint: **NO**
Remarks: **M-108-040**
