## Profile/Photo Observation Report

| P.O.#: | | Surveyor: | <b>Byrd Fitzgerald</b> | PSR: | <b>P-108-040-041</b> |

| Street: | <b>OFF 15TH PL</b> | Flow Control: | <b>Not Controlled</b> |
| City: | <b>Hobart, IN</b> | Year Renewed: | |

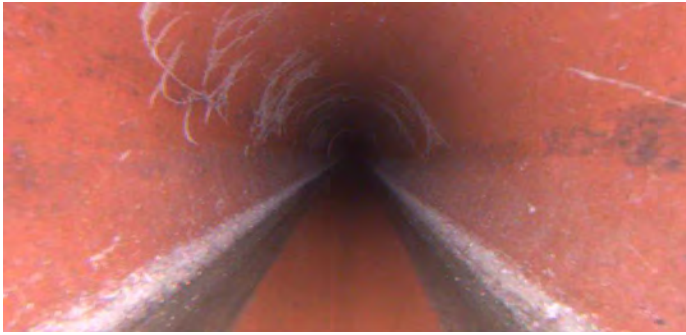
Code: **AMH**  
Description: **Manhole**

Distance (ft): **.0**  
Structural Grade: **0**  
O&M Grade: **0**  
Clock Start/From:  
Clock To:  
1st Value:  
2nd Value:  
Value Percent:  
Continuous Index:  
Within 8" of Joint: **NO**  
Remarks: **M-108-041**

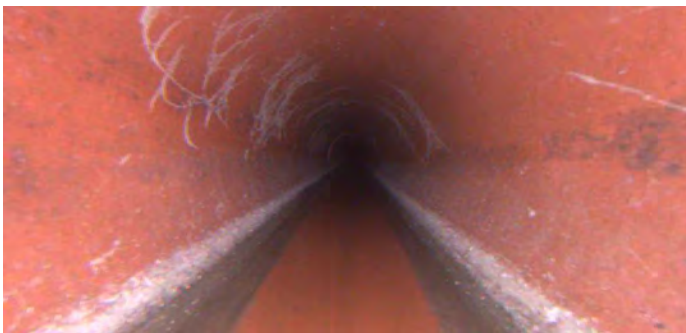
Code: **MWL**  
Description: **Water Level**

Distance (ft): **.0**  
Structural Grade: **0**  
O&M Grade: **0**  
Clock Start/From:  
Clock To:  
1st Value:  
2nd Value:  
Value Percent: **5.000**  
Continuous Index:  
Within 8" of Joint: **NO**  
Remarks:

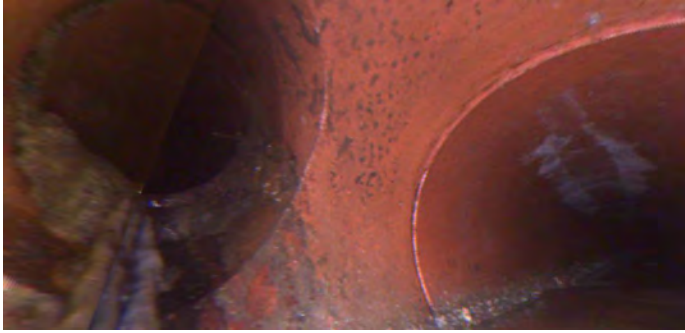
Code: **TF**  
Description: **Tap Factory**

Distance (ft): **56.7**  
Structural Grade: **0**  
O&M Grade: **0**  
Clock Start/From: **10**  
Clock To:  
1st Value: **4.000**  
2nd Value:  
Value Percent:  
Continuous Index:  
Within 8" of Joint: **YES**  
Remarks:

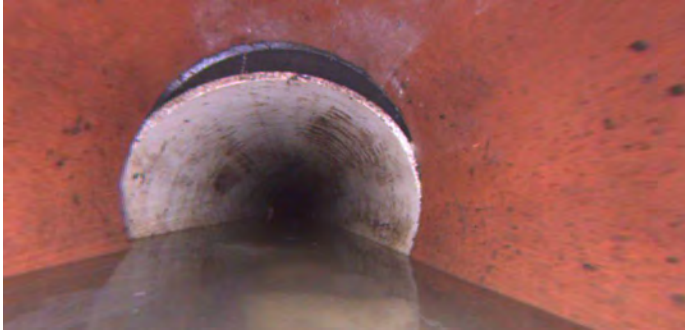
Code: **MMC**  
Description: **Material Change**

Distance (ft): **95.0**  
Structural Grade: **0**  
O&M Grade: **0**  
Clock Start/From:  
Clock To:  
1st Value:  
2nd Value:  
Value Percent:  
Continuous Index:  
Within 8" of Joint: **NO**  
Remarks: **pvc**

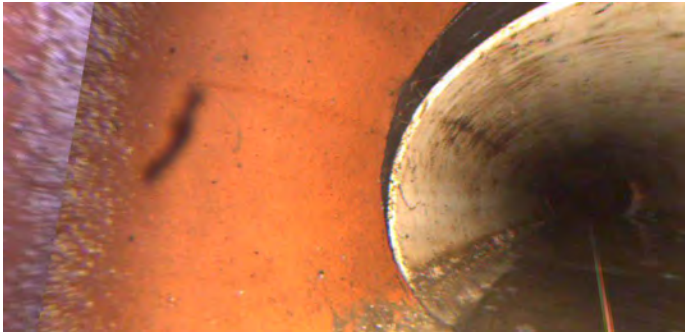
Code: **MMC**  
Description: **Material Change**

Distance (ft): **100.7**  
Structural Grade: **0**  
O&M Grade: **0**  
Clock Start/From:  
Clock To:  
1st Value:  
2nd Value:  
Value Percent:  
Continuous Index:  
Within 8" of Joint: **NO**  
Remarks: **vcp**

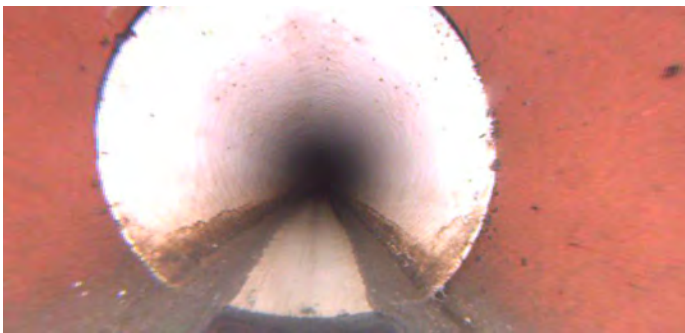
Code: **MMC**  
Description: **Material Change**

Distance (ft): **193.1**  
Structural Grade: **0**  
O&M Grade: **0**  
Clock Start/From:  
Clock To:  
1st Value:  
2nd Value:  
Value Percent:  
Continuous Index:  
Within 8" of Joint: **NO**  
Remarks: **pvc**

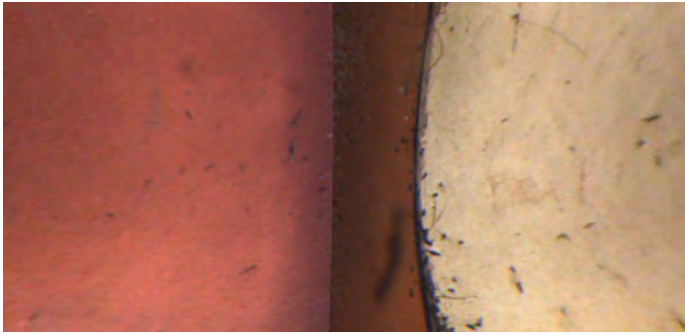
Code: **MMC**  
Description: **Material Change**

Distance (ft): **201.4**  
Structural Grade: **0**  
O&M Grade: **0**  
Clock Start/From:  
Clock To:  
1st Value:  
2nd Value:  
Value Percent:  
Continuous Index:  
Within 8" of Joint: **NO**  
Remarks: **vcp**

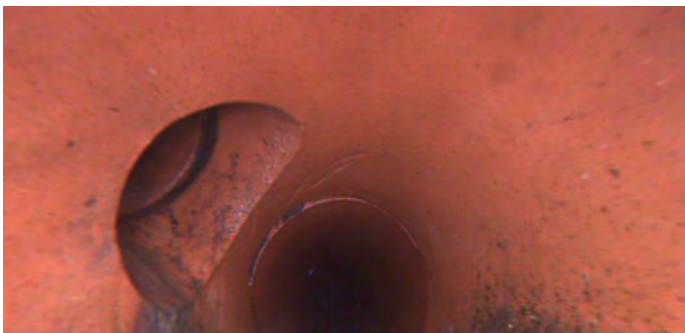
Code: **TF**  
Description: **Tap Factory**

Distance (ft): **207.2**  
Structural Grade: **0**  
O&M Grade: **0**  
Clock Start/From: **10**  
Clock To:  
1st Value: **4.000**  
2nd Value:  
Value Percent:  
Continuous Index:  
Within 8" of Joint:  
Remarks:

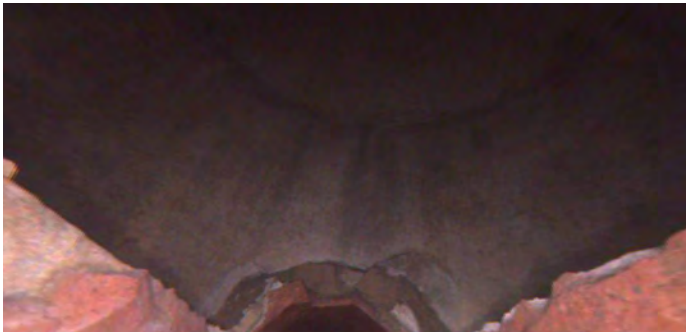
Code: **AMH**  
Description: **Manhole**

Distance (ft): **249.1**  
Structural Grade: **0**  
O&M Grade: **0**  
Clock Start/From:  
Clock To:  
1st Value:  
2nd Value:  
Value Percent:  
Continuous Index:  
Within 8" of Joint: **NO**  
Remarks: **M-108-040**
