Profile/Photo Observation Report

Street:	W 61ST AVE	Flow Control:	Not Controlled
City:	Hobart, IN	Year Renewed:	
Location:	Light Highway	Tape/Media #:	
Purpose:	Routine Assessment	Dia/Height:	10"
Use:	Sanitary	Material:	PVC
Drain Area:	NA	Lining:	
Category:	NA		
Comment:	Flow direction wrong

Location Details:		Direction of Survey:	Downstream
US MH:	M-108-052	DS MH:	M-108-051
		Total Length Surveyed (ft):	415.0

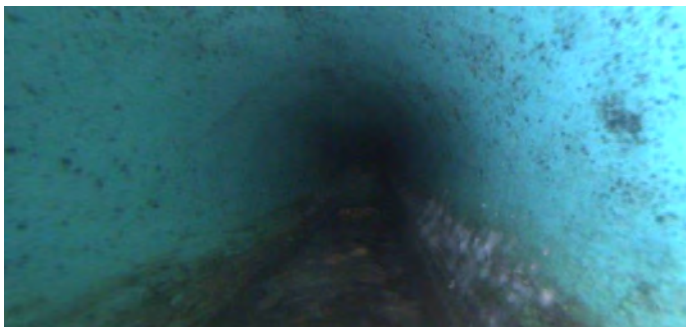
Code: **AMH**
Description: **Manhole**

Distance (ft): **.0**
Structural Grade: **0**
O&M Grade: **0**
Clock Start/From:
Clock To:
1st Value:
2nd Value:
Value Percent:
Continuous Index:
Within 8" of Joint: **NO**
Remarks: **M-108-052**

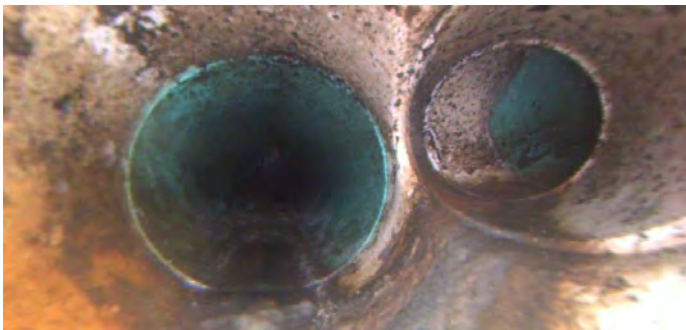
Code: **TF**
Description: **Tap Factory**

Distance (ft): **297.6**
Structural Grade: **0**
O&M Grade: **0**
Clock Start/From: **2**
Clock To:
1st Value: **4.000**
2nd Value:
Value Percent:
Continuous Index:
Within 8" of Joint:
Remarks:

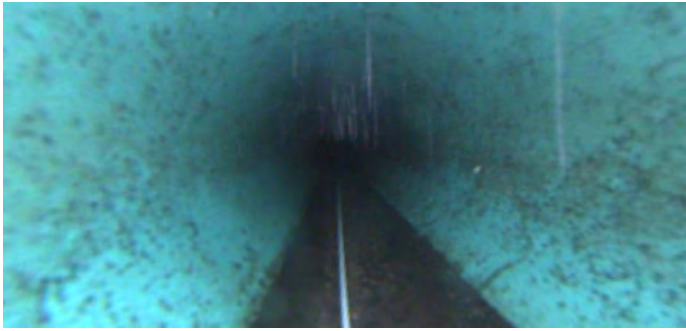
Code: **MGO**
Description: **General Observation**

Distance (ft): **311.3**
Structural Grade: **0**
O&M Grade: **0**
Clock Start/From:
Clock To:
1st Value:
2nd Value:
Value Percent:
Continuous Index:
Within 8" of Joint: **NO**
Remarks: **Switching to rear camera**

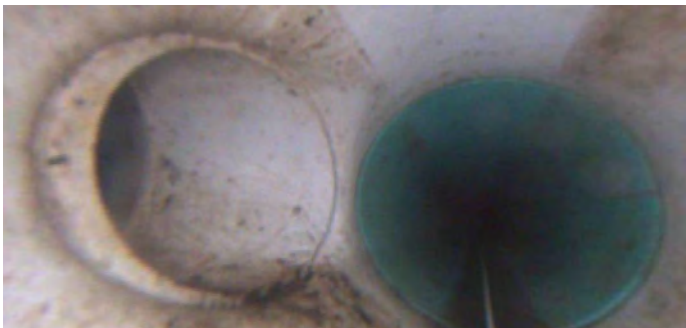
Code: **TF**
Description: **Tap Factory**

Distance (ft): **393.7**
Structural Grade: **0**
O&M Grade: **0**
Clock Start/From: **3**
Clock To:
1st Value: **4.000**
2nd Value:
Value Percent:
Continuous Index:
Within 8" of Joint:
Remarks:

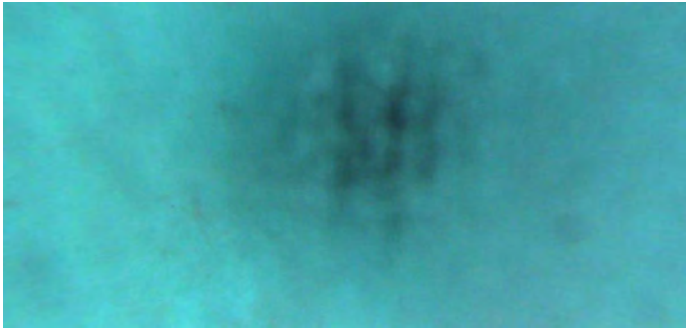
Code: **MGO**
Description: **General Observation**

Distance (ft): **407.1**
Structural Grade: **0**
O&M Grade: **0**
Clock Start/From:
Clock To:
1st Value:
2nd Value:
Value Percent:
Continuous Index:
Within 8" of Joint: **NO**
Remarks: **Switching to front camera**

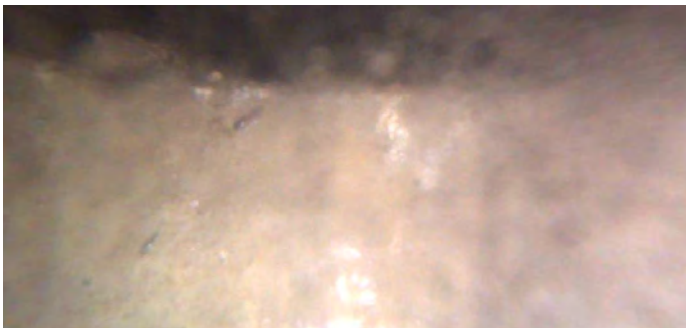
Code: **AMH**
Description: **Manhole**

Distance (ft): **415.0**
Structural Grade: **0**
O&M Grade: **0**
Clock Start/From:
Clock To:
1st Value:
2nd Value:
Value Percent:
Continuous Index:
Within 8" of Joint: **NO**
Remarks: **M-108-051**
