Profile/Photo Observation Report

Date:	04/05/2018	Weather:		Coding:	PACP 6.0
Pipe Length (ft):	336.8	Owner:	NA	Pre Clean:	Not Known
P.O.#:		Surveyor:	Jen Costello	PSR:	P-203-003-002
Customer:		Clean Date:	01/01/1900	Shape:	C

Street:	W OLD RIDGE RD & PARKER ST	Flow Control:	Not Controlled
City:	Hobart, IN	Year Renewed:	
Location:	Other	Tape/Media #:	
Purpose:	Not Known	Dia/Height:	12"
Use:	Sanitary	Material:	VCP
Drain Area:	NA	Lining:	
Category:	NA		
Comment:

Location Details:		Direction of Survey:	Downstream
US MH:	M-203-003	DS MH:	M-203-002
		Total Length Surveyed (ft):	323.1

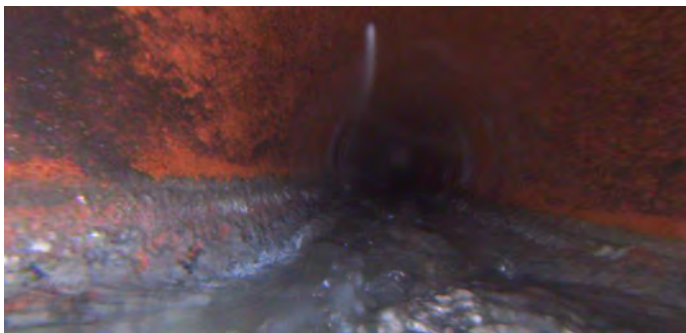
Code: **AMH**
Description: **Manhole**

Distance (ft): **.0**
Structural Grade: **0**
O&M Grade: **0**
Clock Start/From:
Clock To:
1st Value:
2nd Value:
Value Percent:
Continuous Index:
Within 8" of Joint: **NO**
Remarks: **M-203-003**

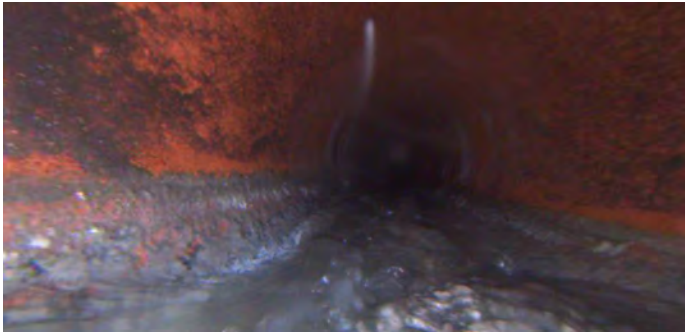
Code:	MWL
Description:	Water Level

Distance (ft):	.0
Structural Grade:	0
O&M Grade:	0
Clock Start/From:	
Clock To:	
1st Value:	
2nd Value:	
Value Percent:	20.000
Continuous Index:	
Within 8" of Joint:	NO
Remarks:

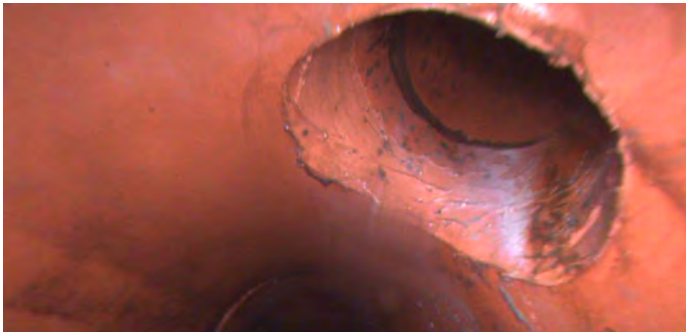
Code: **TF**
Description: **Tap Factory**

Distance (ft): **58.8**
Structural Grade: **0**
O&M Grade: **0**
Clock Start/From: **1**
Clock To:
1st Value: **4.000**
2nd Value:
Value Percent:
Continuous Index:
Within 8" of Joint:
Remarks:

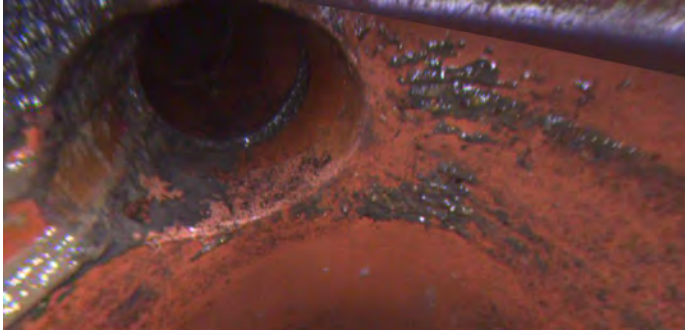
Code: **TF**
Description: **Tap Factory**

Distance (ft): **91.0**
Structural Grade: **0**
O&M Grade: **0**
Clock Start/From: **11**
Clock To:
1st Value: **4.000**
2nd Value:
Value Percent:
Continuous Index:
Within 8" of Joint:
Remarks:

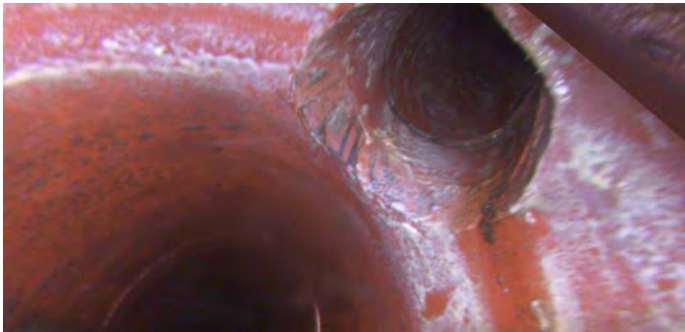
Code: **TF**
Description: **Tap Factory**

Distance (ft): **133.0**
Structural Grade: **0**
O&M Grade: **0**
Clock Start/From: **1**
Clock To:
1st Value: **4.000**
2nd Value:
Value Percent:
Continuous Index:
Within 8" of Joint:
Remarks:

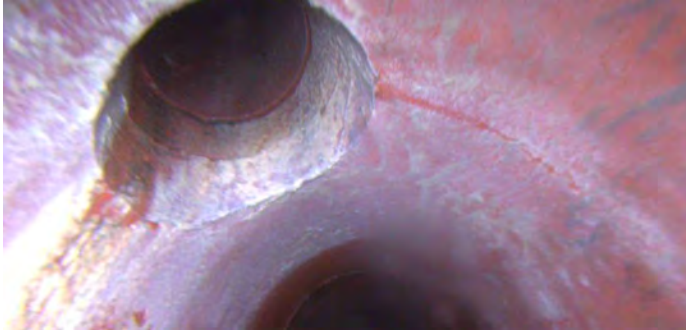
Code: **TF**
Description: **Tap Factory**

Distance (ft): **169.7**
Structural Grade: **0**
O&M Grade: **0**
Clock Start/From: **11**
Clock To:
1st Value: **4.000**
2nd Value:
Value Percent:
Continuous Index:
Within 8" of Joint:
Remarks:

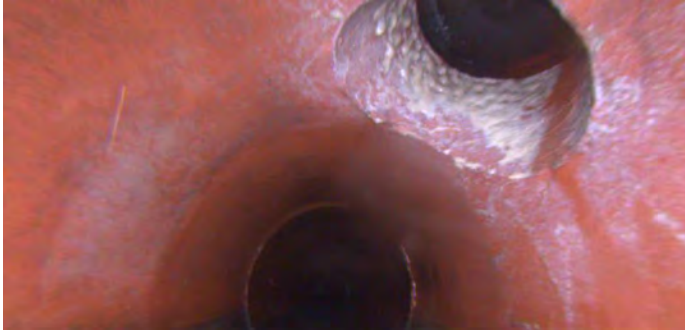
Code: **TFC**
Description: **Tap Factory Capped**

Distance (ft): **221.3**
Structural Grade: **0**
O&M Grade: **0**
Clock Start/From: **1**
Clock To:
1st Value: **4.000**
2nd Value:
Value Percent:
Continuous Index:
Within 8" of Joint:
Remarks:

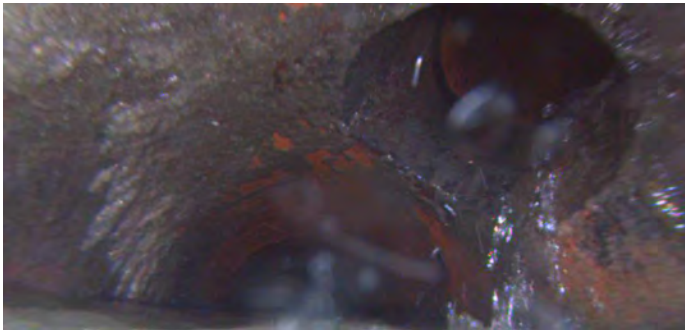
Code: **TFA**
Description: **Tap Factory Active**

Distance (ft): **250.4**
Structural Grade: **0**
O&M Grade: **0**
Clock Start/From: **1**
Clock To:
1st Value: **4.000**
2nd Value:
Value Percent:
Continuous Index:
Within 8" of Joint:
Remarks:

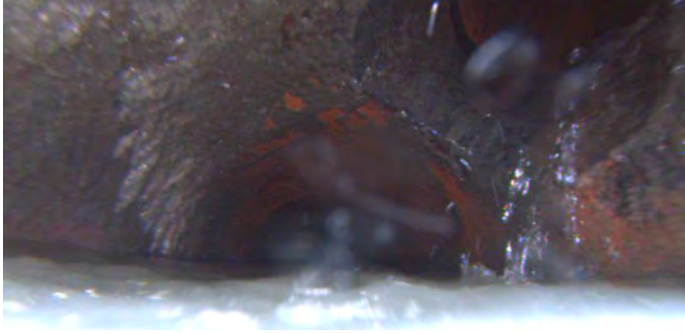
Code: **MWL**
Description: **Water Level**

Distance (ft): **250.4**
Structural Grade: **0**
O&M Grade: **0**
Clock Start/From:
Clock To:
1st Value:
2nd Value:
Value Percent: **40.000**
Continuous Index:
Within 8" of Joint: **NO**
Remarks:

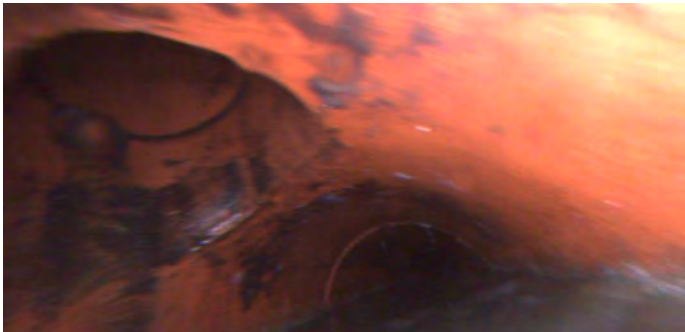
Code: **TF**
Description: **Tap Factory**

Distance (ft): **252.5**
Structural Grade: **0**
O&M Grade: **0**
Clock Start/From: **11**
Clock To:
1st Value: **4.000**
2nd Value:
Value Percent:
Continuous Index:
Within 8" of Joint:
Remarks:

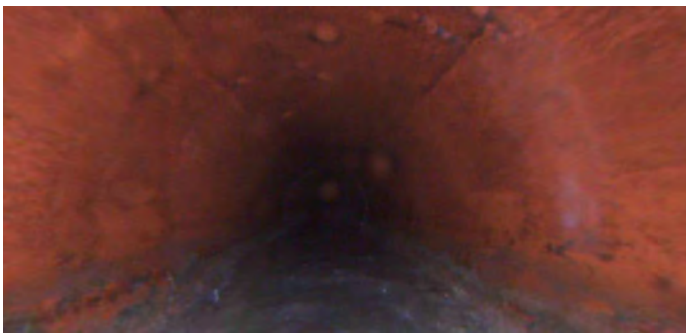
Code: **MWL**
Description: **Water Level**

Distance (ft): **290.3**
Structural Grade: **0**
O&M Grade: **0**
Clock Start/From:
Clock To:
1st Value:
2nd Value:
Value Percent: **10.000**
Continuous Index:
Within 8" of Joint: **NO**
Remarks:

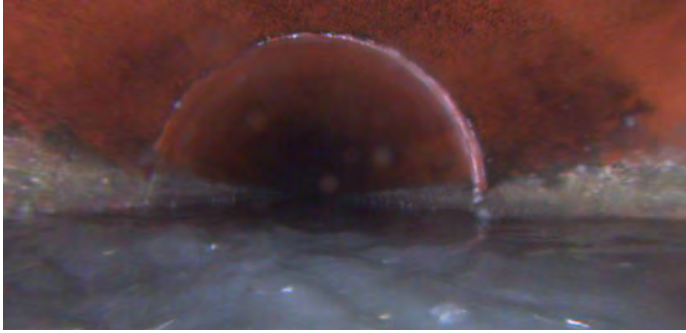
Code: **MWL**
Description: **Water Level**

Distance (ft): **298.0**
Structural Grade: **0**
O&M Grade: **0**
Clock Start/From:
Clock To:
1st Value:
2nd Value:
Value Percent: **40.000**
Continuous Index:
Within 8" of Joint: **NO**
Remarks:

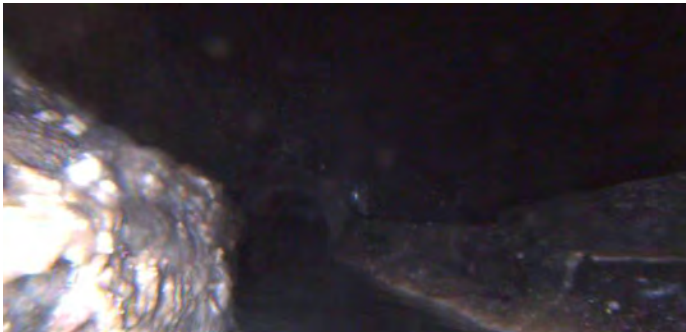
Code: **AMH**
Description: **Manhole**

Distance (ft): **323.1**
Structural Grade: **0**
O&M Grade: **0**
Clock Start/From:
Clock To:
1st Value:
2nd Value:
Value Percent:
Continuous Index:
Within 8" of Joint: **NO**
Remarks: **M-203-002**
