Profile/Photo Observation Report

| Street: | W 38TH AVE | Flow Control: | Not Controlled |
| Purpose: | Routine Assessment | Dia/Height: | 12" |

| US MH: | M-203-023 | DS MH: | M-203-024 |

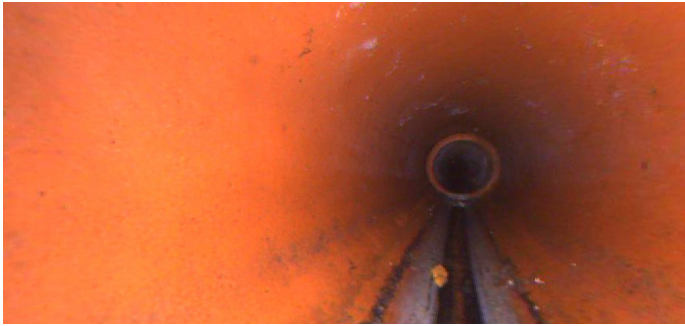
Code: **AMH**
Description: **Manhole**

Distance (ft): **.0**
Structural Grade: **0**
O&M Grade: **0**
Clock Start/From:
Clock To:
1st Value:
2nd Value:
Value Percent:
Continuous Index:
Within 8" of Joint: **NO**
Remarks: **M-203-023**

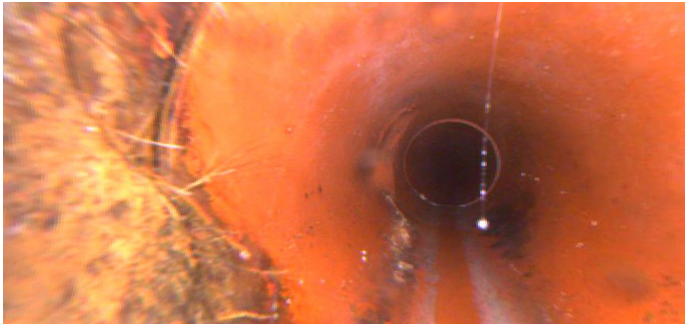
Code: **TF**
Description: **Tap Factory**

Distance (ft): **48.6**
Structural Grade: **0**
O&M Grade: **0**
Clock Start/From: **9**
Clock To:
1st Value: **4.000**
2nd Value:
Value Percent:
Continuous Index:
Within 8" of Joint:
Remarks:

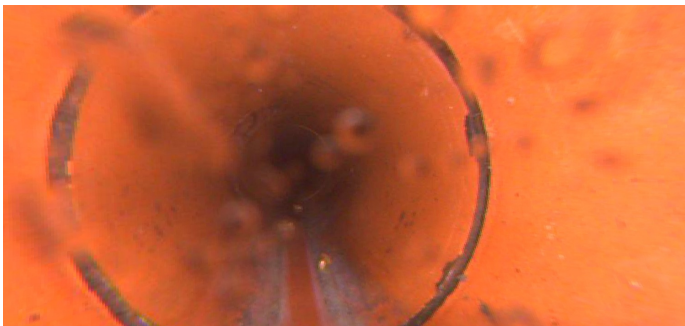
Code: **TF**
Description: **Tap Factory**

Distance (ft): **86.9**
Structural Grade: **0**
O&M Grade: **0**
Clock Start/From: **11**
Clock To:
1st Value: **4.000**
2nd Value:
Value Percent:
Continuous Index:
Within 8" of Joint:
Remarks:

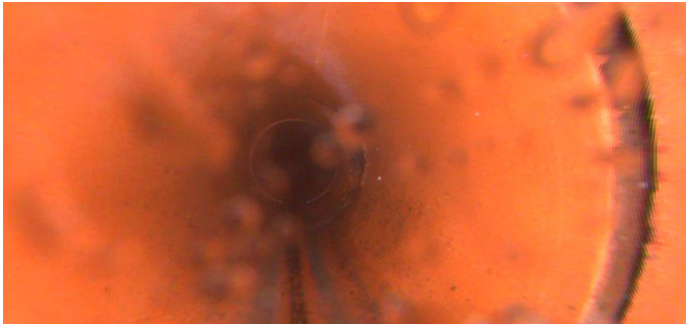
Code: **TF**
Description: **Tap Factory**

Distance (ft): **104.0**
Structural Grade: **0**
O&M Grade: **0**
Clock Start/From: **3**
Clock To:
1st Value: **4.000**
2nd Value:
Value Percent:
Continuous Index:
Within 8" of Joint:
Remarks:

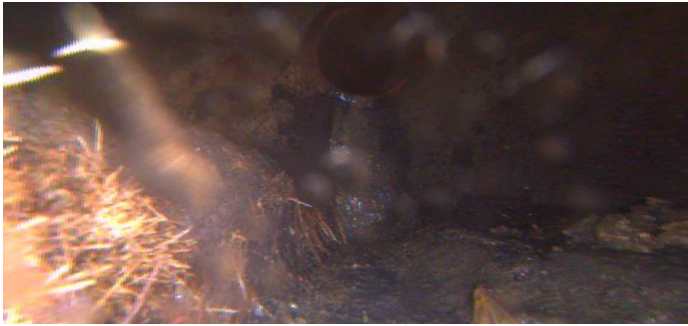
| Code: | AMH |
| Description: | Manhole |
