Profile/Photo Observation Report

Date:	09/25/2018	Weather:		Coding:	PACP 6.0
Pipe Length (ft):	157.1	Owner:	NA	Pre Clean:	Not Known
P.O.#:		Surveyor:	Selasie Honu	PSR:	P-203-024-023
Customer:		Clean Date:	01/01/1900	Shape:	C

Street:	38th. Ave.	Flow Control:	Not Controlled
City:	Hobart, IN	Year Renewed:	
Location:	Light Highway	Tape/Media #:	
Purpose:	Routine Assessment	Dia/Height:	12"
Use:	Sanitary	Material:	VCP
Drain Area:	NA	Lining:	
Category:	NA		
Comment:

Location Details:		Direction of Survey:	Downstream
US MH:	M-203-023	DS MH:	M-203-024
		Total Length Surveyed (ft):	147.8

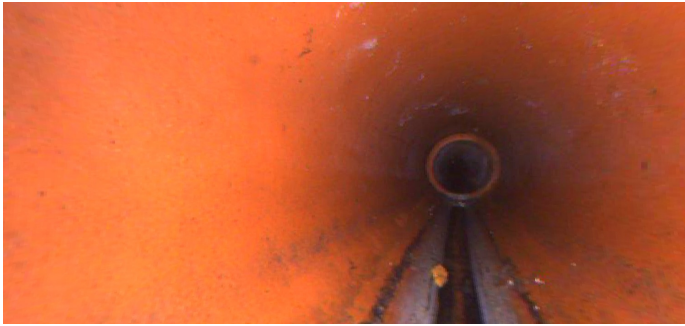
Code: **AMH**
Description: **Manhole**

Distance (ft): **.0**
Structural Grade: **0**
O&M Grade: **0**
Clock Start/From:
Clock To:
1st Value:
2nd Value:
Value Percent:
Continuous Index:
Within 8" of Joint: **NO**
Remarks: **M-203-023**

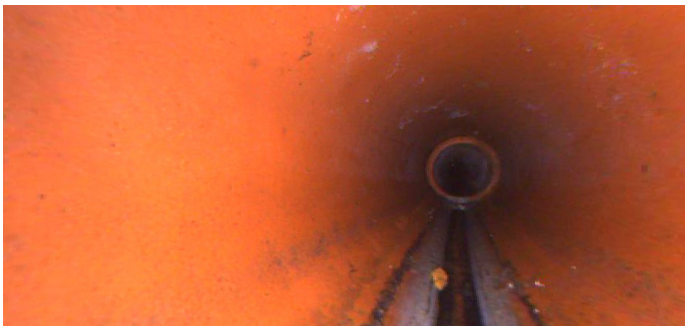
Code: **MWL**
Description: **Water Level**

Distance (ft): **.0**
Structural Grade: **0**
O&M Grade: **0**
Clock Start/From:
Clock To:
1st Value:
2nd Value:
Value Percent: **5.000**
Continuous Index:
Within 8" of Joint: **NO**
Remarks:

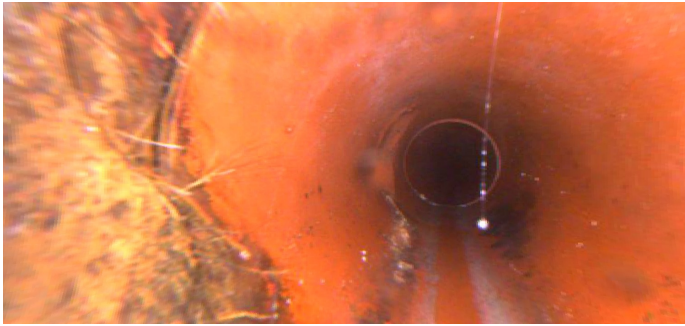
Code: **TF**
Description: **Tap Factory**

Distance (ft): **48.6**
Structural Grade: **0**
O&M Grade: **0**
Clock Start/From: **9**
Clock To:
1st Value: **4.000**
2nd Value:
Value Percent:
Continuous Index:
Within 8" of Joint:
Remarks:

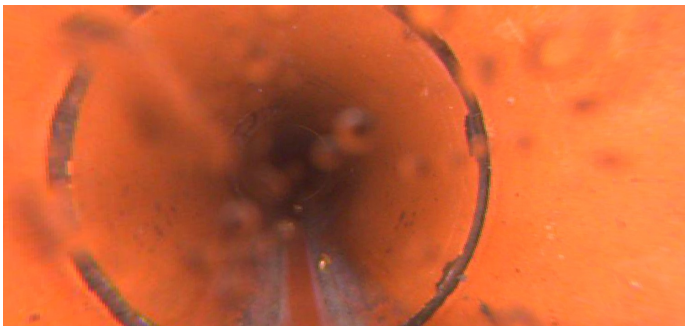
Code: **TF**
Description: **Tap Factory**

Distance (ft): **86.9**
Structural Grade: **0**
O&M Grade: **0**
Clock Start/From: **11**
Clock To:
1st Value: **4.000**
2nd Value:
Value Percent:
Continuous Index:
Within 8" of Joint:
Remarks:

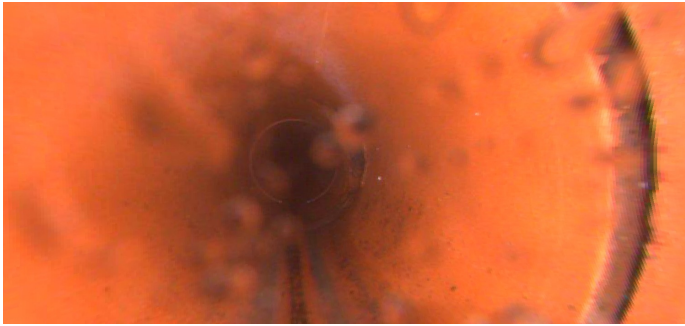
Code: **TF**
Description: **Tap Factory**

Distance (ft): **104.0**
Structural Grade: **0**
O&M Grade: **0**
Clock Start/From: **3**
Clock To:
1st Value: **4.000**
2nd Value:
Value Percent:
Continuous Index:
Within 8" of Joint:
Remarks:

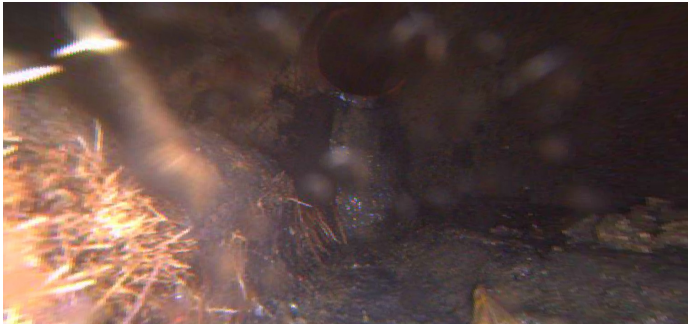
Code:	AMH
Description:	Manhole
Distance (ft):	147.8
Structural Grade:	0
O&M Grade:	0
Clock Start/From:	
Clock To:	
1st Value:	
2nd Value:	
Value Percent:	
Continuous Index:	
Within 8" of Joint:	NO
Remarks:	M-203-024
