Profile/Photo Observation Report

Date:	09/27/2018	Weather:		Coding:	PACP 6.0
Pipe Length (ft):	193.4	Owner:	NA	Pre Clean:	Not Known
P.O.#:		Surveyor:	Selasie Honu	PSR:	P-203-029-028
Customer:		Clean Date:	01/01/1900	Shape:	C

Street:	ALLEY BETWEEN SHERMAN ST & MO	Flow Control:	Not Controlled
City:	Hobart, IN	Year Renewed:	
Location:	Light Highway	Tape/Media #:	
Purpose:	Routine Assessment	Dia/Height:	10"
Use:	Sanitary	Material:	VCP
Drain Area:	NA	Lining:	
Category:	NA		
Comment:

Location Details:		Direction of Survey:	Upstream
US MH:	M-203-028	DS MH:	M-203-029
		Total Length Surveyed (ft):	195.1

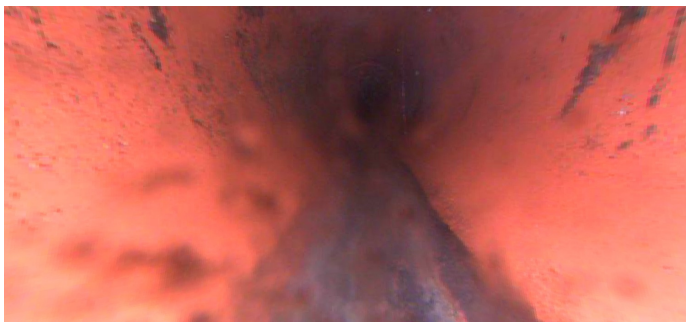
Code: **AMH**
 Description: **Manhole**

Distance (ft): **.0**
 Structural Grade: **0**
 O&M Grade: **0**
 Clock Start/From:
 Clock To:
 1st Value:
 2nd Value:
 Value Percent:
 Continuous Index:
 Within 8" of Joint: **NO**
 Remarks: **M-203-029**

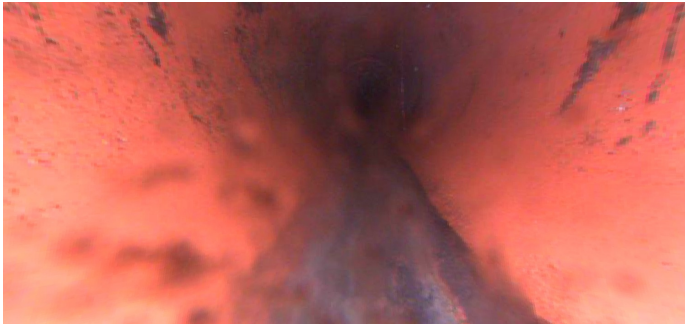
Code:	MWL
Description:	Water Level

Distance (ft):	.0
Structural Grade:	0
O&M Grade:	0
Clock Start/From:	
Clock To:	
1st Value:	
2nd Value:	
Value Percent:	5.000
Continuous Index:	
Within 8" of Joint:	NO
Remarks:

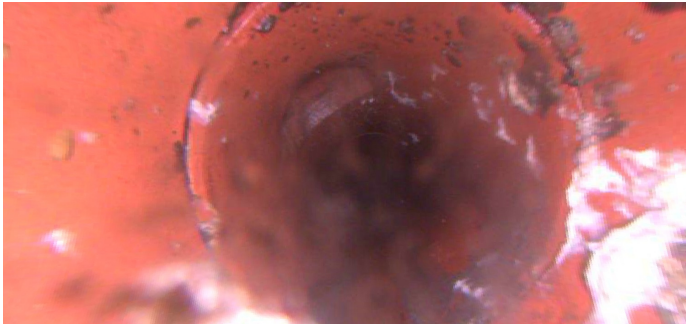
Code: **TF**
Description: **Tap Factory**

Distance (ft): **27.1**
Structural Grade: **0**
O&M Grade: **0**
Clock Start/From: **10**
Clock To:
1st Value: **4.000**
2nd Value:
Value Percent:
Continuous Index:
Within 8" of Joint:
Remarks:

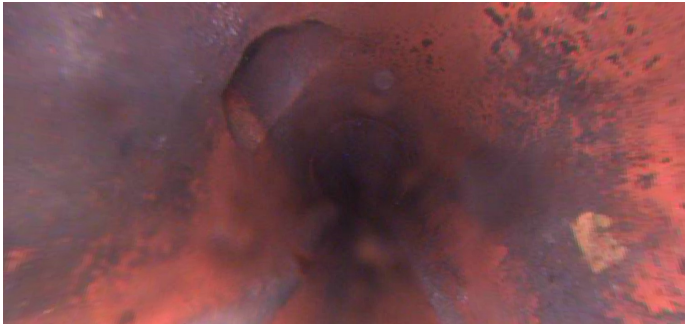
Code: **TF**
Description: **Tap Factory**

Distance (ft): **60.6**
Structural Grade: **0**
O&M Grade: **0**
Clock Start/From: **10**
Clock To:
1st Value: **4.000**
2nd Value:
Value Percent:
Continuous Index:
Within 8" of Joint:
Remarks:

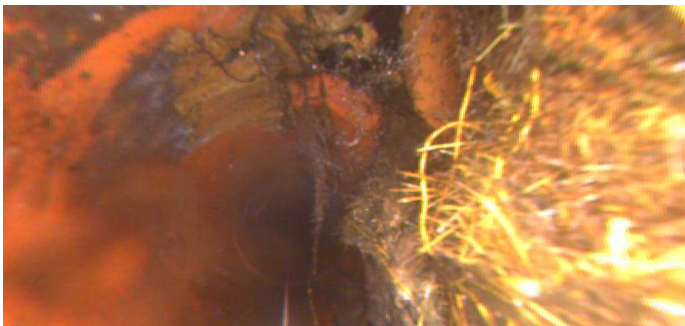
Code: **MGO**
Description: **General Observation**

Distance (ft): **120.9**
Structural Grade: **0**
O&M Grade: **0**
Clock Start/From:
Clock To:
1st Value:
2nd Value:
Value Percent:
Continuous Index:
Within 8" of Joint: **NO**
Remarks: **switched to rear view**

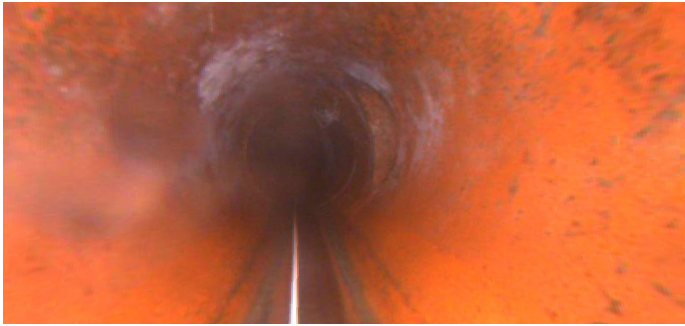
Code: **TF**
Description: **Tap Factory**

Distance (ft): **141.4**
Structural Grade: **0**
O&M Grade: **0**
Clock Start/From: **3**
Clock To:
1st Value: **4.000**
2nd Value:
Value Percent:
Continuous Index:
Within 8" of Joint:
Remarks:

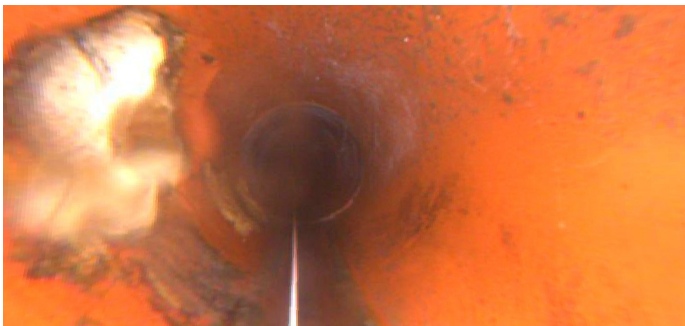
Code: **TF**
Description: **Tap Factory**

Distance (ft): **143.2**
Structural Grade: **0**
O&M Grade: **0**
Clock Start/From: **9**
Clock To:
1st Value: **4.000**
2nd Value:
Value Percent:
Continuous Index:
Within 8" of Joint:
Remarks:

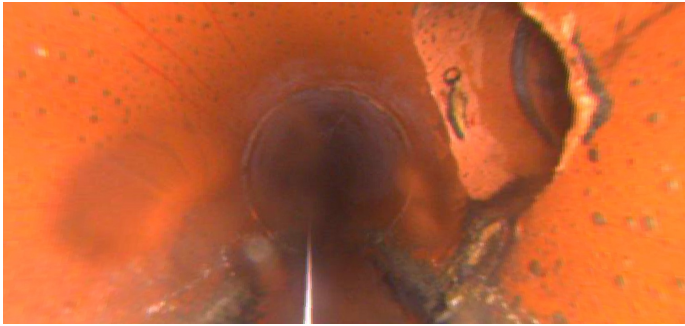
Code: **TF**
Description: **Tap Factory**

Distance (ft): **188.6**
Structural Grade: **0**
O&M Grade: **0**
Clock Start/From: **3**
Clock To:
1st Value: **4.000**
2nd Value:
Value Percent:
Continuous Index:
Within 8" of Joint:
Remarks:

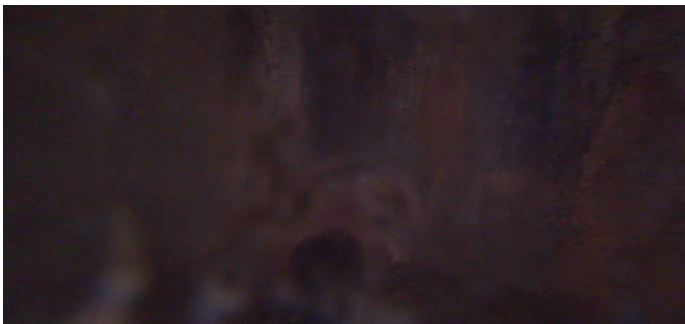
Code: **AMH**
Description: **Manhole**

Distance (ft): **195.1**
Structural Grade: **0**
O&M Grade: **0**
Clock Start/From:
Clock To:
1st Value:
2nd Value:
Value Percent:
Continuous Index:
Within 8" of Joint: **NO**
Remarks: **M-203-028**
