Profile/Photo Observation Report

Date:	09/27/2018	Weather:		Coding:	PACP 6.0
Pipe Length (ft):	193.4	Owner:	NA	Pre Clean:	Not Known
P.O.#:		Surveyor:	Selasie Honu	PSR:	P-203-029-028
Customer:		Clean Date:	01/01/1900	Shape:	C

Street:	39th. Ave.	Flow Control:	Not Controlled
City:	Hobart, IN	Year Renewed:	
Location:	Light Highway	Tape/Media #:	
Purpose:	Routine Assessment	Dia/Height:	10"
Use:	Sanitary	Material:	VCP
Drain Area:	NA	Lining:	
Category:	NA		
Comment:

Location Details:		Direction of Survey:	Upstream
US MH:	M-203-028	DS MH:	M-203-029
		Total Length Surveyed (ft):	195.1

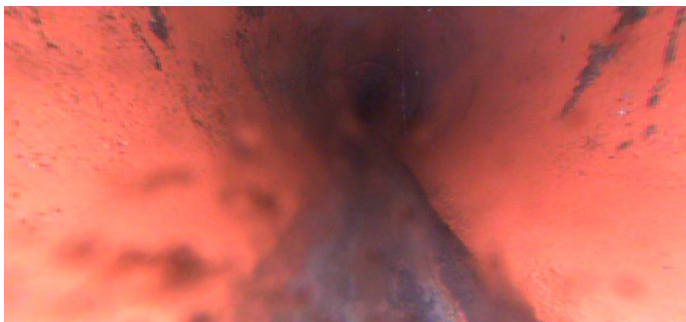
Code: **AMH**
Description: **Manhole**

Distance (ft): **.0**
Structural Grade: **0**
O&M Grade: **0**
Clock Start/From:
Clock To:
1st Value:
2nd Value:
Value Percent:
Continuous Index:
Within 8" of Joint: **NO**
Remarks: **M-203-029**

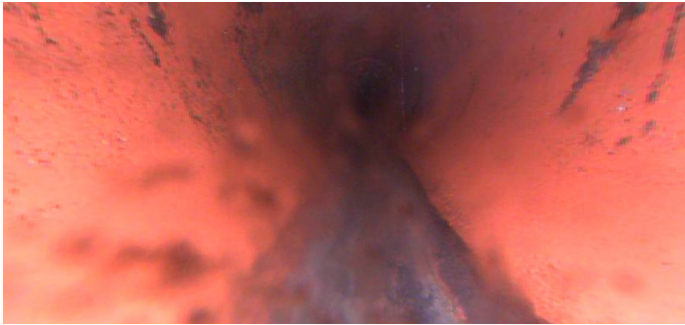
Code:	MWL
Description:	Water Level

Distance (ft):	.0
Structural Grade:	0
O&M Grade:	0
Clock Start/From:	
Clock To:	
1st Value:	
2nd Value:	
Value Percent:	5.000
Continuous Index:	
Within 8" of Joint:	NO
Remarks:

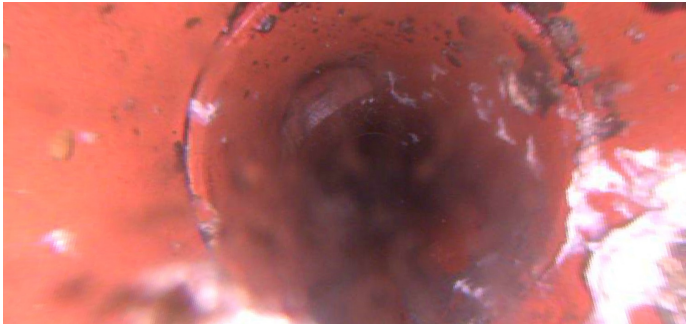
Code: **TF**
Description: **Tap Factory**

Distance (ft): **27.1**
Structural Grade: **0**
O&M Grade: **0**
Clock Start/From: **10**
Clock To:
1st Value: **4.000**
2nd Value:
Value Percent:
Continuous Index:
Within 8" of Joint:
Remarks:

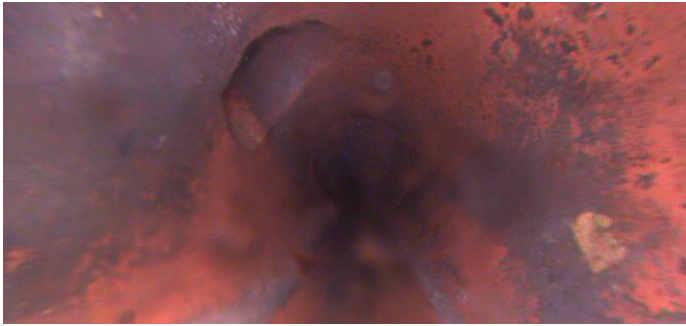
Code: **TF**
Description: **Tap Factory**

Distance (ft): **60.6**
Structural Grade: **0**
O&M Grade: **0**
Clock Start/From: **10**
Clock To:
1st Value: **4.000**
2nd Value:
Value Percent:
Continuous Index:
Within 8" of Joint:
Remarks:

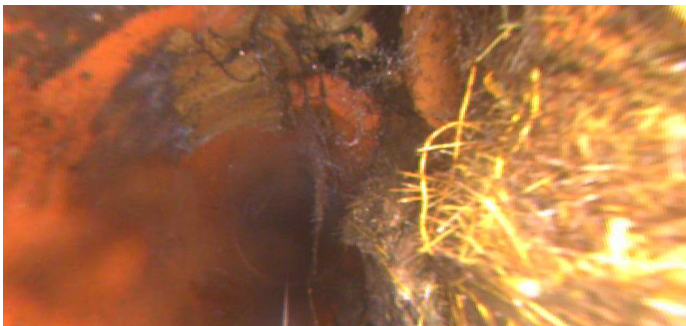
Code: **MGO**
Description: **General Observation**

Distance (ft): **120.9**
Structural Grade: **0**
O&M Grade: **0**
Clock Start/From:
Clock To:
1st Value:
2nd Value:
Value Percent:
Continuous Index:
Within 8" of Joint: **NO**
Remarks: **switched to rear view**

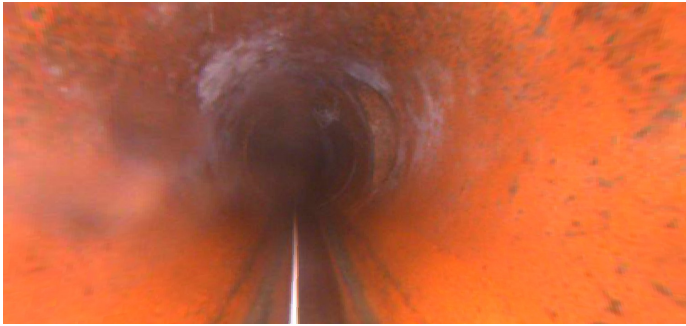
Code: **TF**
Description: **Tap Factory**

Distance (ft): **141.4**
Structural Grade: **0**
O&M Grade: **0**
Clock Start/From: **3**
Clock To:
1st Value: **4.000**
2nd Value:
Value Percent:
Continuous Index:
Within 8" of Joint:
Remarks:

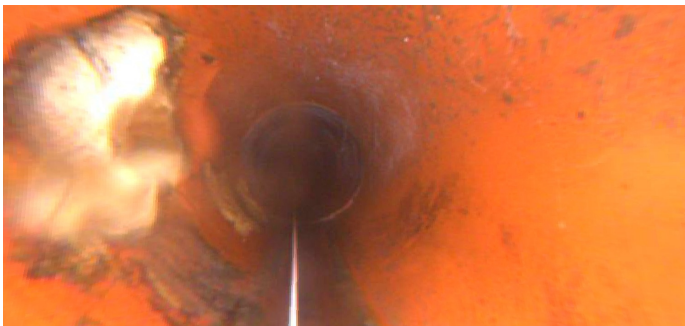
Code: **TF**
Description: **Tap Factory**

Distance (ft): **143.2**
Structural Grade: **0**
O&M Grade: **0**
Clock Start/From: **9**
Clock To:
1st Value: **4.000**
2nd Value:
Value Percent:
Continuous Index:
Within 8" of Joint:
Remarks:

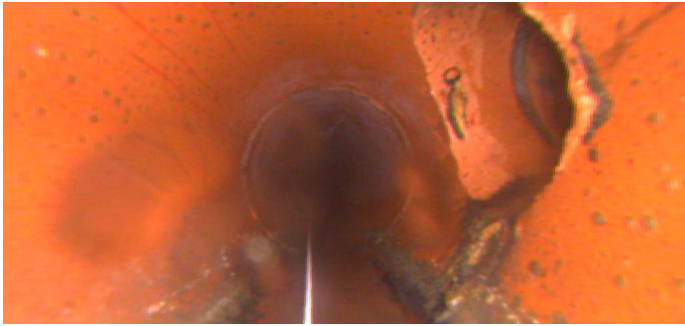
Code: **TF**
Description: **Tap Factory**

Distance (ft): **188.6**
Structural Grade: **0**
O&M Grade: **0**
Clock Start/From: **3**
Clock To:
1st Value: **4.000**
2nd Value:
Value Percent:
Continuous Index:
Within 8" of Joint:
Remarks:

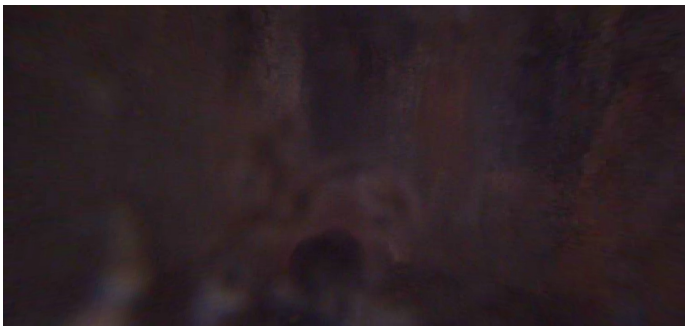
Code: **AMH**
Description: **Manhole**

Distance (ft): **195.1**
Structural Grade: **0**
O&M Grade: **0**
Clock Start/From:
Clock To:
1st Value:
2nd Value:
Value Percent:
Continuous Index:
Within 8" of Joint: **NO**
Remarks: **M-203-028**
