## Profile/Photo Observation Report

Date:	<b>09/25/2018</b>	Weather:		Coding:	<b>PACP 6.0</b>
Pipe Length (ft):	<b>91.2</b>	Owner:	<b>NA</b>	Pre Clean:	<b>Not Known</b>
P.O.#:		Surveyor:	<b>Selasie Honu</b>	PSR:	<b>P-203-069-029</b>
Customer:		Clean Date:	<b>01/01/1900</b>	Shape:	<b>C</b>

Street:	<b>ALLEY BETWEEN SHERMAN ST &amp; MO</b>	Flow Control:	<b>Not Controlled</b>
City:	<b>Hobart, IN</b>	Year Renewed:	
Location:	<b>Light Highway</b>	Tape/Media #:	
Purpose:	<b>Routine Assessment</b>	Dia/Height:	<b>10"</b>
Use:	<b>Sanitary</b>	Material:	<b>VCP</b>
Drain Area:	<b>NA</b>	Lining:	
Category:	<b>NA</b>		
Comment:

Location Details:		Direction of Survey:	<b>Upstream</b>
US MH:	<b>M-203-029</b>	DS MH:	<b>M-203-069</b>
		Total Length Surveyed (ft):	<b>83.9</b>

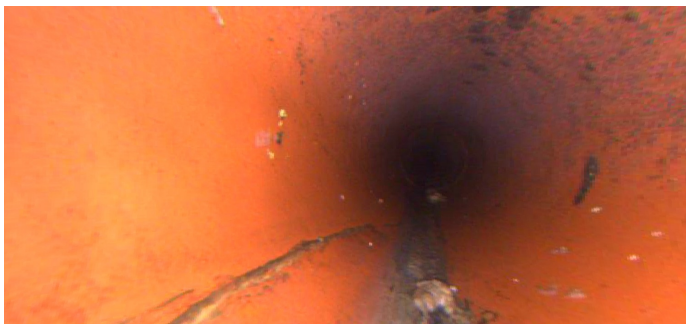
Code: **AMH**  
Description: **Manhole**

Distance (ft): **.0**  
Structural Grade: **0**  
O&M Grade: **0**  
Clock Start/From:  
Clock To:  
1st Value:  
2nd Value:  
Value Percent:  
Continuous Index:  
Within 8" of Joint: **NO**  
Remarks: **M-203-069**

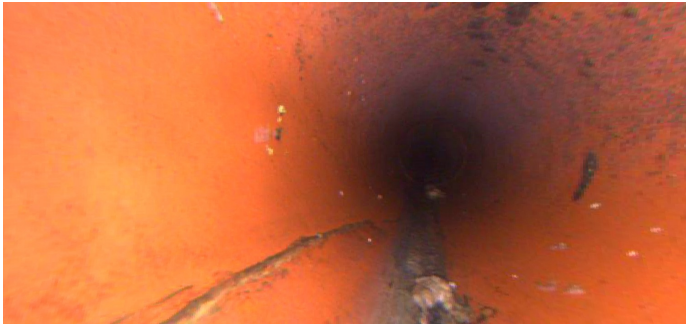
Code:	<b>MWL</b>
Description:	<b>Water Level</b>

Distance (ft):	<b>.0</b>
Structural Grade:	<b>0</b>
O&M Grade:	<b>0</b>
Clock Start/From:	
Clock To:	
1st Value:	
2nd Value:	
Value Percent:	<b>5.000</b>
Continuous Index:	
Within 8" of Joint:	<b>NO</b>
Remarks:

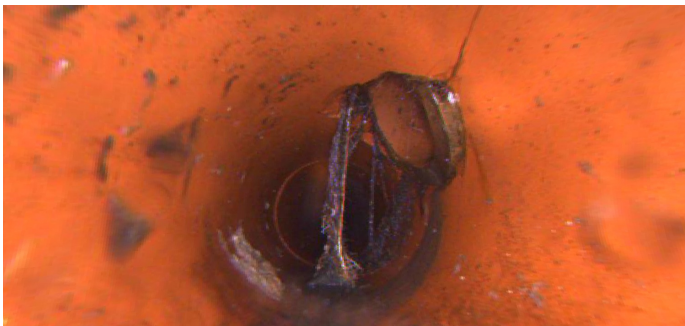
Code: **TF**  
Description: **Tap Factory**

Distance (ft): **42.1**  
Structural Grade: **0**  
O&M Grade: **0**  
Clock Start/From: **1**  
Clock To:  
1st Value: **4.000**  
2nd Value:  
Value Percent:  
Continuous Index:  
Within 8" of Joint:  
Remarks:

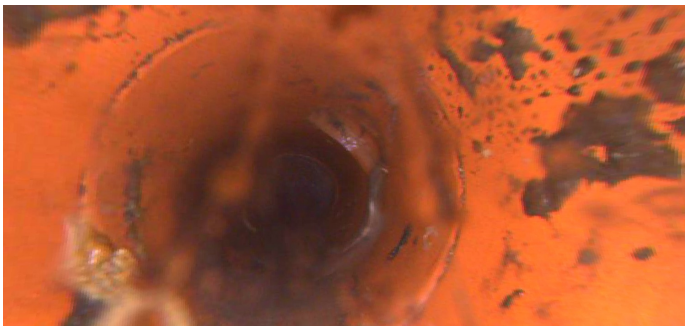
Code: **TF**  
Description: **Tap Factory**

Distance (ft): **68.8**  
Structural Grade: **0**  
O&M Grade: **0**  
Clock Start/From: **2**  
Clock To:  
1st Value: **4.000**  
2nd Value:  
Value Percent:  
Continuous Index:  
Within 8" of Joint:  
Remarks:
