Profile/Photo Observation Report

Street:	39th. Ave.	Flow Control:	Not Controlled
City:	Hobart, IN	Year Renewed:	
Location:	Light Highway	Tape/Media #:	
Purpose:	Routine Assessment	Dia/Height:	10"
Use:	Sanitary	Material:	VCP
Drain Area:	NA	Lining:	
Category:	NA		
Comment:

Location Details:		Direction of Survey:	Upstream
US MH:	M-203-029	DS MH:	M-203-069
		Total Length Surveyed (ft):	83.9

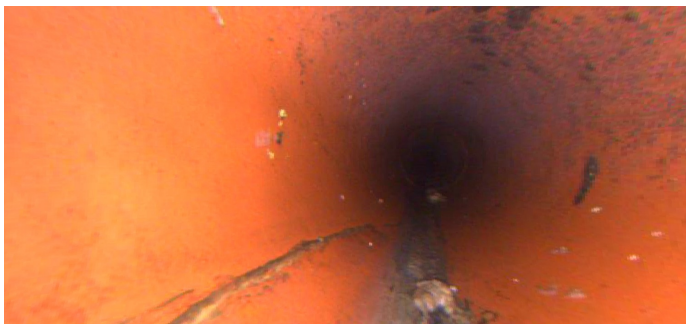
Code: **AMH**
Description: **Manhole**

Distance (ft): **.0**
Structural Grade: **0**
O&M Grade: **0**
Clock Start/From:
Clock To:
1st Value:
2nd Value:
Value Percent:
Continuous Index:
Within 8" of Joint: **NO**
Remarks: **M-203-069**

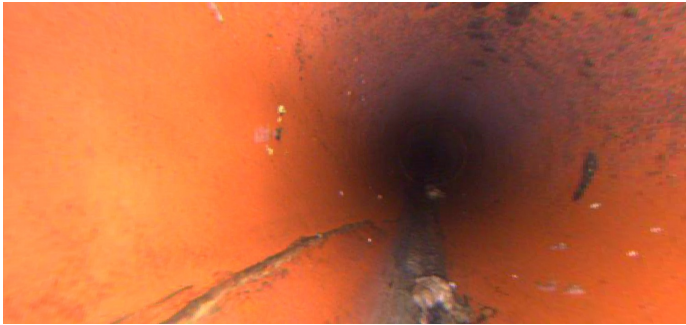
Code:	MWL
Description:	Water Level

Distance (ft):	.0
Structural Grade:	0
O&M Grade:	0
Clock Start/From:	
Clock To:	
1st Value:	
2nd Value:	
Value Percent:	5.000
Continuous Index:	
Within 8" of Joint:	NO
Remarks:

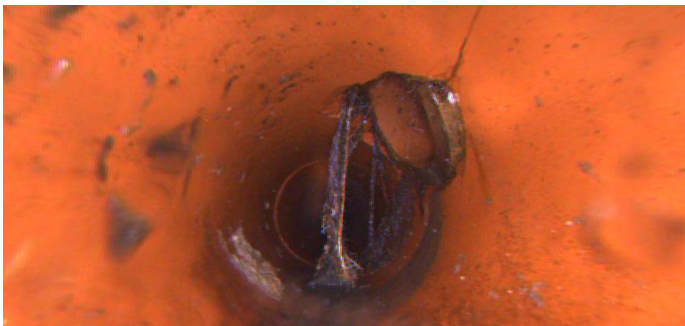
Code: **TF**
Description: **Tap Factory**

Distance (ft): **42.1**
Structural Grade: **0**
O&M Grade: **0**
Clock Start/From: **1**
Clock To:
1st Value: **4.000**
2nd Value:
Value Percent:
Continuous Index:
Within 8" of Joint:
Remarks:

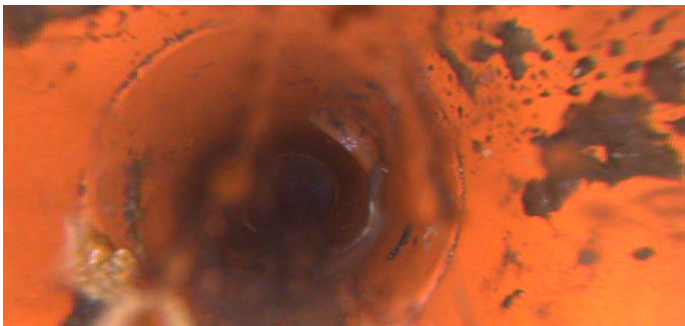
Code: **TF**
Description: **Tap Factory**

Distance (ft): **68.8**
Structural Grade: **0**
O&M Grade: **0**
Clock Start/From: **2**
Clock To:
1st Value: **4.000**
2nd Value:
Value Percent:
Continuous Index:
Within 8" of Joint:
Remarks:
