Profile/Photo Observation Report

Street:	E 38th Ave	Flow Control:	Not Controlled
City:	Hobart, IN	Year Renewed:	
Location:	Other	Tape/Media #:	
Purpose:	Not Known	Dia/Height:	10"
Use:	Sanitary	Material:	PVC
Drain Area:	NA	Lining:	
Category:	NA		
Comment:

Location Details:		Direction of Survey:	Downstream
US MH:	M-203-034	DS MH:	M-203-035
		Total Length Surveyed (ft):	171.1

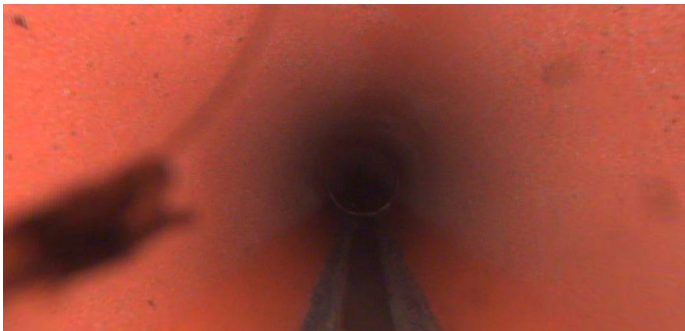
Code: **AMH**
Description: **Manhole**

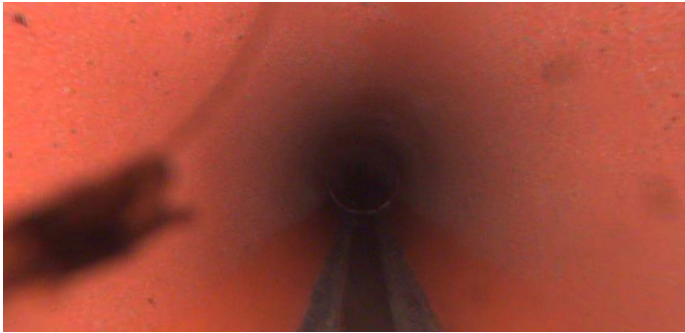
Code:	MWL
Description:	Water Level

Distance (ft):	.0
Structural Grade:	0
O&M Grade:	0
Clock Start/From:	
Clock To:	
1st Value:	
2nd Value:	
Value Percent:	5.000
Continuous Index:	
Within 8" of Joint:	NO
Remarks:

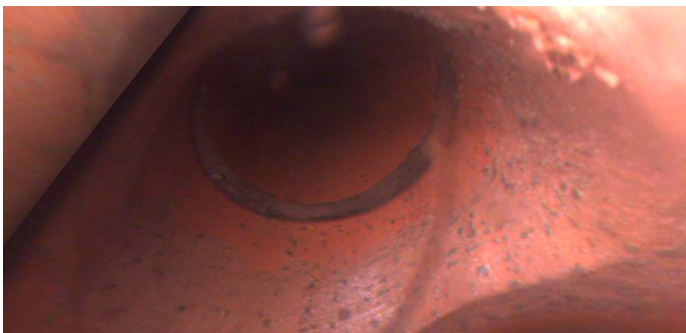
Code: **TF**
Description: **Tap Factory**

Distance (ft): **55.5**
Structural Grade: **0**
O&M Grade: **0**
Clock Start/From: **11**
Clock To:
1st Value: **4.000**
2nd Value:
Value Percent:
Continuous Index:
Within 8" of Joint:
Remarks:

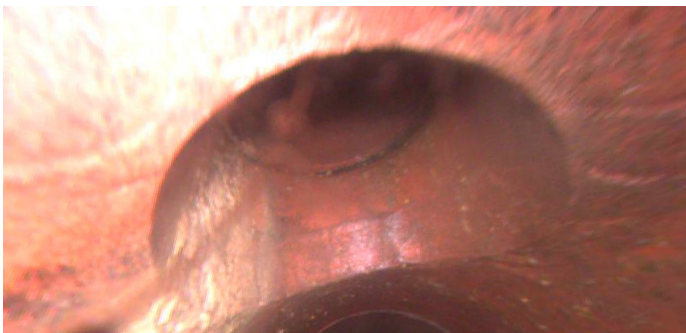
Code: **TF**
Description: **Tap Factory**

Distance (ft): **77.5**
Structural Grade: **0**
O&M Grade: **0**
Clock Start/From: **11**
Clock To:
1st Value: **4.000**
2nd Value:
Value Percent:
Continuous Index:
Within 8" of Joint:
Remarks:

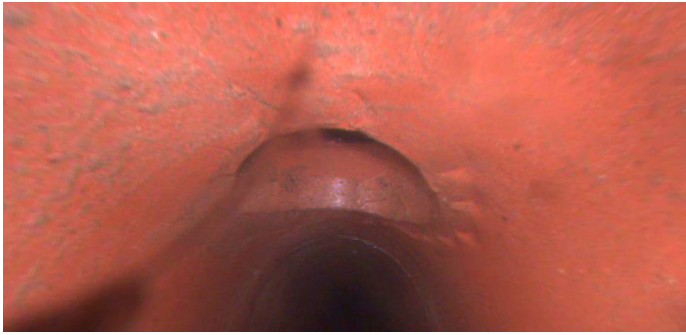
Code: **TF**
Description: **Tap Factory**

Distance (ft): **89.3**
Structural Grade: **0**
O&M Grade: **0**
Clock Start/From: **12**
Clock To:
1st Value: **4.000**
2nd Value:
Value Percent:
Continuous Index:
Within 8" of Joint:
Remarks:

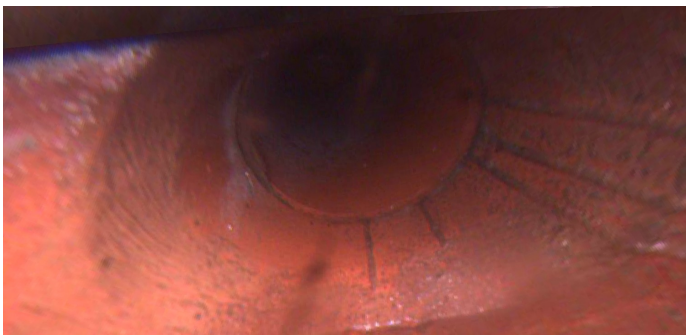
Code: **TF**
Description: **Tap Factory**

Distance (ft): **116.6**
Structural Grade: **0**
O&M Grade: **0**
Clock Start/From: **12**
Clock To:
1st Value: **4.000**
2nd Value:
Value Percent:
Continuous Index:
Within 8" of Joint:
Remarks:

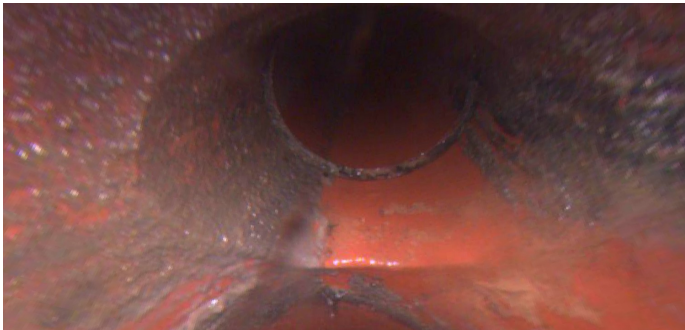
Code: **TF**
Description: **Tap Factory**

Distance (ft): **128.6**
Structural Grade: **0**
O&M Grade: **0**
Clock Start/From: **12**
Clock To:
1st Value: **4.000**
2nd Value:
Value Percent:
Continuous Index:
Within 8" of Joint:
Remarks:

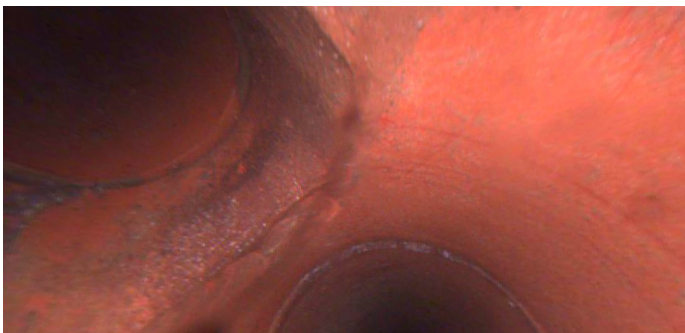
Code: **TF**
Description: **Tap Factory**

Distance (ft): **145.8**
Structural Grade: **0**
O&M Grade: **0**
Clock Start/From: **10**
Clock To:
1st Value: **4.000**
2nd Value:
Value Percent:
Continuous Index:
Within 8" of Joint:
Remarks:
