Profile/Photo Observation Report

Date:	03/25/2018	Weather:		Coding:	PACP 6.0
Pipe Length (ft):	275.3	Owner:	NA	Pre Clean:	Not Known
P.O.#:		Surveyor:	Byrd Fitzgerald	PSR:	P-203-045-043
Customer:		Clean Date:	01/01/1900	Shape:	C

Street:	E 38th Ave	Flow Control:	Not Controlled
City:	Hobart, IN	Year Renewed:	
Location:	Other	Tape/Media #:	
Purpose:	Not Known	Dia/Height:	10"
Use:	Sanitary	Material:	VCP
Drain Area:	NA	Lining:	
Category:	NA		
Comment:

Location Details:		Direction of Survey:	Downstream
US MH:	M-203-043	DS MH:	M-203-045
		Total Length Surveyed (ft):	258.6

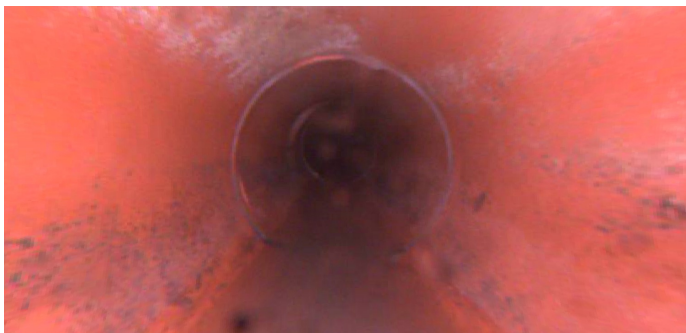
Code: **AMH**
Description: **Manhole**

Distance (ft): **.0**
Structural Grade: **0**
O&M Grade: **0**
Clock Start/From:
Clock To:
1st Value:
2nd Value:
Value Percent:
Continuous Index:
Within 8" of Joint: **NO**
Remarks: **M-203-043**

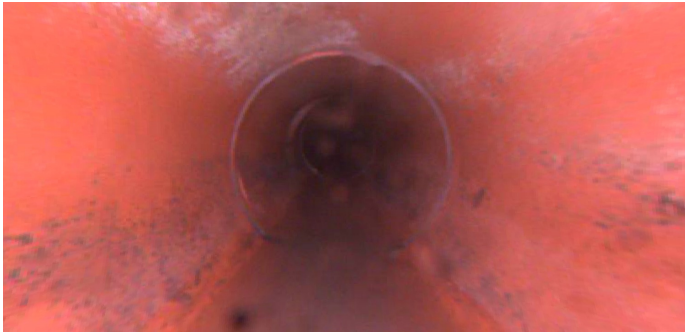
Code:	MWL
Description:	Water Level

Distance (ft):	.0
Structural Grade:	0
O&M Grade:	0
Clock Start/From:	
Clock To:	
1st Value:	
2nd Value:	
Value Percent:	5.000
Continuous Index:	
Within 8" of Joint:	NO
Remarks:

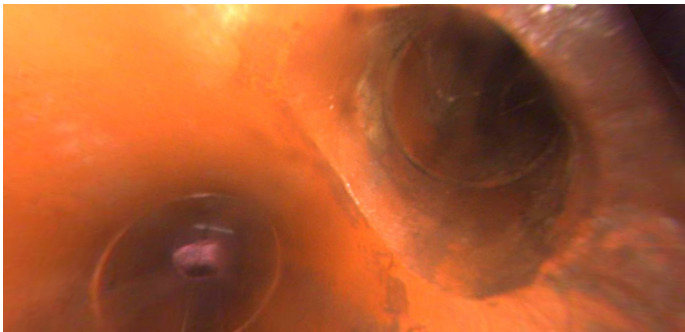
Code:	TF
Description:	Tap Factory

Distance (ft):	3.9
Structural Grade:	0
O&M Grade:	0
Clock Start/From:	10
Clock To:	
1st Value:	4.000
2nd Value:	
Value Percent:	
Continuous Index:	
Within 8" of Joint:	
Remarks:

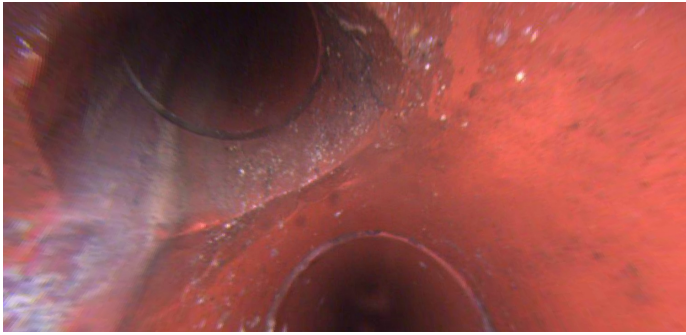
Code: **TF**
Description: **Tap Factory**

Distance (ft): **89.9**
Structural Grade: **0**
O&M Grade: **0**
Clock Start/From: **11**
Clock To:
1st Value: **4.000**
2nd Value:
Value Percent:
Continuous Index:
Within 8" of Joint:
Remarks:

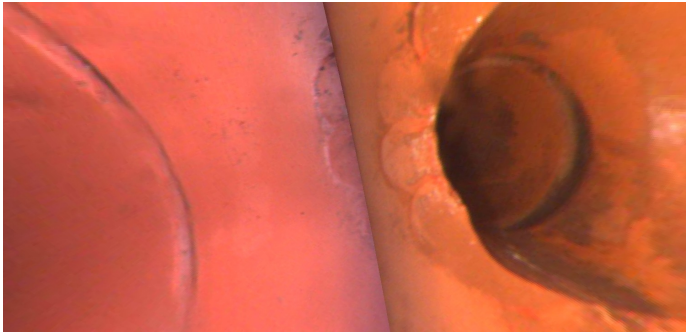
Code: **TF**
Description: **Tap Factory**

Distance (ft): **143.2**
Structural Grade: **0**
O&M Grade: **0**
Clock Start/From: **1**
Clock To:
1st Value: **4.000**
2nd Value:
Value Percent:
Continuous Index:
Within 8" of Joint: **YES**
Remarks:

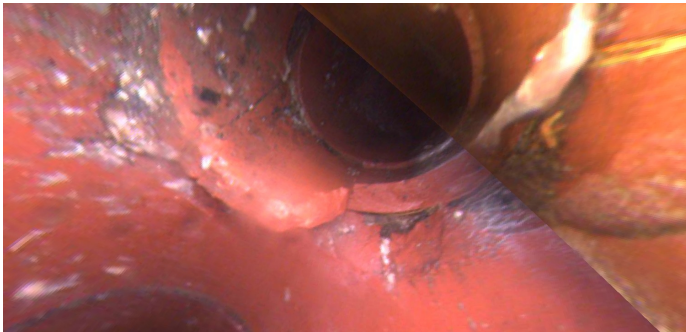
Code: **TB**
Description: **Tap Break-in**

Distance (ft): **170.0**
Structural Grade: **0**
O&M Grade: **0**
Clock Start/From: **1**
Clock To:
1st Value: **4.000**
2nd Value:
Value Percent:
Continuous Index:
Within 8" of Joint:
Remarks:

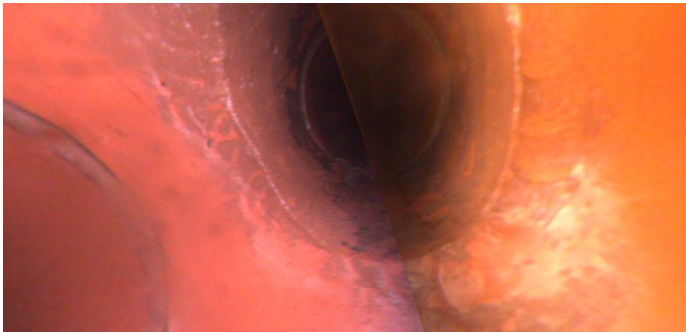
Code: **TF**
Description: **Tap Factory**

Distance (ft): **177.4**
Structural Grade: **0**
O&M Grade: **0**
Clock Start/From: **1**
Clock To:
1st Value: **4.000**
2nd Value:
Value Percent:
Continuous Index:
Within 8" of Joint: **YES**
Remarks:
