Profile/Photo Observation Report

Date:	03/24/2018	Weather:		Coding:	PACP 6.0
Pipe Length (ft):	130.9	Owner:	NA	Pre Clean:	Not Known
P.O.#:		Surveyor:	Byrd Fitzgerald	PSR:	P-203-053-054
Customer:		Clean Date:	01/01/1900	Shape:	C

Street:	ALLEY BETWEEN SANDUSKY ST & EV	Flow Control:	Not Controlled
City:	Hobart, IN	Year Renewed:	
Location:	Other	Tape/Media #:	
Purpose:	Not Known	Dia/Height:	10"
Use:	Sanitary	Material:	PVC
Drain Area:	NA	Lining:	
Category:	NA		
Comment:	6 inch

Location Details:		Direction of Survey:	Upstream
US MH:	M-203-054	DS MH:	M-203-053
		Total Length Surveyed (ft):	36.9

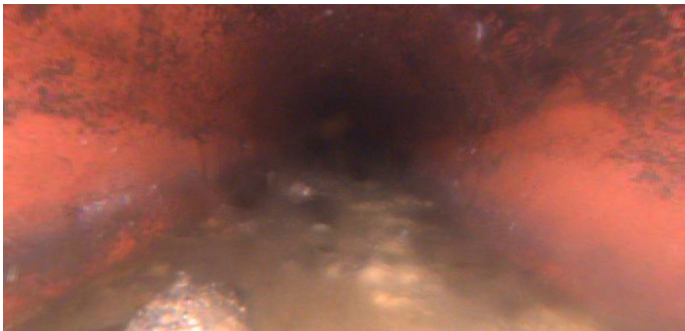
Code: **AMH**
Description: **Manhole**

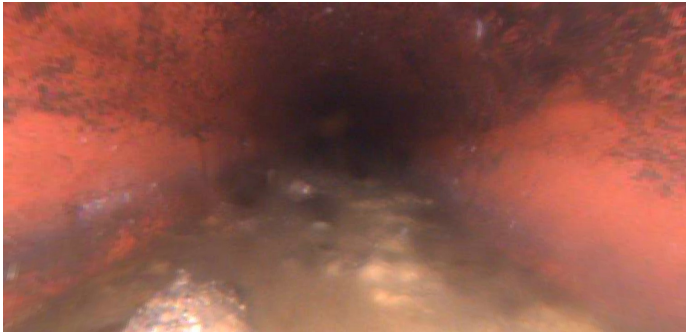
Code:	MWL
Description:	Water Level

Distance (ft):	.0
Structural Grade:	0
O&M Grade:	0
Clock Start/From:	
Clock To:	
1st Value:	
2nd Value:	
Value Percent:	5.000
Continuous Index:	
Within 8" of Joint:	NO
Remarks:

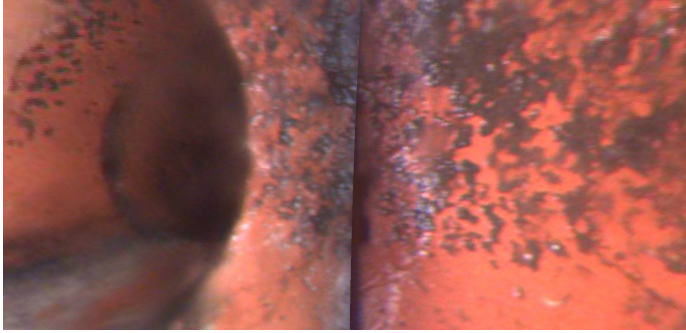
Code: **TF**
Description: **Tap Factory**

Distance (ft): **5.9**
Structural Grade: **0**
O&M Grade: **0**
Clock Start/From: **10**
Clock To:
1st Value: **4.000**
2nd Value:
Value Percent:
Continuous Index:
Within 8" of Joint: **YES**
Remarks:

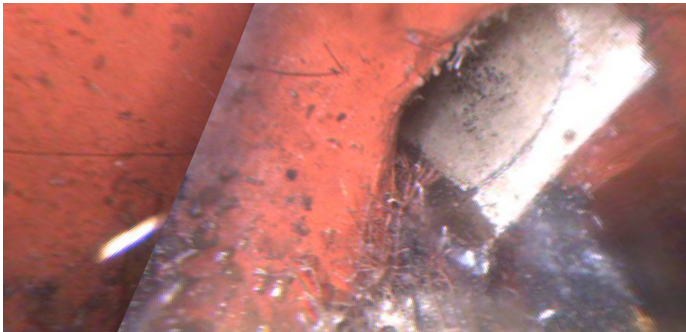
Code: **TF**
Description: **Tap Factory**

Distance (ft): **19.7**
Structural Grade: **0**
O&M Grade: **0**
Clock Start/From: **2**
Clock To:
1st Value: **4.000**
2nd Value:
Value Percent:
Continuous Index:
Within 8" of Joint: **YES**
Remarks:

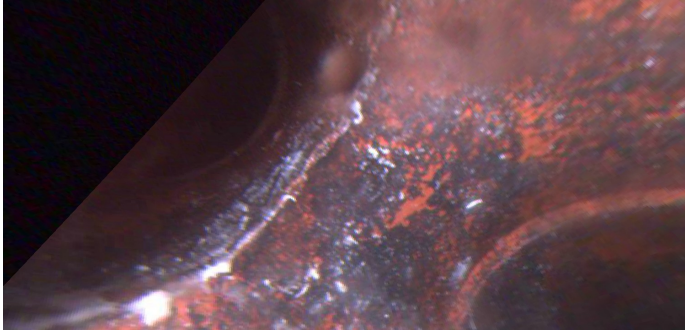
Code: **TF**
Description: **Tap Factory**

Distance (ft): **27.2**
Structural Grade: **0**
O&M Grade: **0**
Clock Start/From: **2**
Clock To:
1st Value: **4.000**
2nd Value:
Value Percent:
Continuous Index:
Within 8" of Joint:
Remarks:
