Profile/Photo Observation Report

Date:	03/23/2018	Weather:		Coding:	PACP 6.0
Pipe Length (ft):	271.6	Owner:	NA	Pre Clean:	Not Known
P.O.#:		Surveyor:	Justin Gonzales	PSR:	P-203-065-060
Customer:		Clean Date:	01/01/1900	Shape:	C

Street:	E 38th Ave	Flow Control:	Not Controlled
City:	Hobart, IN	Year Renewed:	
Location:	Other	Tape/Media #:	
Purpose:	Not Known	Dia/Height:	12"
Use:	Sanitary	Material:	PVC
Drain Area:	NA	Lining:	
Category:	NA		
Comment:

Location Details:		Direction of Survey:	Upstream
US MH:	M-203-065	DS MH:	M-203-060
		Total Length Surveyed (ft):	251.6

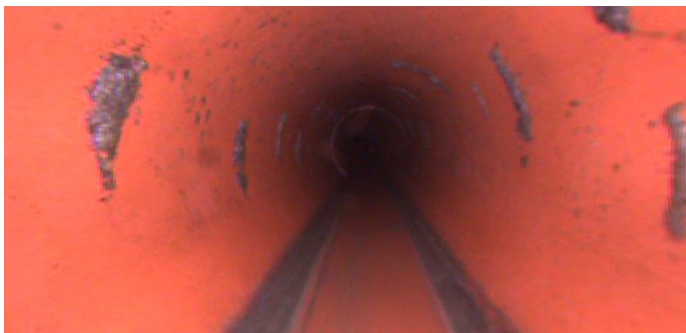
Code: **AMH**
Description: **Manhole**

Distance (ft): **.0**
Structural Grade: **0**
O&M Grade: **0**
Clock Start/From:
Clock To:
1st Value:
2nd Value:
Value Percent:
Continuous Index:
Within 8" of Joint: **NO**
Remarks: **M-203-060**

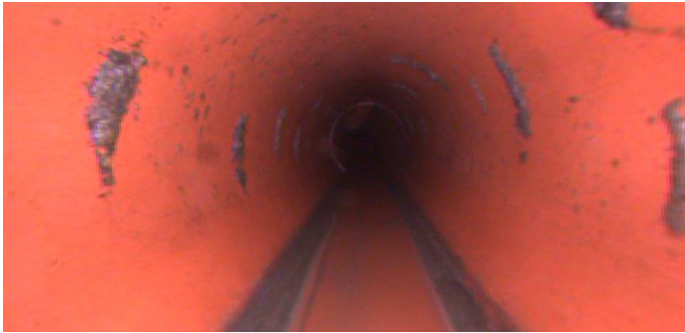
Code:	MWL
Description:	Water Level

Distance (ft):	.0
Structural Grade:	0
O&M Grade:	0
Clock Start/From:	
Clock To:	
1st Value:	
2nd Value:	
Value Percent:	5.000
Continuous Index:	
Within 8" of Joint:	NO
Remarks:

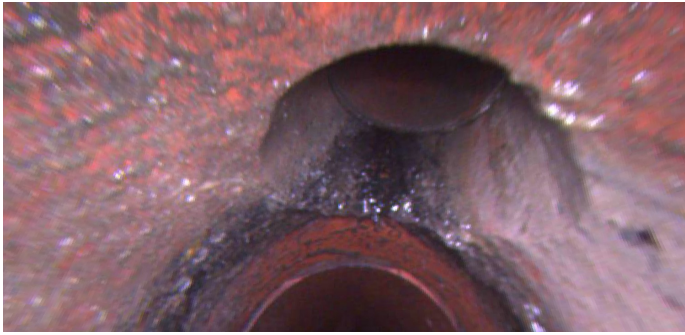
Code: **TF**
Description: **Tap Factory**

Distance (ft): **32.6**
Structural Grade: **0**
O&M Grade: **0**
Clock Start/From: **1**
Clock To:
1st Value: **4.000**
2nd Value:
Value Percent:
Continuous Index:
Within 8" of Joint:
Remarks:

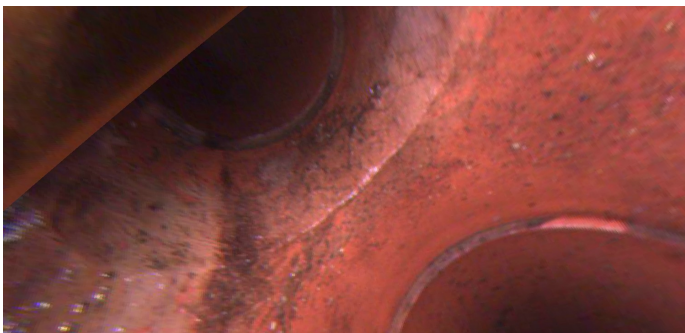
Code: **TF**
Description: **Tap Factory**

Distance (ft): **45.1**
Structural Grade: **0**
O&M Grade: **0**
Clock Start/From: **11**
Clock To:
1st Value: **4.000**
2nd Value:
Value Percent:
Continuous Index:
Within 8" of Joint:
Remarks:

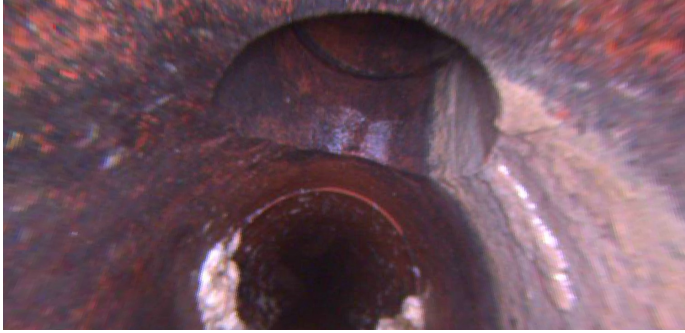
Code: **TF**
Description: **Tap Factory**

Distance (ft): **71.6**
Structural Grade: **0**
O&M Grade: **0**
Clock Start/From: **1**
Clock To:
1st Value: **4.000**
2nd Value:
Value Percent:
Continuous Index:
Within 8" of Joint:
Remarks:

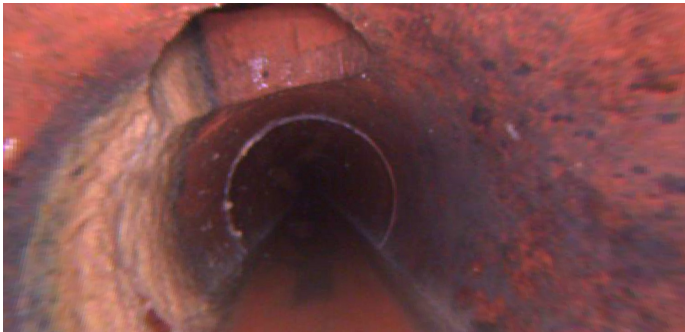
Code: **TF**
Description: **Tap Factory**

Distance (ft): **98.0**
Structural Grade: **0**
O&M Grade: **0**
Clock Start/From: **11**
Clock To:
1st Value: **4.000**
2nd Value:
Value Percent:
Continuous Index:
Within 8" of Joint:
Remarks:

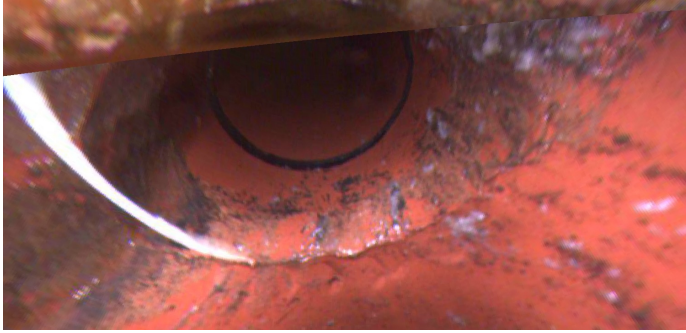
Code: **TF**
Description: **Tap Factory**

Distance (ft): **130.0**
Structural Grade: **0**
O&M Grade: **0**
Clock Start/From: **11**
Clock To:
1st Value: **4.000**
2nd Value:
Value Percent:
Continuous Index:
Within 8" of Joint:
Remarks:

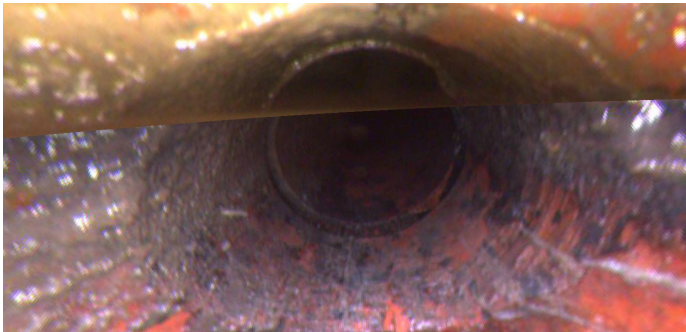
Code: **TF**
Description: **Tap Factory**

Distance (ft): **146.9**
Structural Grade: **0**
O&M Grade: **0**
Clock Start/From: **12**
Clock To:
1st Value: **4.000**
2nd Value:
Value Percent:
Continuous Index:
Within 8" of Joint:
Remarks:

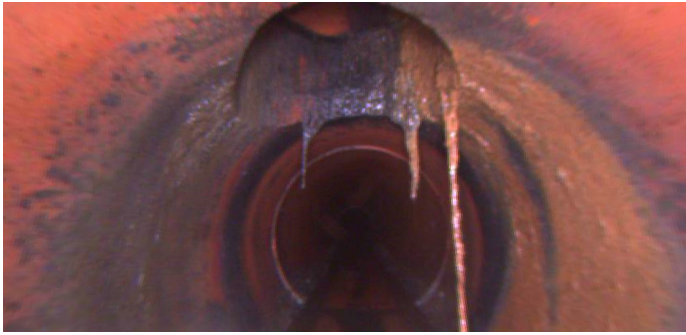
Code: **TF**
Description: **Tap Factory**

Distance (ft): **178.3**
Structural Grade: **0**
O&M Grade: **0**
Clock Start/From: **11**
Clock To:
1st Value: **4.000**
2nd Value:
Value Percent:
Continuous Index:
Within 8" of Joint:
Remarks:

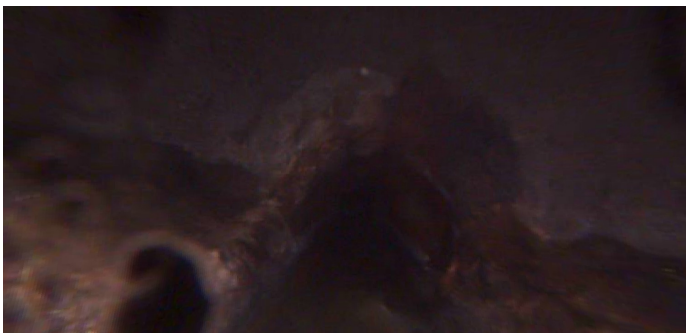
Code: **AMH**
Description: **Manhole**

Distance (ft): **251.6**
Structural Grade: **0**
O&M Grade: **0**
Clock Start/From:
Clock To:
1st Value:
2nd Value:
Value Percent:
Continuous Index:
Within 8" of Joint: **NO**
Remarks: **M-203-065**
