Profile/Photo Observation Report

Street:	FOXCROFT STREET	Flow Control:	Not Controlled
City:	Hobart, IN	Year Renewed:	
Location:	Light Highway	Tape/Media #:	
Purpose:	Routine Assessment	Dia/Height:	8"
Use:	Sanitary	Material:	PVC
Drain Area:	NA	Lining:	
Category:	NA		
Comment:	P_C at 41 ft debris . Flow direction wrong		
Location Details:		Direction of Survey:	Upstream
US MH:	M-208-003	DS MH:	M-208-002
		Total Length Surveyed (ft):	42.2

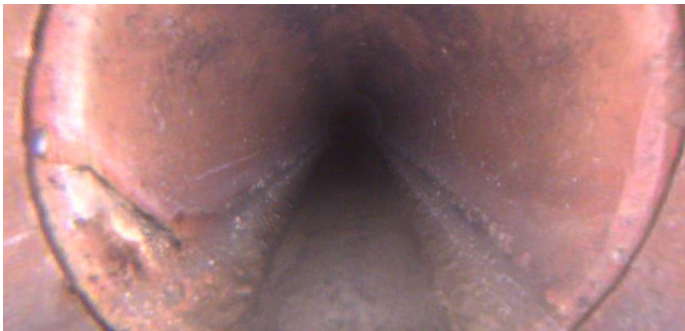
Code: **AMH**
Description: **Manhole**

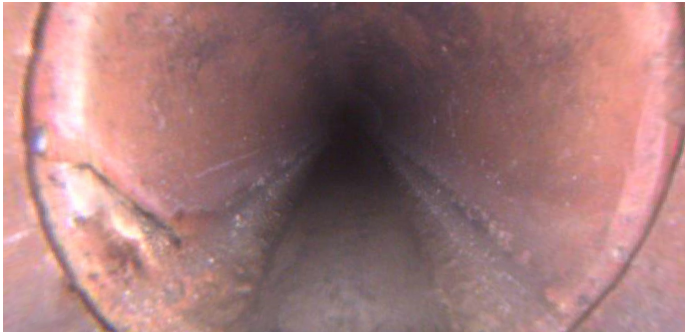
Code:	MWL
Description:	Water Level

Distance (ft):	.0
Structural Grade:	0
O&M Grade:	0
Clock Start/From:	
Clock To:	
1st Value:	
2nd Value:	
Value Percent:	5.000
Continuous Index:	
Within 8" of Joint:	NO
Remarks:
