Profile/Photo Observation Report

Date:	03/22/2018	Weather:		Coding:	PACP 6.0
Pipe Length (ft):	201.5	Owner:	NA	Pre Clean:	No Pre-Cleaning
P.O.#:		Surveyor:	Selasie Honu	PSR:	P-208-007-008
Customer:		Clean Date:	01/01/1900	Shape:	C

Street:	FOXCROFT STREET	Flow Control:	Not Controlled
City:	Hobart, IN	Year Renewed:	
Location:	Light Highway	Tape/Media #:	
Purpose:	Routine Assessment	Dia/Height:	8"
Use:	Sanitary	Material:	VCP
Drain Area:	NA	Lining:	
Category:	NA		
Comment:

Location Details:		Direction of Survey:	Upstream
US MH:	M-208-007	DS MH:	M-208-008
		Total Length Surveyed (ft):	68.9

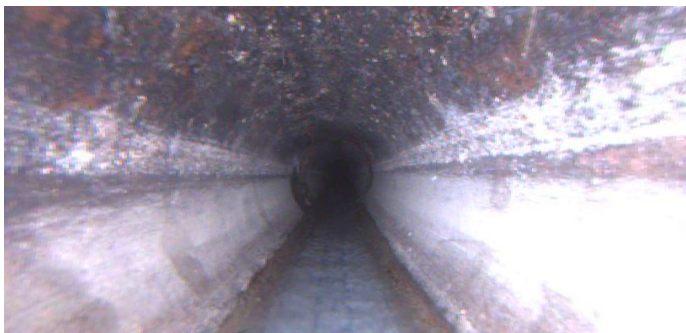
Code: **AMH**
Description: **Manhole**

Distance (ft): **.0**
Structural Grade: **0**
O&M Grade: **0**
Clock Start/From:
Clock To:
1st Value:
2nd Value:
Value Percent:
Continuous Index:
Within 8" of Joint: **NO**
Remarks: **M-208-008**
