Profile/Photo Observation Report

Street:	FOXCROFT STREET	Flow Control:	Not Controlled
City:	Hobart, IN	Year Renewed:	
Location:	Light Highway	Tape/Media #:	
Purpose:	Routine Assessment	Dia/Height:	8"
Use:	Sanitary	Material:	VCP
Drain Area:	NA	Lining:	
Category:	NA		
Comment:	P_C at 17 ft build up around pipe. Flow direction wrong		
Location Details:		Direction of Survey:	Downstream
US MH:	M-208-010	DS MH:	M-208-009
		Total Length Surveyed (ft):	18.7

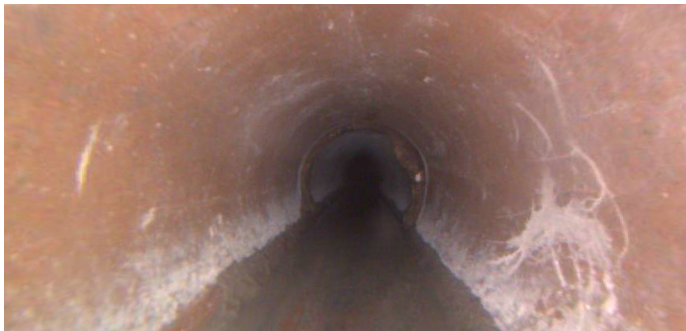
Code: **AMH**
Description: **Manhole**

Distance (ft): **.0**
Structural Grade: **0**
O&M Grade: **0**
Clock Start/From:
Clock To:
1st Value:
2nd Value:
Value Percent:
Continuous Index:
Within 8" of Joint: **NO**
Remarks: **M-208-010**
