Profile/Photo Observation Report

Date:	03/23/2018	Weather:		Coding:	PACP 6.0
Pipe Length (ft):	310.1	Owner:	NA	Pre Clean:	No Pre-Cleaning
P.O.#:		Surveyor:	Jen Costello	PSR:	P-208-008-012
Customer:		Clean Date:	01/01/1900	Shape:	C

Street:	16TH ST	Flow Control:	Not Controlled
City:	Hobart, IN	Year Renewed:	
Location:	Light Highway	Tape/Media #:	
Purpose:	Routine Assessment	Dia/Height:	12"
Use:	Sanitary	Material:	VCP
Drain Area:	NA	Lining:	
Category:	NA		
Comment:	P_C at 26 ft nothing visilbe . Flow direction wrong		
Location Details:		Direction of Survey:	Downstream
US MH:	M-208-012	DS MH:	M-208-008
		Total Length Surveyed (ft):	27.6

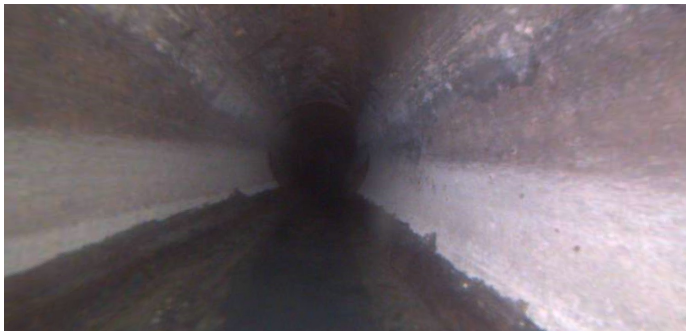
Code: **AMH**
Description: **Manhole**

Distance (ft): **.0**
Structural Grade: **0**
O&M Grade: **0**
Clock Start/From:
Clock To:
1st Value:
2nd Value:
Value Percent:
Continuous Index:
Within 8" of Joint: **NO**
Remarks: **M-208-012**

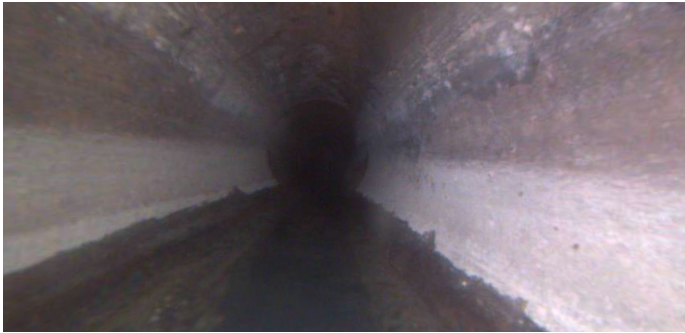
Code:	MWL
Description:	Water Level

Distance (ft):	.0
Structural Grade:	0
O&M Grade:	0
Clock Start/From:	
Clock To:	
1st Value:	
2nd Value:	
Value Percent:	5.000
Continuous Index:	
Within 8" of Joint:	NO
Remarks:
