Profile/Photo Observation Report

Date:	03/23/2018	Weather:		Coding:	PACP 6.0
Pipe Length (ft):	199.0	Owner:	NA	Pre Clean:	No Pre-Cleaning
P.O.#:		Surveyor:	Jen Costello	PSR:	P-208-011-012
Customer:		Clean Date:	01/01/1900	Shape:	C

Street:	FOXCROFT STREET	Flow Control:	Not Controlled
City:	Hobart, IN	Year Renewed:	
Location:	Light Highway	Tape/Media #:	
Purpose:	Routine Assessment	Dia/Height:	12"
Use:	Sanitary	Material:	VCP
Drain Area:	NA	Lining:	
Category:	NA		
Comment:	False MH_F at 26 ft solo was stop at build on the top of pipe \nFlow direction wrong		
Location Details:		Direction of Survey:	Downstream
US MH:	M-208-012	DS MH:	M-208-011
		Total Length Surveyed (ft):	27.5

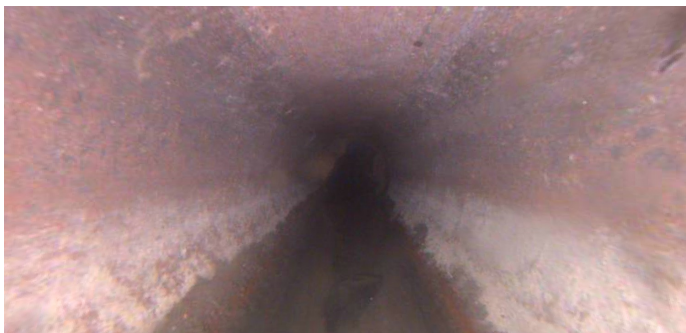
Code: **AMH**
Description: **Manhole**

Distance (ft): **.0**
Structural Grade: **0**
O&M Grade: **0**
Clock Start/From:
Clock To:
1st Value:
2nd Value:
Value Percent:
Continuous Index:
Within 8" of Joint: **NO**
Remarks: **M-208-012**
