Profile/Photo Observation Report

Date:	03/23/2018	Weather:		Coding:	PACP 6.0
Pipe Length (ft):	114.0	Owner:	NA	Pre Clean:	No Pre-Cleaning
P.O.#:		Surveyor:	Jen Costello	PSR:	P-208-013-014
Customer:		Clean Date:	01/01/1900	Shape:	C

Street:	FOXCROFT STREET	Flow Control:	Not Controlled
City:	Hobart, IN	Year Renewed:	
Location:	Light Highway	Tape/Media #:	
Purpose:	Routine Assessment	Dia/Height:	12"
Use:	Sanitary	Material:	VCP
Drain Area:	NA	Lining:	
Category:	NA		
Comment:	P_C at 33 ft build up at the joint .Flow direction wrong		
Location Details:		Direction of Survey:	Downstream
US MH:	M-208-014	DS MH:	M-208-013
		Total Length Surveyed (ft):	34.8

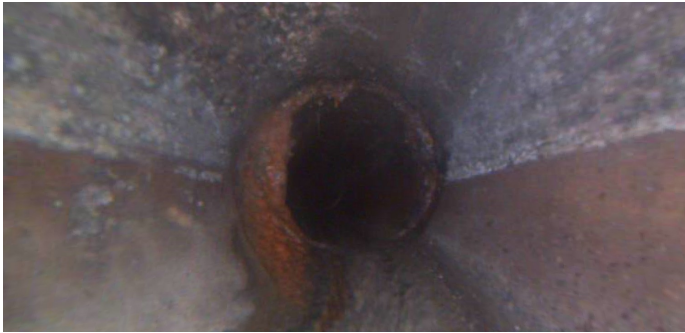
Code:	MWL
Description:	Water Level

Distance (ft):	.0
Structural Grade:	0
O&M Grade:	0
Clock Start/From:	
Clock To:	
1st Value:	
2nd Value:	
Value Percent:	5.000
Continuous Index:	
Within 8" of Joint:	NO
Remarks:
