Profile/Photo Observation Report

Date:	04/11/2018	Weather:		Coding:	PACP 6.0
Pipe Length (ft):		Owner:	City of Hobart	Pre Clean:	Not Known
P.O.#:	231	Surveyor:	B. Helbling	PSR:	P-208-014-029
Customer:	City of Hobart	Clean Date:		Shape:	C

Street:	16th Street	Flow Control:	Not Controlled
City:	Hobart, IN	Year Renewed:	
Location:	Yard	Tape/Media #:	DEP231
Purpose:	Routine Assessment	Dia/Height:	21"
Use:	Sanitary	Material:	VCP
Drain Area:		Lining:	
Category:	NA		
Comment:	YES501824 Submittal 2		
Location Details:		Direction of Survey:	Upstream
US MH:	M-208-014	DS MH:	M-208-029
		Total Length Surveyed (ft):	25.2

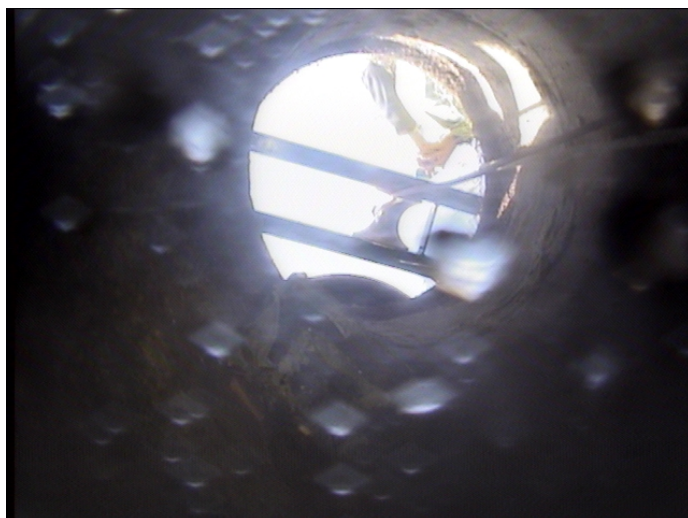
Code: **AMH**
 Description: **Manhole**

Distance (ft): **.0**
 Structural Grade: **0**
 O&M Grade: **0**
 Clock Start/From:
 Clock To:
 1st Value:
 2nd Value:
 Value Percent:
 Continuous Index:
 Within 8" of Joint: **NO**
 Remarks: **M-208-029**

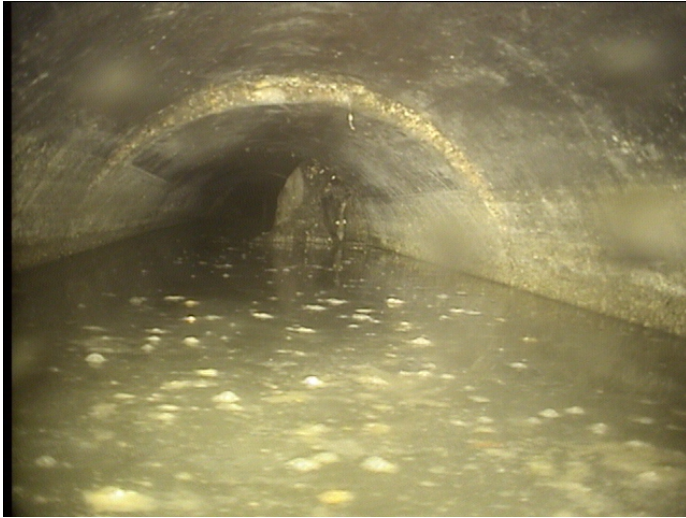
Code: **MWL**
Description: **Water Level**

Distance (ft): **.0**
Structural Grade: **0**
O&M Grade: **0**
Clock Start/From:
Clock To:
1st Value:
2nd Value:
Value Percent: **50.000**
Continuous Index:
Within 8" of Joint: **NO**
Remarks:

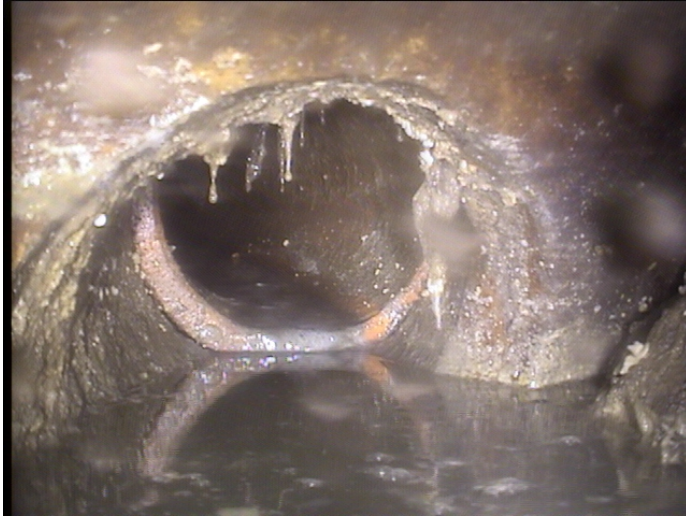
Code: **TF**
Description: **Tap Factory**

Distance (ft): **12.8**
Structural Grade: **0**
O&M Grade: **0**
Clock Start/From: **9**
Clock To:
1st Value: **6.000**
2nd Value:
Value Percent:
Continuous Index:
Within 8" of Joint: **NO**
Remarks:
