## Profile/Photo Observation Report

Date:	<b>01/24/2025</b>	Weather:		Coding:	<b>PACP 7.0</b>
Pipe Length (ft):	<b>289.0</b>	Owner:	<b>City of Hobart</b>	Pre Clean:	<b>Heavy Cleaning</b>
P.O.#:	<b>YES502259</b>	Surveyor:	<b>S. Bucklin</b>	PSR:	<b>P-208-017-018</b>
Customer:	<b>City of Hobart</b>	Clean Date:	<b>08/01/2024</b>	Shape:	<b>C</b>

Street:	<b>Brookview Court</b>	Flow Control:	<b>Not Controlled</b>
City:	<b>Hobart, IN</b>	Year Renewed:	
Location:	<b>Easement/Right of Way</b>	Tape/Media #:	
Purpose:	<b>Sewer System Evaluation Survey (SS</b>	Dia/Height:	<b>15"</b>
Use:	<b>Sanitary Sewage Pipe</b>	Material:	<b>VCP</b>
Drain Area:		Lining:	<b>None</b>
Category:	<b>NA</b>		
Comment:			
Location Details:		Direction of Survey:	<b>Upstream</b>
US MH:	<b>M-208-017</b>	DS MH:	<b>M-208-018</b>
		Total Length Surveyed (ft):	<b>274.2</b>

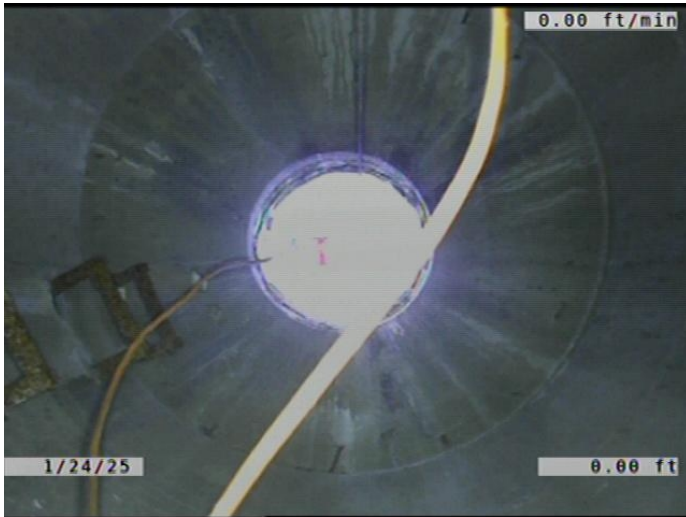
Code: **AMH**  
Description: **Manhole**

Distance (ft): **.0**  
Structural Grade: **0**  
O&M Grade: **0**  
Clock Start/From:  
Clock To:  
1st Value:  
2nd Value:  
Value Percent:  
Continuous Index:  
Within 8" of Joint: **NO**  
Remarks: **M-208-018**

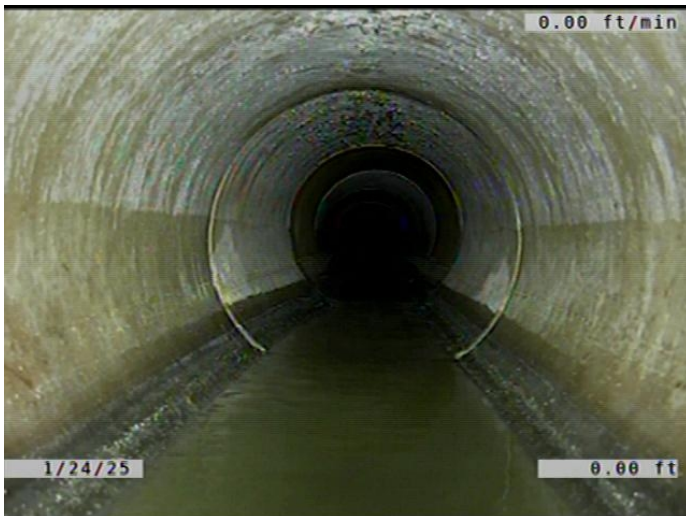
Code: **MWL**  
Description: **Miscellaneous Water Level**

Distance (ft): **.0**  
Structural Grade: **0**  
O&M Grade: **0**  
Clock Start/From:  
Clock To:  
1st Value:  
2nd Value:  
Value Percent: **10.000**  
Continuous Index:  
Within 8" of Joint: **NO**  
Remarks:

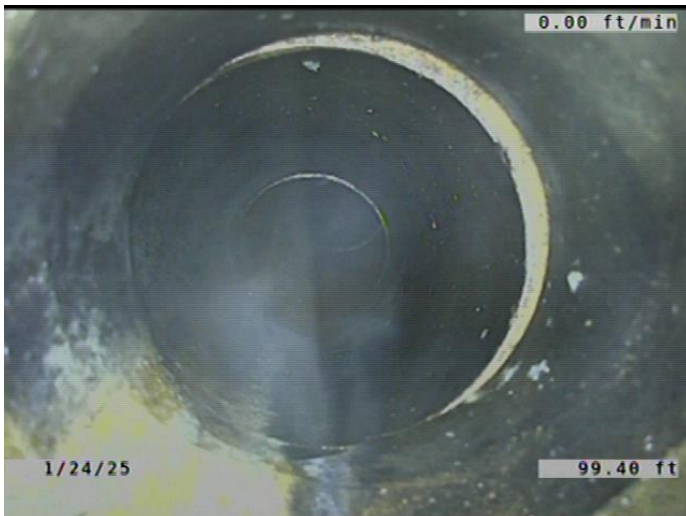
Code:	<b>TF</b>
Description:	<b>Tap Factory</b>
Distance (ft):	<b>99.4</b>
Structural Grade:	<b>0</b>
O&M Grade:	<b>0</b>
Clock Start/From:	<b>11</b>
Clock To:	
1st Value:	<b>6.000</b>
2nd Value:	
Value Percent:	
Continuous Index:	
Within 8" of Joint:	<b>YES</b>
Remarks:

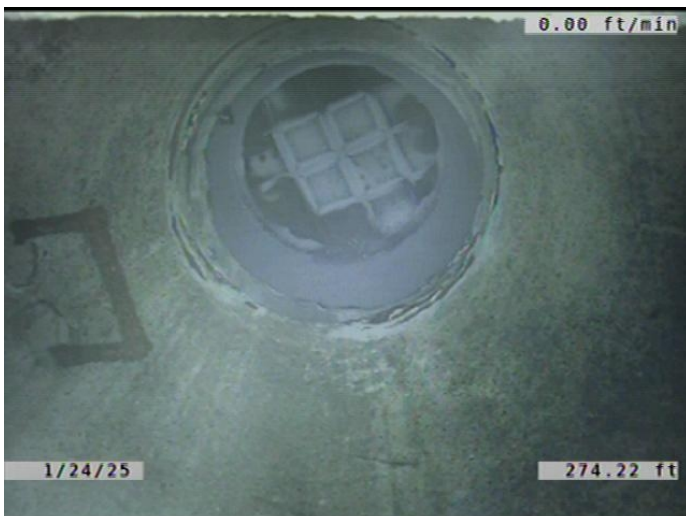
Code:	<b>AMH</b>
Description:	<b>Manhole</b>
Distance (ft):	<b>274.2</b>
Structural Grade:	<b>0</b>
O&M Grade:	<b>0</b>
Clock Start/From:	
Clock To:	
1st Value:	
2nd Value:	
Value Percent:	
Continuous Index:	
Within 8" of Joint:	<b>NO</b>
Remarks:	<b>M-208-017</b>
