Profile/Photo Observation Report

Date:	01/17/2025	Weather:		Coding:	PACP 7.0
Pipe Length (ft):	217.0	Owner:	City of Hobart	Pre Clean:	Heavy Cleaning
P.O.#:	YES502259	Surveyor:	S. Bucklin	PSR:	P-209-025-021
Customer:	City of Hobart	Clean Date:	07/16/2024	Shape:	C

Street:	Liverpool Road	Flow Control:	De-watered Using Jetter
City:	Hobart, IN	Year Renewed:	
Location:	Local rural streets with light traffic, t	Tape/Media #:	
Purpose:	Sewer System Evaluation Survey (SS	Dia/Height:	15"
Use:	Sanitary Sewage Pipe	Material:	VCP
Drain Area:		Lining:	None
Category:	NA		
Comment:			
Location Details:		Direction of Survey:	Downstream
US MH:	M-209-025	DS MH:	M-208-021
		Total Length Surveyed (ft):	217.0

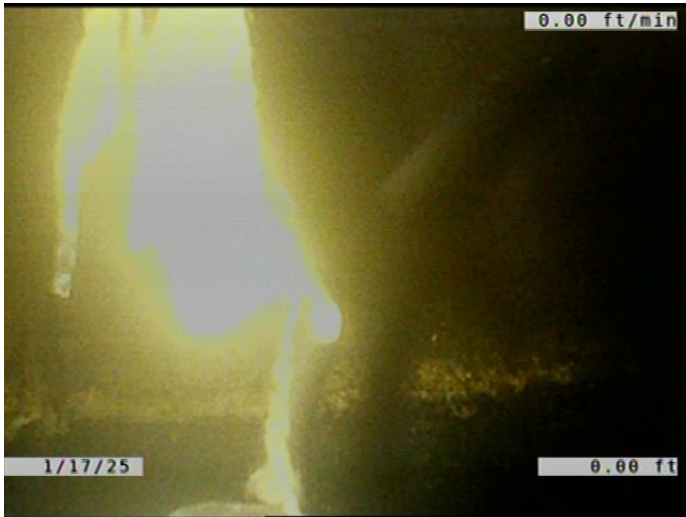
Code: **AMH**
Description: **Manhole**

Distance (ft): **.0**
Structural Grade: **0**
O&M Grade: **0**
Clock Start/From:
Clock To:
1st Value:
2nd Value:
Value Percent:
Continuous Index:
Within 8" of Joint: **NO**
Remarks: **M-209-025**

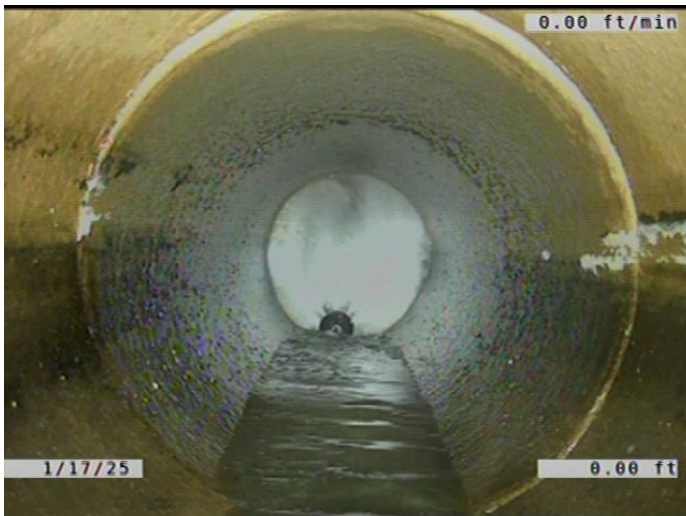
Code: **MWL**
Description: **Miscellaneous Water Level**

Distance (ft): **.0**
Structural Grade: **0**
O&M Grade: **0**
Clock Start/From:
Clock To:
1st Value:
2nd Value:
Value Percent: **5.000**
Continuous Index:
Within 8" of Joint: **NO**
Remarks:

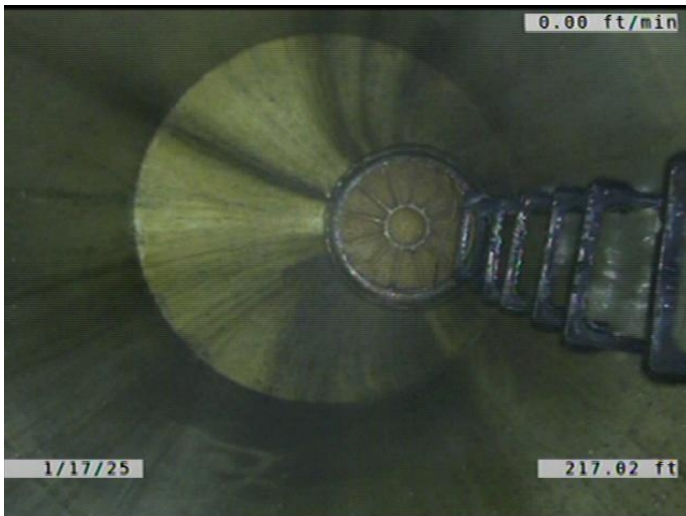
Code: **AMH**
 Description: **Manhole**

Distance (ft): **217.0**
 Structural Grade: **0**
 O&M Grade: **0**
 Clock Start/From:
 Clock To:
 1st Value:
 2nd Value:
 Value Percent:
 Continuous Index:
 Within 8" of Joint: **NO**
 Remarks: **M-208-021**
