Profile/Photo Observation Report

| Pipe Length (ft): | 354.0 | Owner: | City of Hobart | Pre Clean: | Heavy Cleaning |

| Street: | South Liverpool Road | Flow Control: | Not Controlled |
| US MH: | M-208-021.1 | DS MH: | M-208-022 |

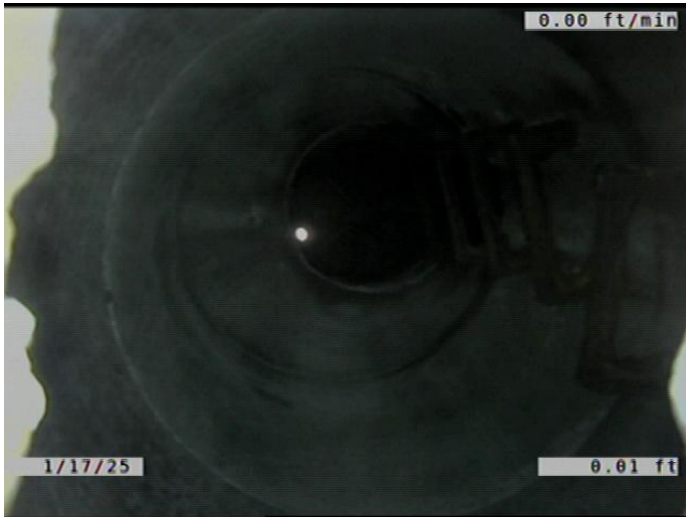
Code: **AMH**
Description: **Manhole**

Distance (ft): **.0**
Structural Grade: **0**
O&M Grade: **0**
Clock Start/From:
Clock To:
1st Value:
2nd Value:
Value Percent:
Continuous Index:
Within 8" of Joint: **NO**
Remarks: **M-208-021.1**

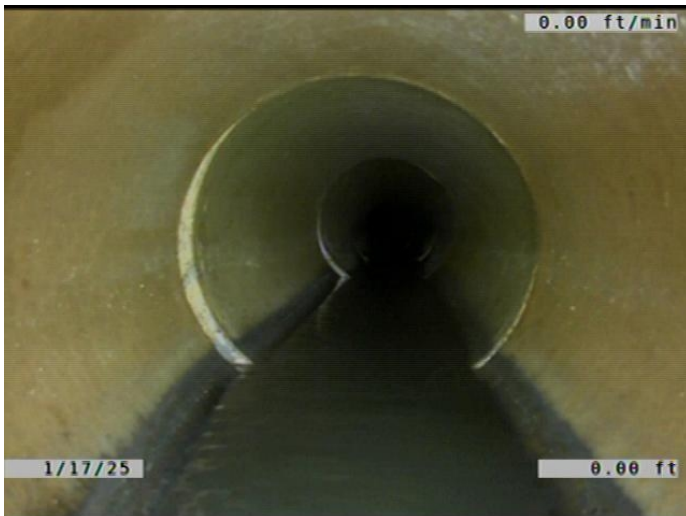
Code: **MWL**
Description: **Miscellaneous Water Level**

Distance (ft): **.0**
Structural Grade: **0**
O&M Grade: **0**
Clock Start/From:
Clock To:
1st Value:
2nd Value:
Value Percent: **10.000**
Continuous Index:
Within 8" of Joint: **NO**
Remarks:

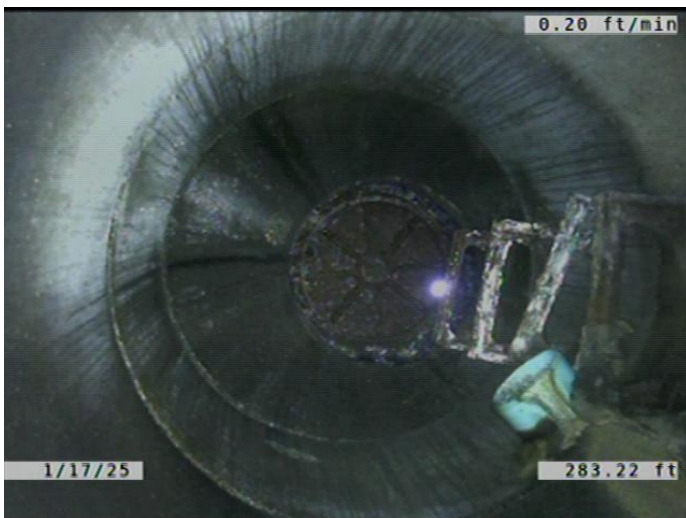
Code: **AMH**
Description: **Manhole**

Distance (ft): **283.2**
Structural Grade: **0**
O&M Grade: **0**
Clock Start/From:
Clock To:
1st Value:
2nd Value:
Value Percent:
Continuous Index:
Within 8" of Joint: **NO**
Remarks: **M-208-022**
