Profile/Photo Observation Report

Date:	03/19/2018	Weather:		Coding:	PACP 6.0
Pipe Length (ft):	151.7	Owner:	NA	Pre Clean:	No Pre-Cleaning
P.O.#:		Surveyor:	Byrd Fitzgerald	PSR:	P-209-007-008
Customer:		Clean Date:	01/01/1900	Shape:	C

Street:	OFF MINNESOTA ST	Flow Control:	Not Controlled
City:	Hobart, IN	Year Renewed:	
Location:	Light Highway	Tape/Media #:	
Purpose:	Routine Assessment	Dia/Height:	12"
Use:	Sanitary	Material:	VCP
Drain Area:	NA	Lining:	
Category:	NA		
Comment:	P_C at 229l ft past MH at 153 ft . flow direction wrong .		
Location Details:		Direction of Survey:	Upstream
US MH:	M-209-008	DS MH:	M-209-007
		Total Length Surveyed (ft):	230.8

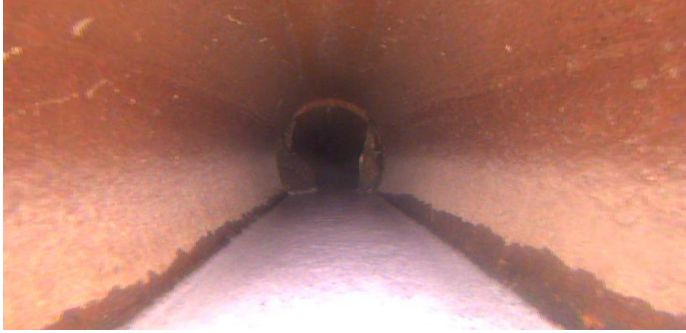
Code: **AMH**
Description: **Manhole**

Distance (ft): **.0**
Structural Grade: **0**
O&M Grade: **0**
Clock Start/From:
Clock To:
1st Value:
2nd Value:
Value Percent:
Continuous Index:
Within 8" of Joint: **NO**
Remarks: **M-209-008**

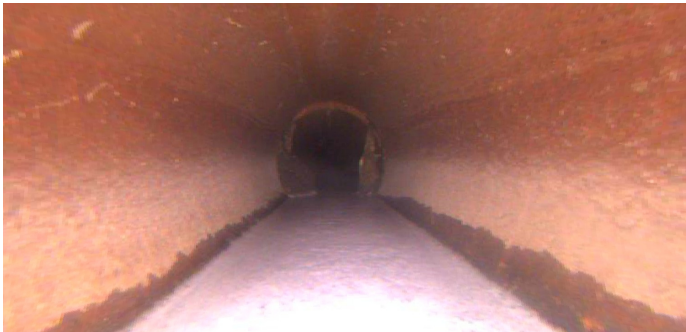
Code: **MWL**
Description: **Water Level**

Distance (ft): **.0**
Structural Grade: **0**
O&M Grade: **0**
Clock Start/From:
Clock To:
1st Value:
2nd Value:
Value Percent: **5.000**
Continuous Index:
Within 8" of Joint: **NO**
Remarks:

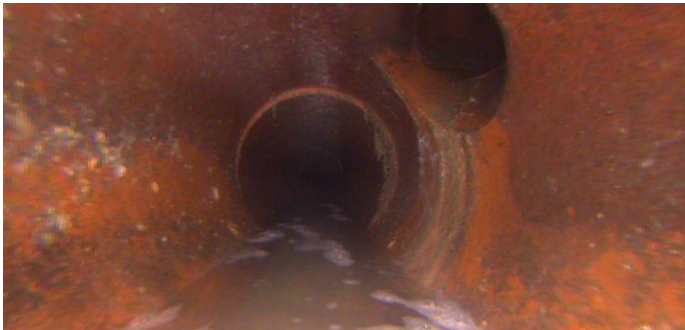
Code: **TFA**
Description: **Tap Factory Active**

Distance (ft): **25.6**
Structural Grade: **0**
O&M Grade: **0**
Clock Start/From: **2**
Clock To:
1st Value: **4.000**
2nd Value:
Value Percent:
Continuous Index:
Within 8" of Joint: **YES**
Remarks:

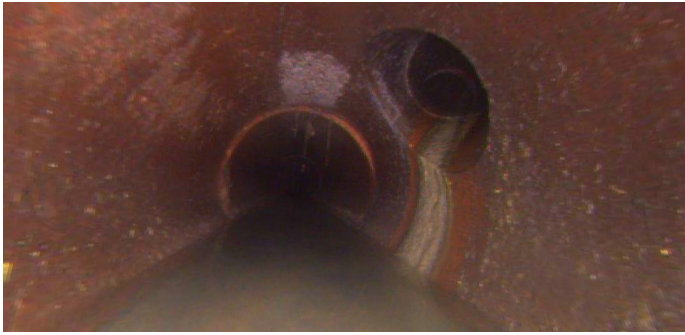
Code: **TF**
Description: **Tap Factory**

Distance (ft): **92.2**
Structural Grade: **0**
O&M Grade: **0**
Clock Start/From: **2**
Clock To:
1st Value: **4.000**
2nd Value:
Value Percent:
Continuous Index:
Within 8" of Joint: **YES**
Remarks:

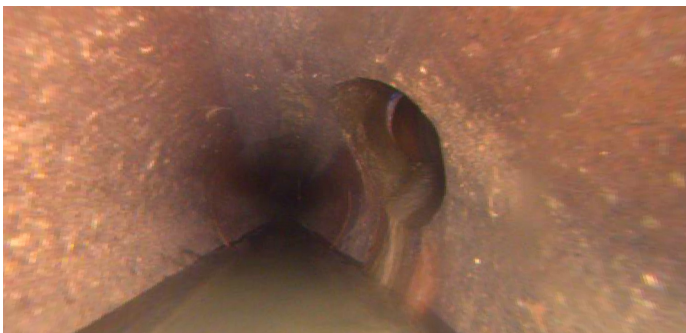
Code: **TF**
Description: **Tap Factory**

Distance (ft): **145.6**
Structural Grade: **0**
O&M Grade: **0**
Clock Start/From: **2**
Clock To:
1st Value: **4.000**
2nd Value:
Value Percent:
Continuous Index:
Within 8" of Joint: **YES**
Remarks:

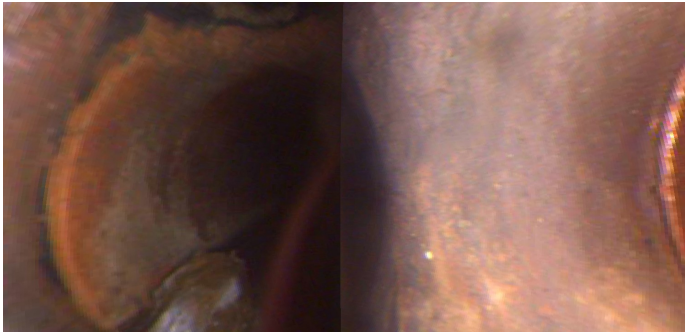
Code: **TB**
Description: **Tap Break-in**

Distance (ft): **154.3**
Structural Grade: **0**
O&M Grade: **0**
Clock Start/From: **9**
Clock To:
1st Value: **6.000**
2nd Value:
Value Percent:
Continuous Index:
Within 8" of Joint:
Remarks:
