## Profile/Photo Observation Report

Date:	<b>03/20/2018</b>	Weather:		Coding:	<b>PACP 6.0</b>
Pipe Length (ft):	<b>393.1</b>	Owner:	<b>NA</b>	Pre Clean:	<b>No Pre-Cleaning</b>
P.O.#:		Surveyor:	<b>John Kuglmaier</b>	PSR:	<b>P-209-011-012</b>
Customer:		Clean Date:	<b>01/01/1900</b>	Shape:	<b>C</b>

Street:	<b>ALLEY BETWEEN MINNESOTA ST &amp; C</b>	Flow Control:	<b>Not Controlled</b>
City:	<b>Hobart, IN</b>	Year Renewed:	
Location:	<b>Light Highway</b>	Tape/Media #:	
Purpose:	<b>Routine Assessment</b>	Dia/Height:	<b>8"</b>
Use:	<b>Sanitary</b>	Material:	<b>VCP</b>
Drain Area:	<b>NA</b>	Lining:	
Category:	<b>NA</b>		
Comment:	<b>P_C at 76 ft roots . Flow wrong</b>		
Location Details:		Direction of Survey:	<b>Downstream</b>
US MH:	<b>M-209-012</b>	DS MH:	<b>M-209-011</b>
		Total Length Surveyed (ft):	<b>77.1</b>

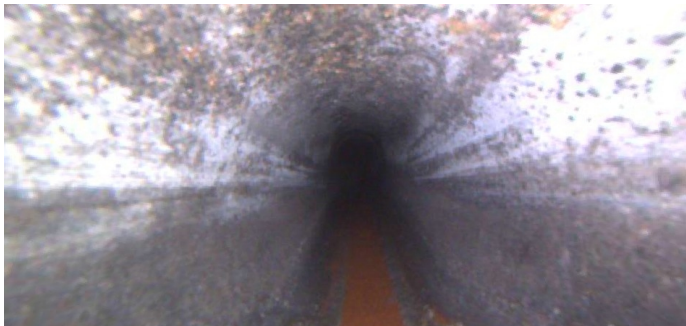
Code: **AMH**  
Description: **Manhole**

Distance (ft): **.0**  
Structural Grade: **0**  
O&M Grade: **0**  
Clock Start/From:  
Clock To:  
1st Value:  
2nd Value:  
Value Percent:  
Continuous Index:  
Within 8" of Joint: **NO**  
Remarks: **M-209-012**

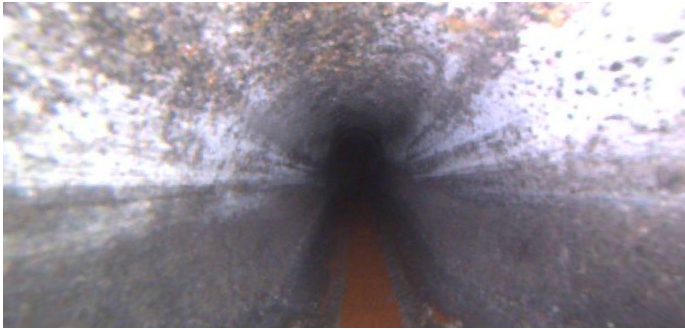
Code:	<b>MWL</b>
Description:	<b>Water Level</b>

Distance (ft):	<b>.0</b>
Structural Grade:	<b>0</b>
O&M Grade:	<b>0</b>
Clock Start/From:	
Clock To:	
1st Value:	
2nd Value:	
Value Percent:	<b>5.000</b>
Continuous Index:	
Within 8" of Joint:	<b>NO</b>
Remarks:

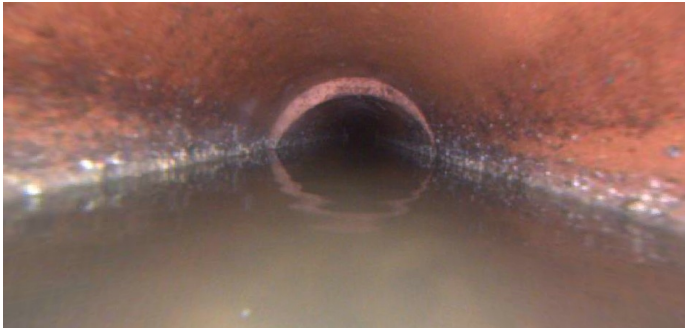
Code: **MWL**  
Description: **Water Level**

Distance (ft): **29.7**  
Structural Grade: **0**  
O&M Grade: **0**  
Clock Start/From:  
Clock To:  
1st Value:  
2nd Value:  
Value Percent: **50.000**  
Continuous Index:  
Within 8" of Joint: **NO**  
Remarks:

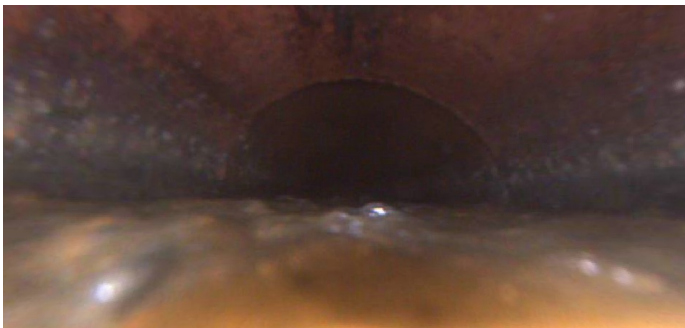
Code: **MGO**  
Description: **General Observation**

Distance (ft): **31.6**  
Structural Grade: **0**  
O&M Grade: **0**  
Clock Start/From:  
Clock To:  
1st Value:  
2nd Value:  
Value Percent:  
Continuous Index:  
Within 8" of Joint: **NO**  
Remarks: **Switching to rear camera**

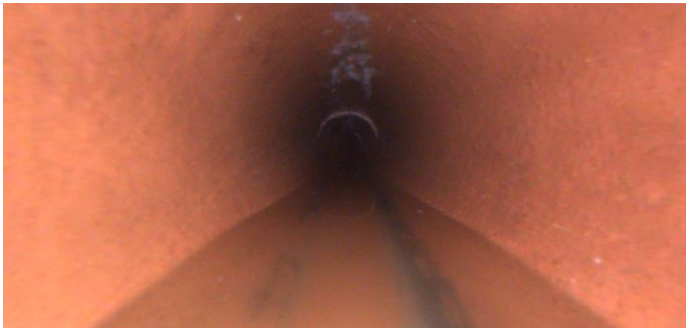
Code: **MGO**  
Description: **General Observation**

Distance (ft): **40.2**  
Structural Grade: **0**  
O&M Grade: **0**  
Clock Start/From:  
Clock To:  
1st Value:  
2nd Value:  
Value Percent:  
Continuous Index:  
Within 8" of Joint: **NO**  
Remarks: **Switching to front camera**

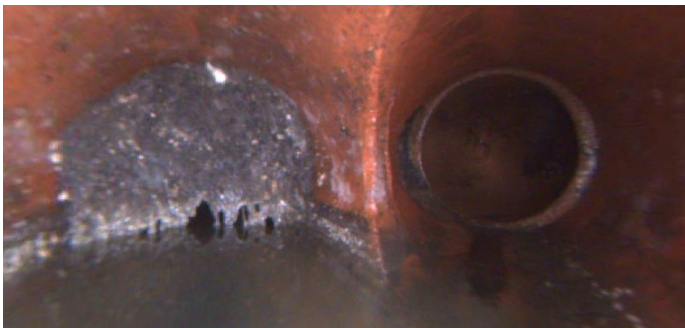
Code: TF  
Description: Tap Factory

Distance (ft): 72.3  
Structural Grade: 0  
O&M Grade: 0  
Clock Start/From: 3  
Clock To:  
1st Value: 4.000  
2nd Value:  
Value Percent:  
Continuous Index:  
Within 8" of Joint:  
Remarks:

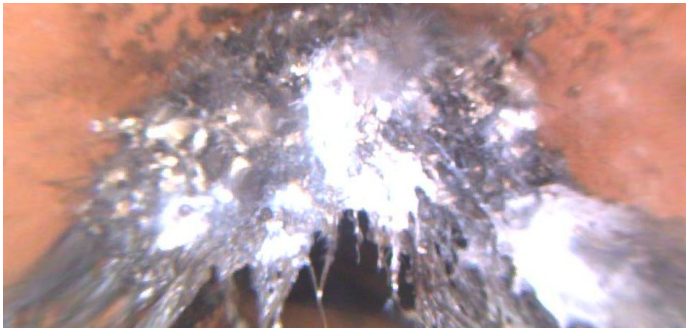
Code: **MSA**  
Description: **Abandoned Survey**

Distance (ft): **77.1**  
Structural Grade: **0**  
O&M Grade: **0**  
Clock Start/From:  
Clock To:  
1st Value:  
2nd Value:  
Value Percent:  
Continuous Index:  
Within 8" of Joint: **NO**  
Remarks: **RMJ**
