## Profile/Photo Observation Report

Date:	<b>03/20/2018</b>	Weather:		Coding:	<b>PACP 6.0</b>
Pipe Length (ft):	<b>393.1</b>	Owner:	<b>NA</b>	Pre Clean:	<b>No Pre-Cleaning</b>
P.O.#:		Surveyor:	<b>John Kuglmaier</b>	PSR:	<b>P-209-011-012</b>
Customer:		Clean Date:	<b>01/01/1900</b>	Shape:	<b>C</b>

Street:	<b>FOXCROFT STREET</b>	Flow Control:	<b>Not Controlled</b>
City:	<b>Hobart, IN</b>	Year Renewed:	
Location:	<b>Light Highway</b>	Tape/Media #:	
Purpose:	<b>Routine Assessment</b>	Dia/Height:	<b>8"</b>
Use:	<b>Sanitary</b>	Material:	<b>VCP</b>
Drain Area:	<b>NA</b>	Lining:	
Category:	<b>NA</b>		
Comment:	<b>P_C at 76 ft roots . Flow wrong</b>

Location Details:		Direction of Survey:	<b>Downstream</b>
US MH:	<b>M-209-012</b>	DS MH:	<b>M-209-011</b>
		Total Length Surveyed (ft):	<b>77.1</b>

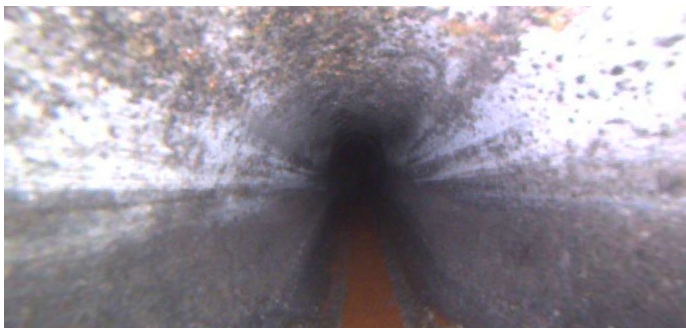
Code: **AMH**  
Description: **Manhole**

Distance (ft): **.0**  
Structural Grade: **0**  
O&M Grade: **0**  
Clock Start/From:  
Clock To:  
1st Value:  
2nd Value:  
Value Percent:  
Continuous Index:  
Within 8" of Joint: **NO**  
Remarks: **M-209-012**

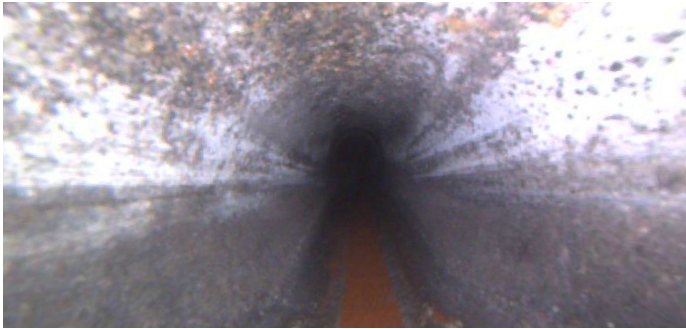
Code:	<b>MWL</b>
Description:	<b>Water Level</b>

Distance (ft):	<b>.0</b>
Structural Grade:	<b>0</b>
O&M Grade:	<b>0</b>
Clock Start/From:	
Clock To:	
1st Value:	
2nd Value:	
Value Percent:	<b>5.000</b>
Continuous Index:	
Within 8" of Joint:	<b>NO</b>
Remarks:

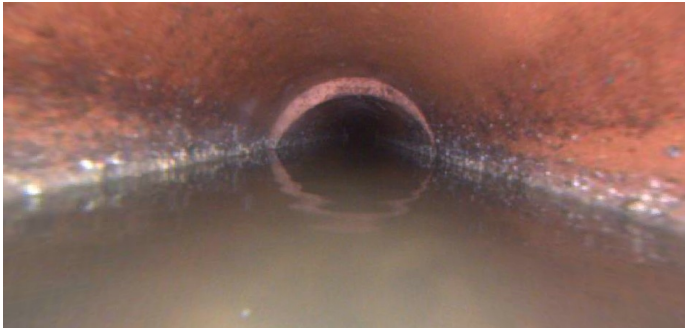
Code: **MWL**  
Description: **Water Level**

Distance (ft): **29.7**  
Structural Grade: **0**  
O&M Grade: **0**  
Clock Start/From:  
Clock To:  
1st Value:  
2nd Value:  
Value Percent: **50.000**  
Continuous Index:  
Within 8" of Joint: **NO**  
Remarks:

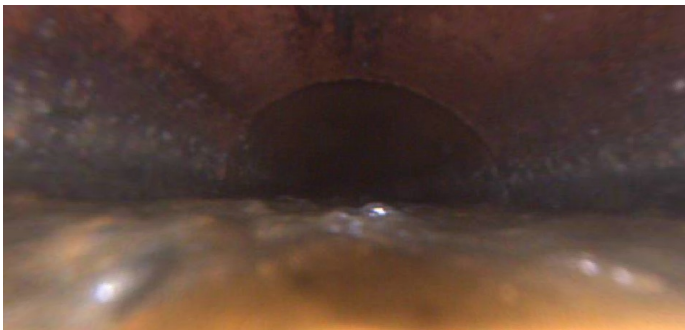
Code: **MGO**  
Description: **General Observation**

Distance (ft): **31.6**  
Structural Grade: **0**  
O&M Grade: **0**  
Clock Start/From:  
Clock To:  
1st Value:  
2nd Value:  
Value Percent:  
Continuous Index:  
Within 8" of Joint: **NO**  
Remarks: **Switching to rear camera**

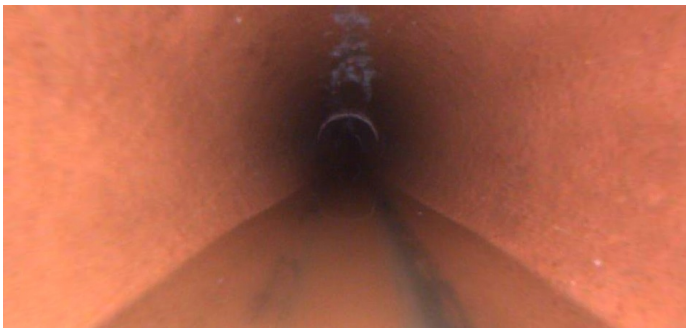
Code: **MGO**  
Description: **General Observation**

Distance (ft): **40.2**  
Structural Grade: **0**  
O&M Grade: **0**  
Clock Start/From:  
Clock To:  
1st Value:  
2nd Value:  
Value Percent:  
Continuous Index:  
Within 8" of Joint: **NO**  
Remarks: **Switching to front camera**

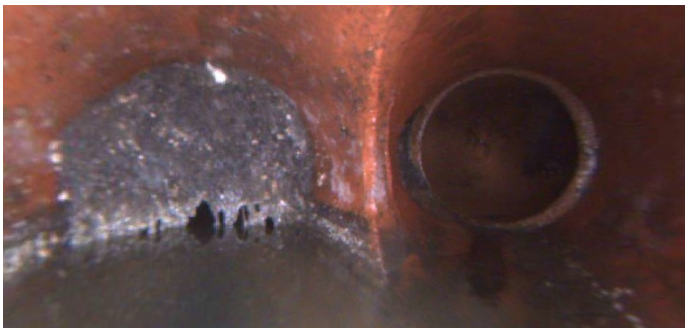
Code: TF  
Description: Tap Factory

Distance (ft): 72.3  
Structural Grade: 0  
O&M Grade: 0  
Clock Start/From: 3  
Clock To:  
1st Value: 4.000  
2nd Value:  
Value Percent:  
Continuous Index:  
Within 8" of Joint:  
Remarks:

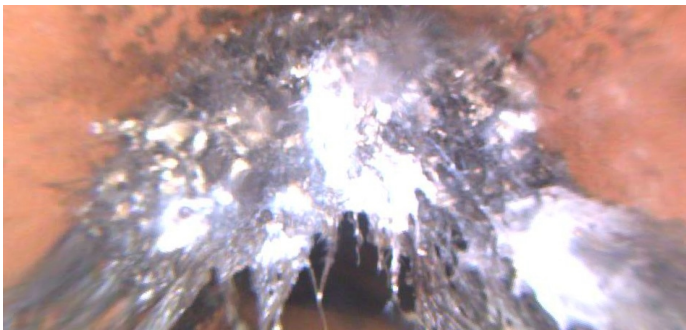
Code: **MSA**  
Description: **Abandoned Survey**

Distance (ft): **77.1**  
Structural Grade: **0**  
O&M Grade: **0**  
Clock Start/From:  
Clock To:  
1st Value:  
2nd Value:  
Value Percent:  
Continuous Index:  
Within 8" of Joint: **NO**  
Remarks: **RMJ**
