Profile/Photo Observation Report

Date:	03/20/2018	Weather:		Coding:	PACP 6.0
Pipe Length (ft):	237.2	Owner:	NA	Pre Clean:	No Pre-Cleaning
P.O.#:		Surveyor:	John Kuglmaier	PSR:	P-209-012-013
Customer:		Clean Date:	01/01/1900	Shape:	C

Street:	ALLEY BETWEEN MINNESOTA ST & C	Flow Control:	Not Controlled
City:	Hobart, IN	Year Renewed:	
Location:	Light Highway	Tape/Media #:	
Purpose:	Routine Assessment	Dia/Height:	8"
Use:	Sanitary	Material:	VCP
Drain Area:	NA	Lining:	
Category:	NA		
Comment:	O_C at 76 ft can see last image and cant find MH . Flow wrong		
Location Details:		Direction of Survey:	Upstream
US MH:	M-209-013	DS MH:	M-209-012
		Total Length Surveyed (ft):	78.0

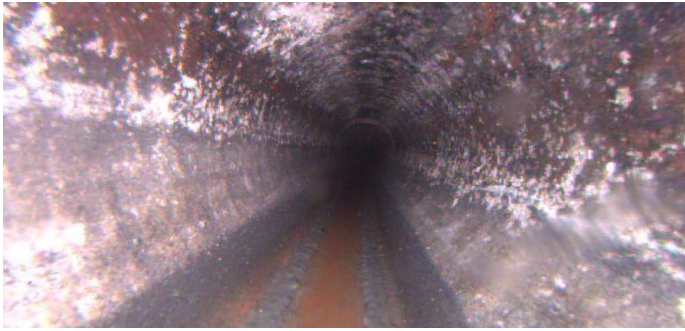
Code: **AMH**
Description: **Manhole**

Distance (ft): **.0**
Structural Grade: **0**
O&M Grade: **0**
Clock Start/From:
Clock To:
1st Value:
2nd Value:
Value Percent:
Continuous Index:
Within 8" of Joint: **NO**
Remarks: **M-209-012**

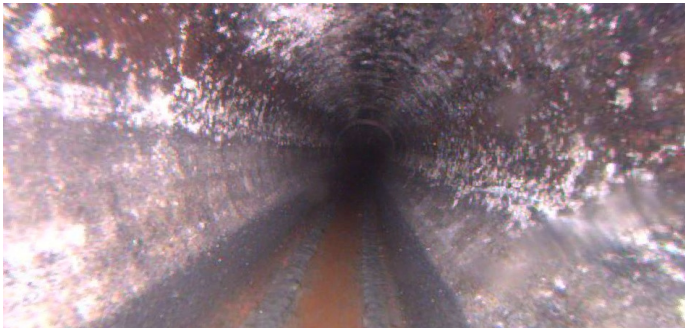
Code: **MWL**
Description: **Water Level**

Distance (ft): **.0**
Structural Grade: **0**
O&M Grade: **0**
Clock Start/From:
Clock To:
1st Value:
2nd Value:
Value Percent: **5.000**
Continuous Index:
Within 8" of Joint: **NO**
Remarks:

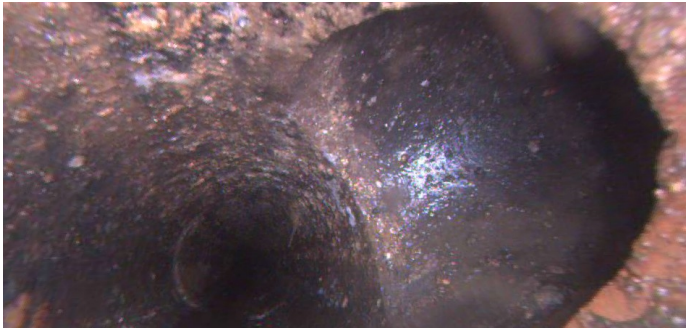
Code: **TF**
Description: **Tap Factory**

Distance (ft): **14.8**
Structural Grade: **0**
O&M Grade: **0**
Clock Start/From: **2**
Clock To:
1st Value: **4.000**
2nd Value:
Value Percent:
Continuous Index:
Within 8" of Joint:
Remarks:

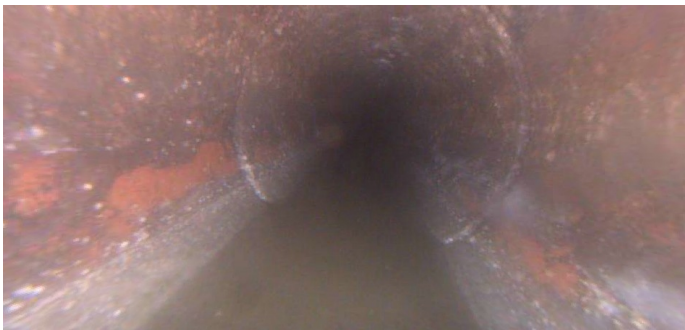
Code: **MWL**
Description: **Water Level**

Distance (ft): **32.1**
Structural Grade: **0**
O&M Grade: **0**
Clock Start/From:
Clock To:
1st Value:
2nd Value:
Value Percent: **15.000**
Continuous Index:
Within 8" of Joint: **NO**
Remarks:

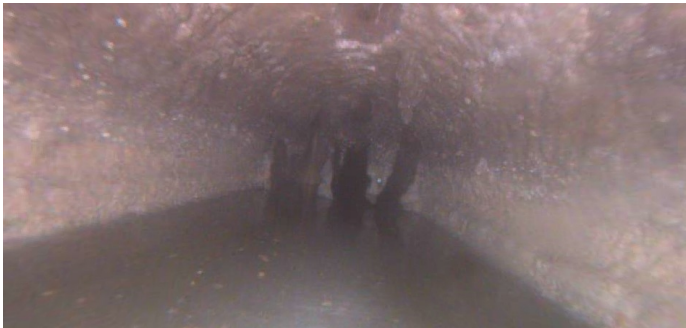
Code: **MWL**
Description: **Water Level**

Distance (ft): **43.9**
Structural Grade: **0**
O&M Grade: **0**
Clock Start/From:
Clock To:
1st Value:
2nd Value:
Value Percent: **35.000**
Continuous Index:
Within 8" of Joint: **NO**
Remarks:

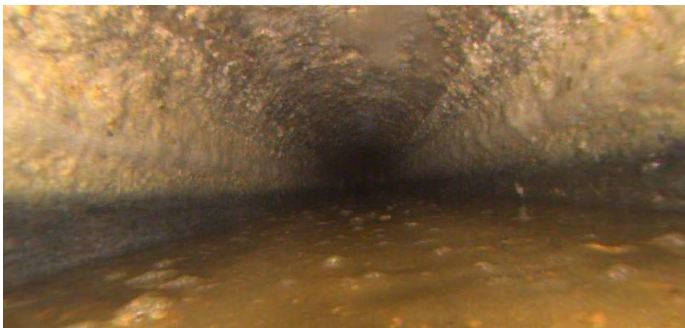
Code: **MGO**
Description: **General Observation**

Distance (ft): **50.6**
Structural Grade: **0**
O&M Grade: **0**
Clock Start/From:
Clock To:
1st Value:
2nd Value:
Value Percent:
Continuous Index:
Within 8" of Joint: **NO**
Remarks: **Switching to rear camera**

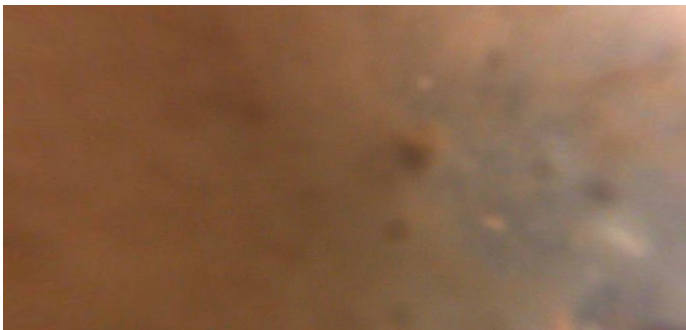
Code: **MGO**
Description: **General Observation**

Distance (ft): **75.8**
Structural Grade: **0**
O&M Grade: **0**
Clock Start/From:
Clock To:
1st Value:
2nd Value:
Value Percent:
Continuous Index:
Within 8" of Joint: **NO**
Remarks: **Switching to front camera**
