Profile/Photo Observation Report

Date:	03/19/2018	Weather:		Coding:	PACP 6.0
Pipe Length (ft):	288.5	Owner:	NA	Pre Clean:	No Pre-Cleaning
P.O.#:		Surveyor:	John Kuglmaier	PSR:	P-209-008-014
Customer:		Clean Date:	01/01/1900	Shape:	C

Street:	FOXCROFT STREET	Flow Control:	Not Controlled
City:	Hobart, IN	Year Renewed:	
Location:	Light Highway	Tape/Media #:	
Purpose:	Routine Assessment	Dia/Height:	8"
Use:	Sanitary	Material:	VCP
Drain Area:	NA	Lining:	
Category:	NA		
Comment:	P_C at 102 ft nothing visible . flow direction		
Location Details:		Direction of Survey:	Downstream
US MH:	M-209-014	DS MH:	M-209-008
		Total Length Surveyed (ft):	103.2

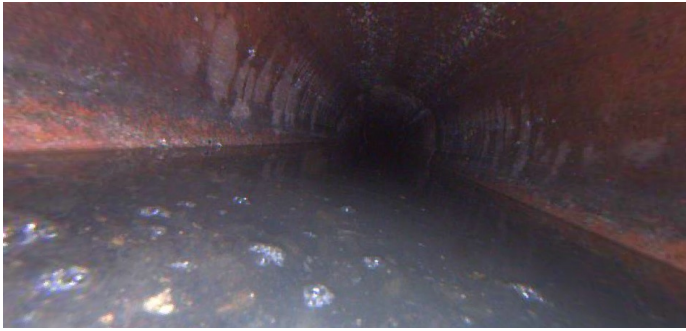
Code: **AMH**
Description: **Manhole**

Distance (ft): **.0**
Structural Grade: **0**
O&M Grade: **0**
Clock Start/From:
Clock To:
1st Value:
2nd Value:
Value Percent:
Continuous Index:
Within 8" of Joint: **NO**
Remarks: **M-209-014**

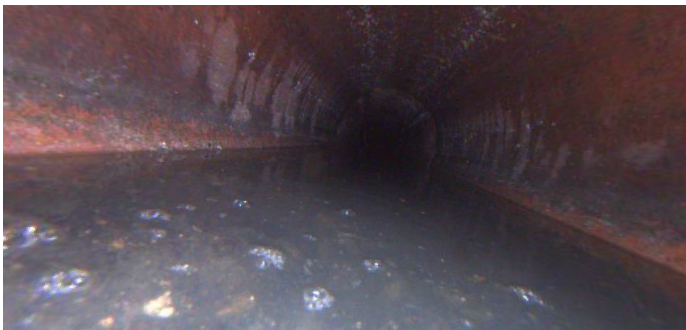
Code: **MWL**
Description: **Water Level**

Distance (ft): **.0**
Structural Grade: **0**
O&M Grade: **0**
Clock Start/From:
Clock To:
1st Value:
2nd Value:
Value Percent: **25.000**
Continuous Index:
Within 8" of Joint: **NO**
Remarks:

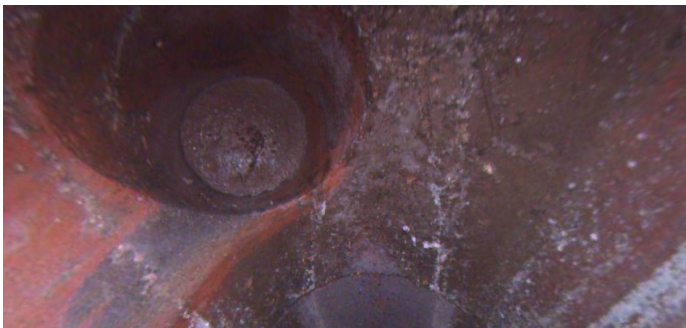
Code: **TFC**
Description: **Tap Factory Capped**

Distance (ft): **29.7**
Structural Grade: **0**
O&M Grade: **0**
Clock Start/From: **11**
Clock To:
1st Value: **4.000**
2nd Value:
Value Percent:
Continuous Index:
Within 8" of Joint:
Remarks:

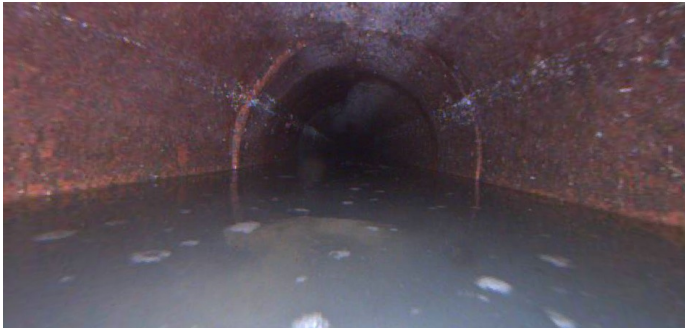
Code: **MWL**
Description: **Water Level**

Distance (ft): **75.4**
Structural Grade: **0**
O&M Grade: **0**
Clock Start/From:
Clock To:
1st Value:
2nd Value:
Value Percent: **40.000**
Continuous Index:
Within 8" of Joint: **NO**
Remarks:

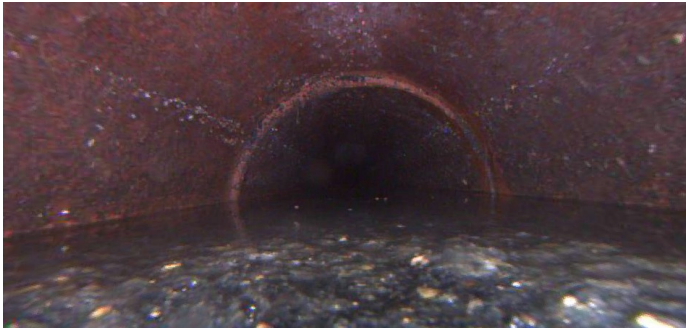
Code: **MWL**
Description: **Water Level**

Distance (ft): **91.5**
Structural Grade: **0**
O&M Grade: **0**
Clock Start/From:
Clock To:
1st Value:
2nd Value:
Value Percent: **50.000**
Continuous Index:
Within 8" of Joint: **NO**
Remarks:

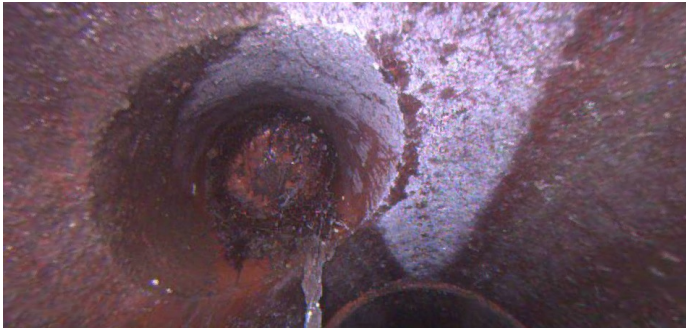
Code: **TFC**
Description: **Tap Factory Capped**

Distance (ft): **101.8**
Structural Grade: **0**
O&M Grade: **0**
Clock Start/From: **11**
Clock To:
1st Value: **4.000**
2nd Value:
Value Percent:
Continuous Index:
Within 8" of Joint:
Remarks:

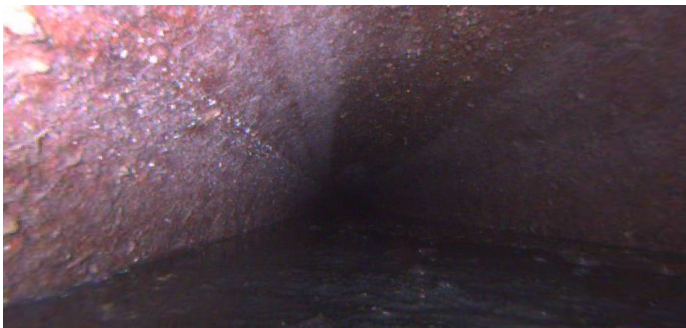
Code: **MSA**
Description: **Abandoned Survey**

Distance (ft): **103.2**
Structural Grade: **0**
O&M Grade: **0**
Clock Start/From:
Clock To:
1st Value:
2nd Value:
Value Percent:
Continuous Index:
Within 8" of Joint: **NO**
Remarks: **Unknown**
