Profile/Photo Observation Report

Date:	03/19/2018	Weather:		Coding:	PACP 6.0
Pipe Length (ft):	295.2	Owner:	NA	Pre Clean:	No Pre-Cleaning
P.O.#:		Surveyor:	John Kuglmaier	PSR:	P-209-020-024
Customer:		Clean Date:	01/01/1900	Shape:	C

Street:	E 61ST PL	Flow Control:	Not Controlled
City:	Hobart, IN	Year Renewed:	
Location:	Light Highway	Tape/Media #:	
Purpose:	Routine Assessment	Dia/Height:	12"
Use:	Sanitary	Material:	VCP
Drain Area:	NA	Lining:	
Category:	NA		
Comment:	P_C at 323 ft debris past MH at 296 .Flow direction wrong		
Location Details:		Direction of Survey:	Upstream
US MH:	M-209-024	DS MH:	M-209-020
		Total Length Surveyed (ft):	322.6

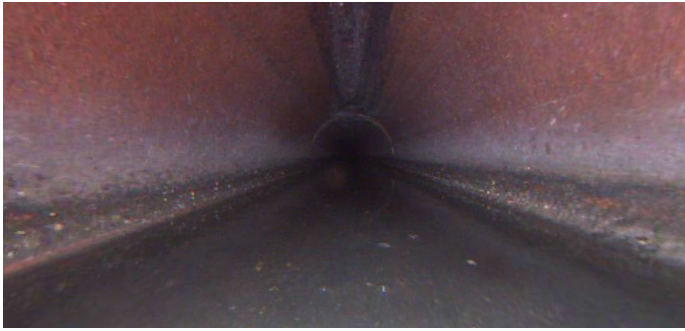
Code: **AMH**
Description: **Manhole**

Distance (ft): **.0**
Structural Grade: **0**
O&M Grade: **0**
Clock Start/From:
Clock To:
1st Value:
2nd Value:
Value Percent:
Continuous Index:
Within 8" of Joint: **NO**
Remarks: **M-209-020**

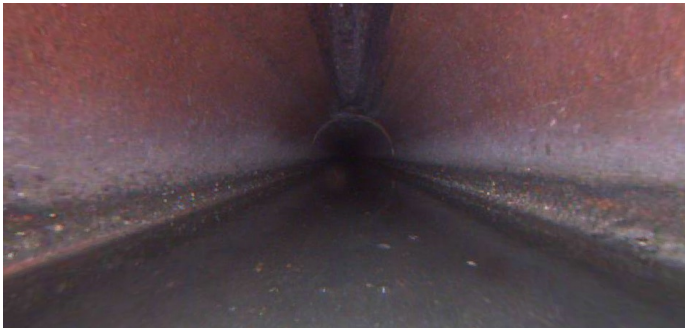
Code: **MWL**
Description: **Water Level**

Distance (ft): **.0**
Structural Grade: **0**
O&M Grade: **0**
Clock Start/From:
Clock To:
1st Value:
2nd Value:
Value Percent: **25.000**
Continuous Index:
Within 8" of Joint: **NO**
Remarks:

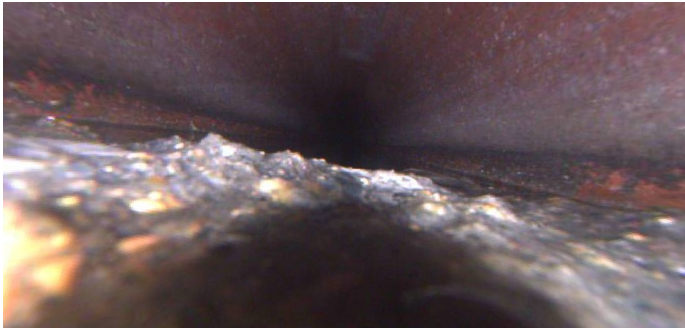
Code: **MWL**
Description: **Water Level**

Distance (ft): **5.7**
Structural Grade: **0**
O&M Grade: **0**
Clock Start/From:
Clock To:
1st Value:
2nd Value:
Value Percent: **35.000**
Continuous Index:
Within 8" of Joint: **NO**
Remarks:

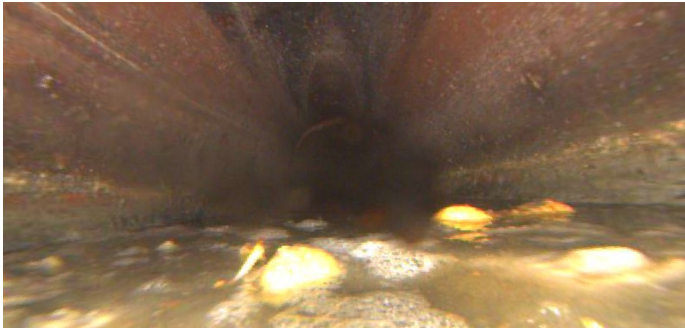
Code: **MGO**
Description: **General Observation**

Distance (ft): **17.7**
Structural Grade: **0**
O&M Grade: **0**
Clock Start/From:
Clock To:
1st Value:
2nd Value:
Value Percent:
Continuous Index:
Within 8" of Joint: **NO**
Remarks: **Switching to rear camera**

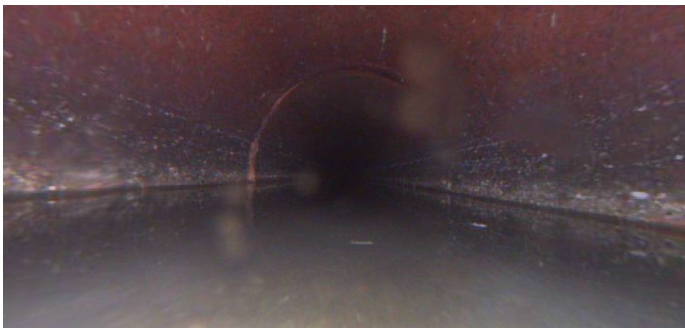
Code: **MGO**
Description: **General Observation**

Distance (ft): **23.3**
Structural Grade: **0**
O&M Grade: **0**
Clock Start/From:
Clock To:
1st Value:
2nd Value:
Value Percent:
Continuous Index:
Within 8" of Joint: **NO**
Remarks: **Switching to front camera**

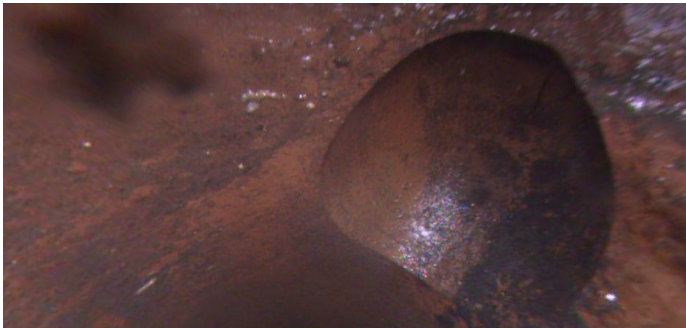
Code: **TF**
Description: **Tap Factory**

Distance (ft): **251.5**
Structural Grade: **0**
O&M Grade: **0**
Clock Start/From: **1**
Clock To:
1st Value: **4.000**
2nd Value:
Value Percent:
Continuous Index:
Within 8" of Joint:
Remarks:

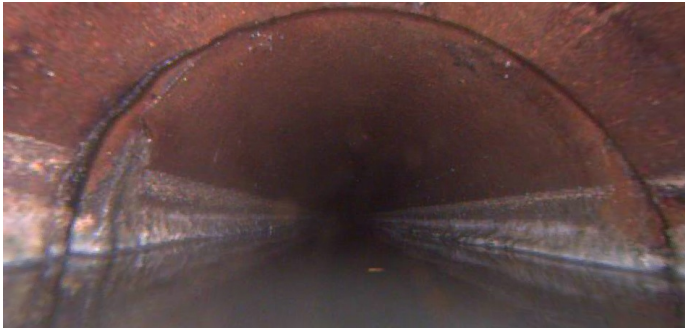
Code: **MWL**
Description: **Water Level**

Distance (ft): **257.9**
Structural Grade: **0**
O&M Grade: **0**
Clock Start/From:
Clock To:
1st Value:
2nd Value:
Value Percent: **50.000**
Continuous Index:
Within 8" of Joint: **NO**
Remarks:

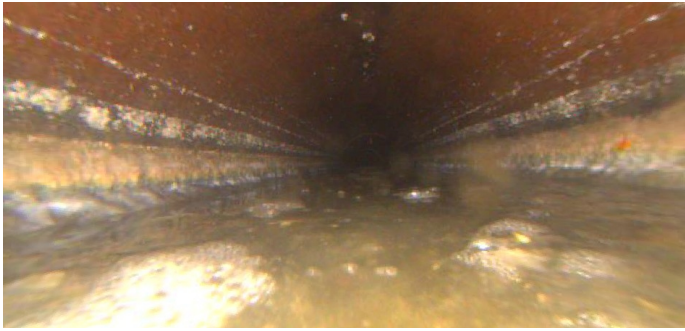
Code: **MGO**
Description: **General Observation**

Distance (ft): **273.3**
Structural Grade: **0**
O&M Grade: **0**
Clock Start/From:
Clock To:
1st Value:
2nd Value:
Value Percent:
Continuous Index:
Within 8" of Joint: **NO**
Remarks: **Switching to rear camera**

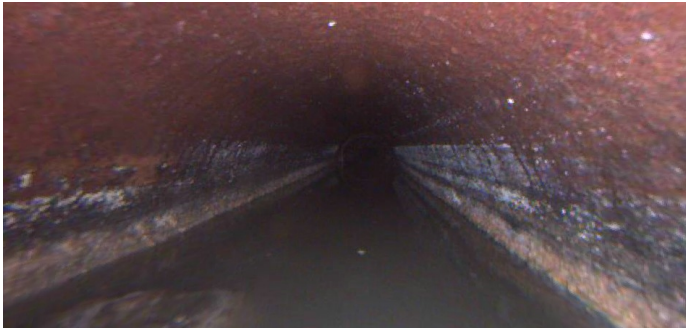
Code: **MGO**
Description: **General Observation**

Distance (ft): **288.9**
Structural Grade: **0**
O&M Grade: **0**
Clock Start/From:
Clock To:
1st Value:
2nd Value:
Value Percent:
Continuous Index:
Within 8" of Joint: **NO**
Remarks: **Switching to front camera**

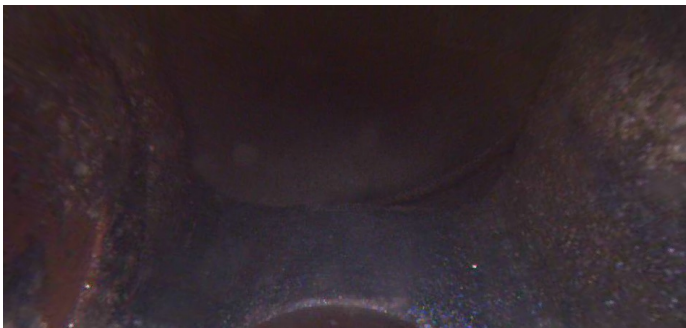
Code: **AMH**
Description: **Manhole**

Distance (ft): **294.3**
Structural Grade: **0**
O&M Grade: **0**
Clock Start/From:
Clock To:
1st Value:
2nd Value:
Value Percent:
Continuous Index:
Within 8" of Joint: **NO**
Remarks: **M-209-024**
