Profile/Photo Observation Report

Date:	03/19/2018	Weather:		Coding:	PACP 6.0
Pipe Length (ft):	295.2	Owner:	NA	Pre Clean:	No Pre-Cleaning
P.O.#:		Surveyor:	John Kuglmaier	PSR:	P-209-020-024
Customer:		Clean Date:	01/01/1900	Shape:	C

Street:	FOXCROFT STREET	Flow Control:	Not Controlled
City:	Hobart, IN	Year Renewed:	
Location:	Light Highway	Tape/Media #:	
Purpose:	Routine Assessment	Dia/Height:	12"
Use:	Sanitary	Material:	VCP
Drain Area:	NA	Lining:	
Category:	NA		
Comment:	P_C at 323 ft debris past MH at 296 .Flow direction wrong		
Location Details:		Direction of Survey:	Upstream
US MH:	M-209-024	DS MH:	M-209-020
		Total Length Surveyed (ft):	322.6

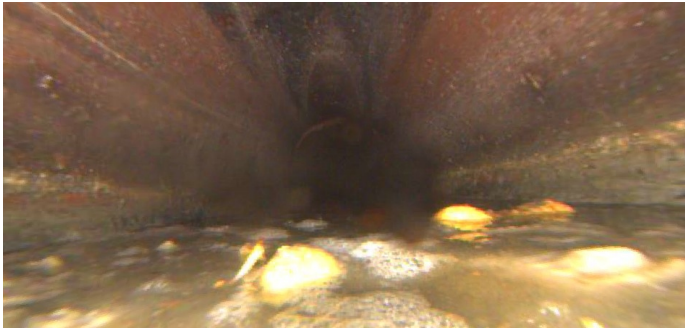
Code: **MGO**
Description: **General Observation**

Distance (ft): **17.7**
Structural Grade: **0**
O&M Grade: **0**
Clock Start/From:
Clock To:
1st Value:
2nd Value:
Value Percent:
Continuous Index:
Within 8" of Joint: **NO**
Remarks: **Switching to rear camera**

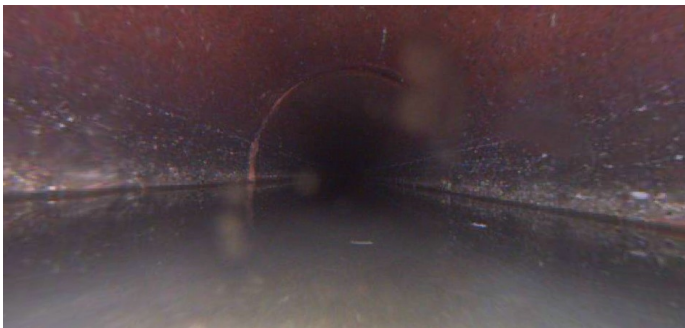
Code: **MGO**
Description: **General Observation**

Distance (ft): **23.3**
Structural Grade: **0**
O&M Grade: **0**
Clock Start/From:
Clock To:
1st Value:
2nd Value:
Value Percent:
Continuous Index:
Within 8" of Joint: **NO**
Remarks: **Switching to front camera**

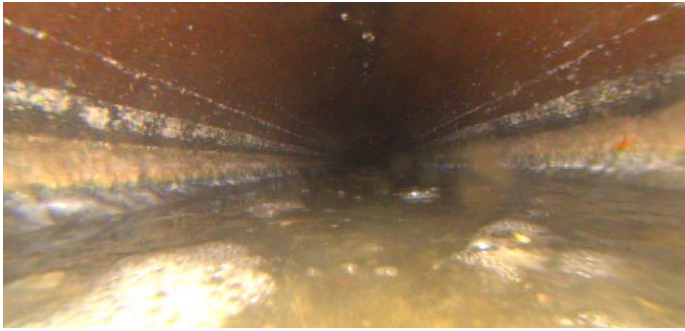
Code: **MGO**
Description: **General Observation**

Distance (ft): **273.3**
Structural Grade: **0**
O&M Grade: **0**
Clock Start/From:
Clock To:
1st Value:
2nd Value:
Value Percent:
Continuous Index:
Within 8" of Joint: **NO**
Remarks: **Switching to rear camera**

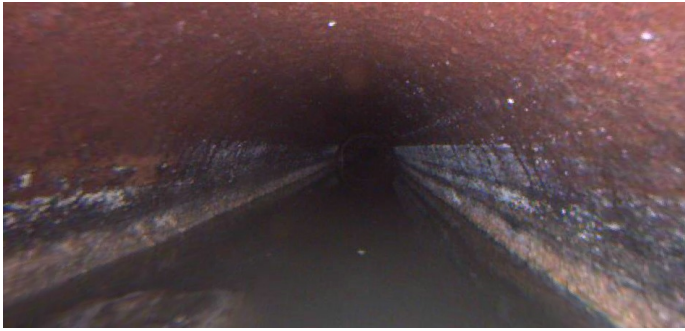
Code: **MGO**
Description: **General Observation**

Distance (ft): **288.9**
Structural Grade: **0**
O&M Grade: **0**
Clock Start/From:
Clock To:
1st Value:
2nd Value:
Value Percent:
Continuous Index:
Within 8" of Joint: **NO**
Remarks: **Switching to front camera**
