## Profile/Photo Observation Report

Date:	<b>01/17/2025</b>	Weather:		Coding:	<b>PACP 7.0</b>
Pipe Length (ft):	<b>156.0</b>	Owner:	<b>City of Hobart</b>	Pre Clean:	<b>Heavy Cleaning</b>
P.O.#:	<b>YES502259</b>	Surveyor:	<b>S. Bucklin</b>	PSR:	<b>P-209-024-025</b>
Customer:	<b>City of Hobart</b>	Clean Date:	<b>07/14/2024</b>	Shape:	<b>C</b>

Street:	<b>East 61st Place</b>	Flow Control:	<b>De-watered Using Jetter</b>
City:	<b>Hobart, IN</b>	Year Renewed:	
Location:	<b>Local rural streets with light traffic, t</b>	Tape/Media #:	
Purpose:	<b>Sewer System Evaluation Survey (SS</b>	Dia/Height:	<b>15"</b>
Use:	<b>Sanitary Sewage Pipe</b>	Material:	<b>VCP</b>
Drain Area:		Lining:	<b>None</b>
Category:	<b>NA</b>		
Comment:			
Location Details:		Direction of Survey:	<b>Upstream</b>
US MH:	<b>M-209-024</b>	DS MH:	<b>M-209-025</b>
		Total Length Surveyed (ft):	<b>154.6</b>

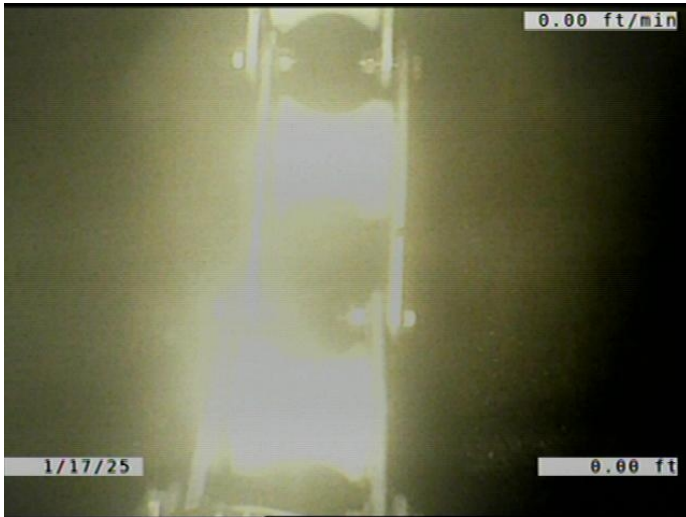
Code: **AMH**  
Description: **Manhole**

Distance (ft): **.0**  
Structural Grade: **0**  
O&M Grade: **0**  
Clock Start/From:  
Clock To:  
1st Value:  
2nd Value:  
Value Percent:  
Continuous Index:  
Within 8" of Joint: **NO**  
Remarks: **M-209-025**

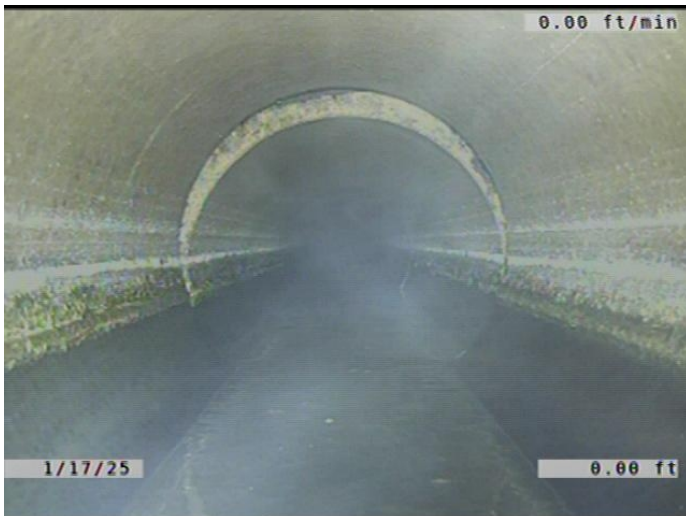
Code: **MWL**  
Description: **Miscellaneous Water Level**

Distance (ft): **.0**  
Structural Grade: **0**  
O&M Grade: **0**  
Clock Start/From:  
Clock To:  
1st Value:  
2nd Value:  
Value Percent: **10.000**  
Continuous Index:  
Within 8" of Joint: **NO**  
Remarks:

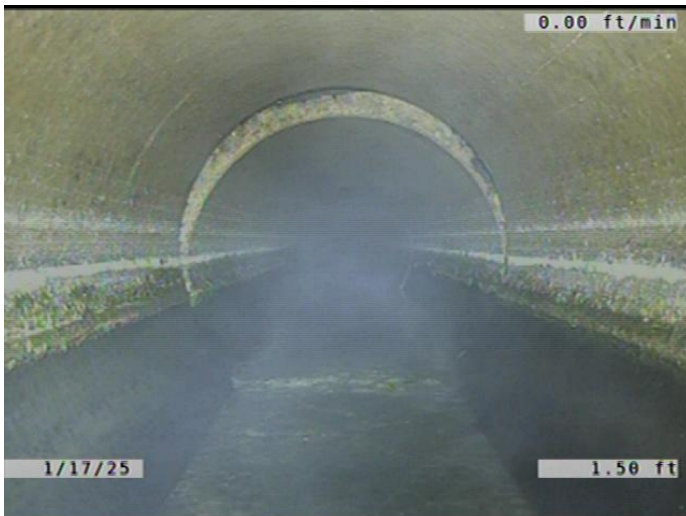
Code: **MWM**  
Description: **Miscellaneous Water Mark**

Distance (ft): **1.5**  
Structural Grade: **0**  
O&M Grade: **0**  
Clock Start/From:  
Clock To:  
1st Value:  
2nd Value:  
Value Percent: **85.000**  
Continuous Index:  
Within 8" of Joint: **NO**  
Remarks:

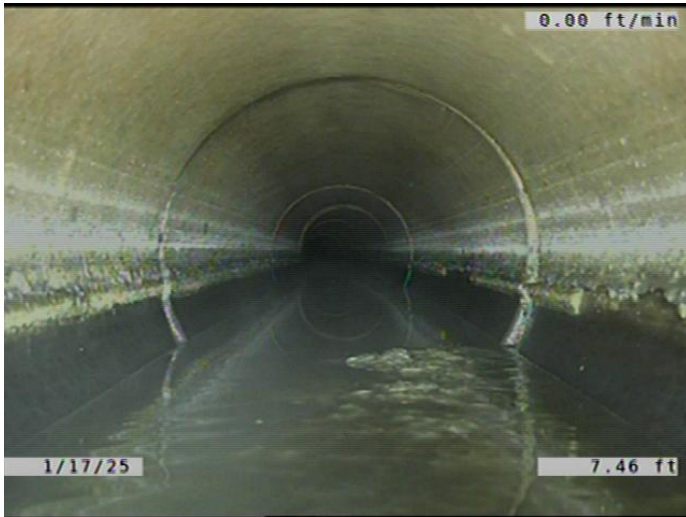
Code: **MWL**  
 Description: **Miscellaneous Water Level**

Distance (ft): **7.5**  
 Structural Grade: **0**  
 O&M Grade: **0**  
 Clock Start/From:  
 Clock To:  
 1st Value:  
 2nd Value:  
 Value Percent: **20.000**  
 Continuous Index:  
 Within 8" of Joint: **NO**  
 Remarks:

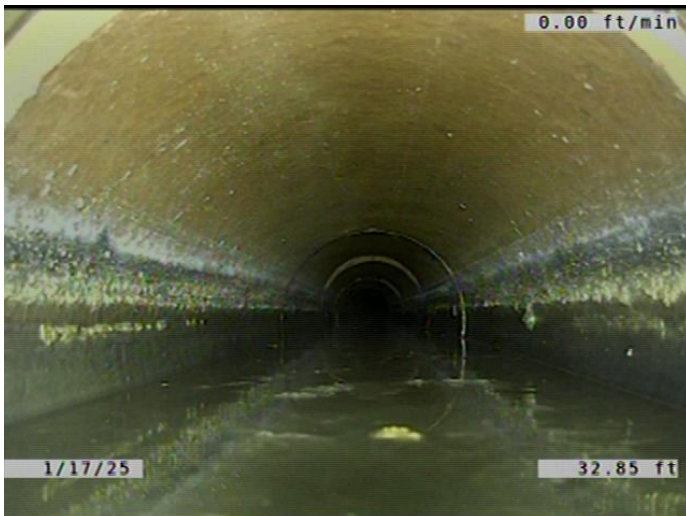
Code:	<b>MWL</b>
Description:	<b>Miscellaneous Water Level</b>
Distance (ft):	<b>32.8</b>
Structural Grade:	<b>0</b>
O&M Grade:	<b>0</b>
Clock Start/From:	
Clock To:	
1st Value:	
2nd Value:	
Value Percent:	<b>30.000</b>
Continuous Index:	
Within 8" of Joint:	<b>NO</b>
Remarks:

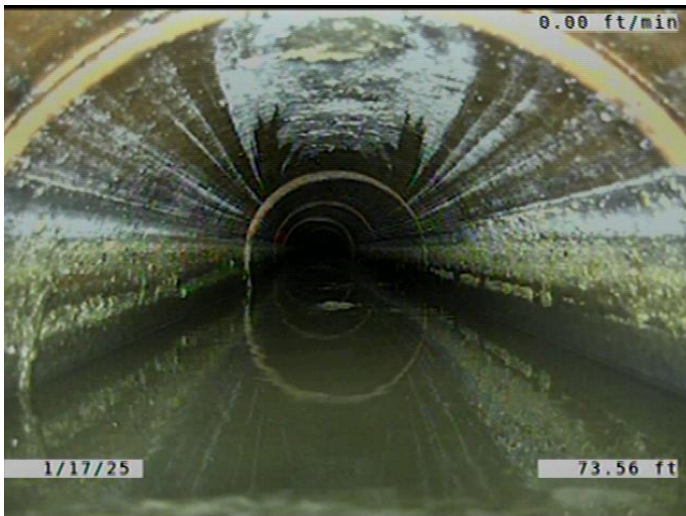
Code: **MWM**  
 Description: **Miscellaneous Water Mark**

Distance (ft): **73.6**  
 Structural Grade: **0**  
 O&M Grade: **0**  
 Clock Start/From:  
 Clock To:  
 1st Value:  
 2nd Value:  
 Value Percent: **100.000**  
 Continuous Index:  
 Within 8" of Joint: **NO**  
 Remarks:

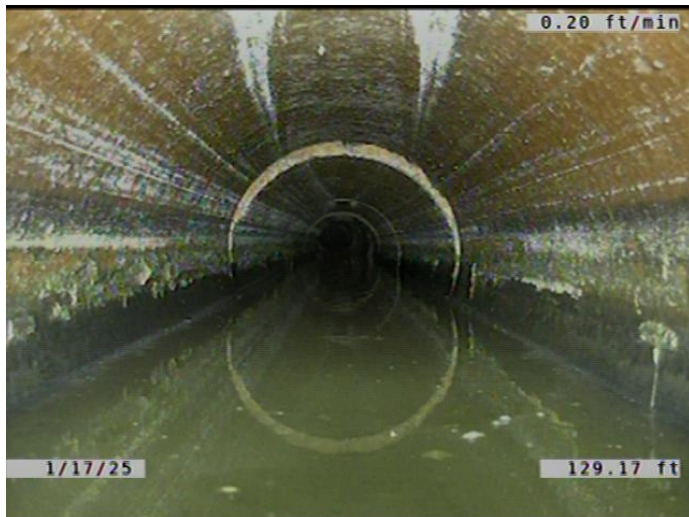
Code: **MWM**  
 Description: **Miscellaneous Water Mark**

Distance (ft): **129.2**  
 Structural Grade: **0**  
 O&M Grade: **0**  
 Clock Start/From:  
 Clock To:  
 1st Value:  
 2nd Value:  
 Value Percent: **90.000**  
 Continuous Index:  
 Within 8" of Joint: **NO**  
 Remarks:

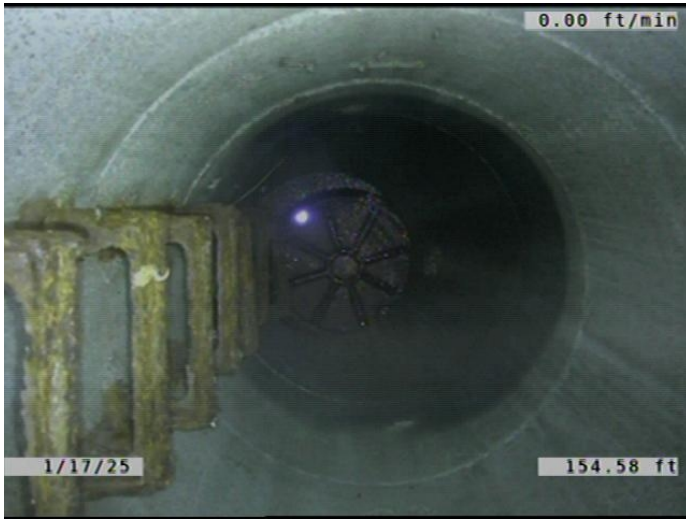
Code:	<b>AMH</b>
Description:	<b>Manhole</b>
Distance (ft):	<b>154.6</b>
Structural Grade:	<b>0</b>
O&M Grade:	<b>0</b>
Clock Start/From:	
Clock To:	
1st Value:	
2nd Value:	
Value Percent:	
Continuous Index:	
Within 8" of Joint:	<b>NO</b>
Remarks:	<b>M-209-024</b>
