Profile/Photo Observation Report

Date:	04/07/2018	Weather:		Coding:	PACP 6.0
Pipe Length (ft):		Owner:	City of Hobart	Pre Clean:	No Pre-Cleaning
P.O.#:	12-1	Surveyor:	M. Pielacha	PSR:	M-303-002-M-303-001
Customer:	City of Hobart	Clean Date:		Shape:	C

Street:	West Old Ridge Road	Flow Control:	Not Controlled
City:	Hobart, IN	Year Renewed:	
Location:	Other	Tape/Media #:	DEP 12
Purpose:	Routine Assessment	Dia/Height:	18"
Use:	Sanitary	Material:	VCP
Drain Area:		Lining:	
Category:	NA		
Comment:			
Location Details:		Direction of Survey:	Upstream
US MH:	M-303-002	DS MH:	M-303-001
		Total Length Surveyed (ft):	164.3

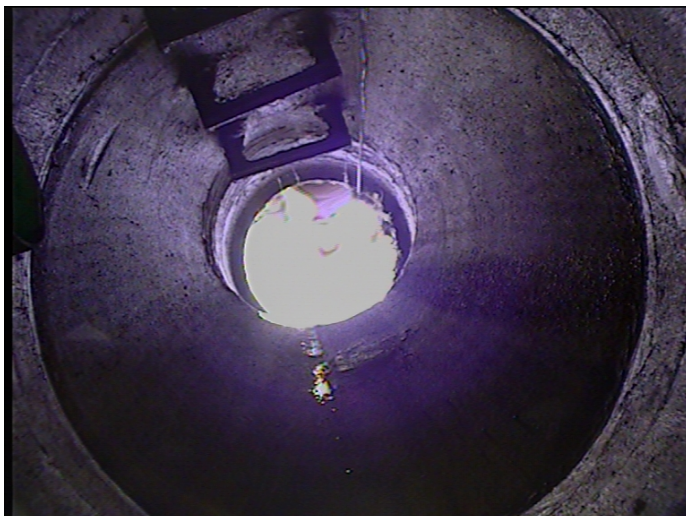
Code: **AMH**
 Description: **Manhole**

Distance (ft): **.0**
 Structural Grade: **0**
 O&M Grade: **0**
 Clock Start/From:
 Clock To:
 1st Value:
 2nd Value:
 Value Percent:
 Continuous Index:
 Within 8" of Joint: **NO**
 Remarks: **M-303-001**

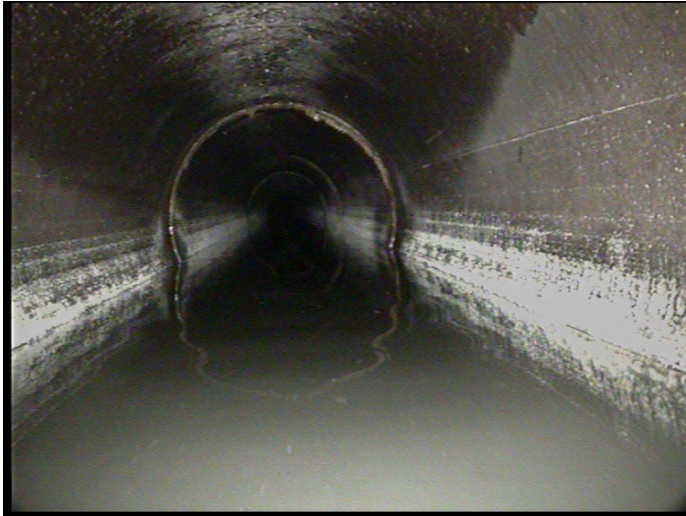
Code: **MWL**
Description: **Water Level**

Distance (ft): **.0**
Structural Grade: **0**
O&M Grade: **0**
Clock Start/From:
Clock To:
1st Value:
2nd Value:
Value Percent: **15.000**
Continuous Index:
Within 8" of Joint: **NO**
Remarks:

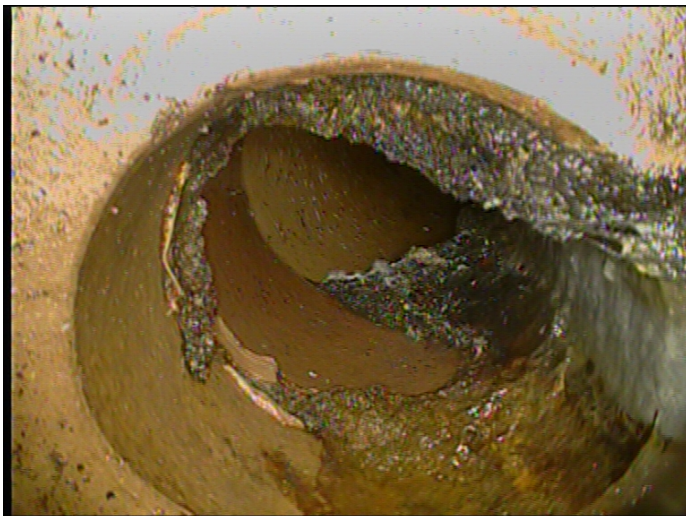
Code:	TF
Description:	Tap Factory
Distance (ft):	122.4
Structural Grade:	0
O&M Grade:	0
Clock Start/From:	2
Clock To:	
1st Value:	4.000
2nd Value:	
Value Percent:	
Continuous Index:	
Within 8" of Joint:	NO
Remarks:
